Effects of High Temperature on the Microstructure of Automotive Engine Valves

ABSTRACT

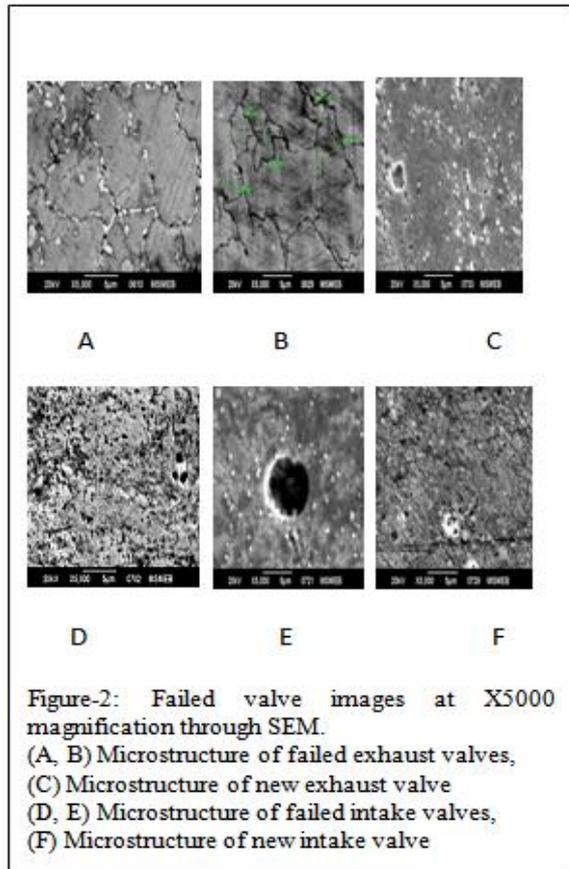
Images depicting the microstructure of failed exhaust valves are shown in Figure - 2 at X5000 magnification. The white colour spots in the images indicate the presence of carbides in the valve material. If the distribution of the carbide is fine, it increases the hardness of the material but a coarse distribution of the carbides makes them shift towards the grain boundaries with an accompanying reduction in the hardness and weakening of the material. The grain boundaries shown in the SEM image shows that they are broken and grains are not uniformly distributed. The size of grains increases after working at high temperatures. The size of grains indicates the strength of the material; big size grains indicate lower strength whereas small size of grains (or finer grain sizes) indicates higher material strength. This means that an increase in the size of the grains, or elongated grains, in SEM images of failed exhaust valves material indicates that the valve material strength has come down after being subjected to high temperatures for considerable periods. The microstructure of steel used for manufacturing the

internal combustion engine valves is a combination of ferrite matrix and carbide distributed all through. The process heading towards the equilibrium state continues and the microstructure changes to a ferrite - carbide mixture. Selective electron microscope diffraction identifies the complex and larger carbide particles in the matrix; the first identification happening at grain boundaries. Inside the grains and in the grain boundaries, carbide particles precipitate. At many locations, they form a network or grid like shape at the grain boundaries.

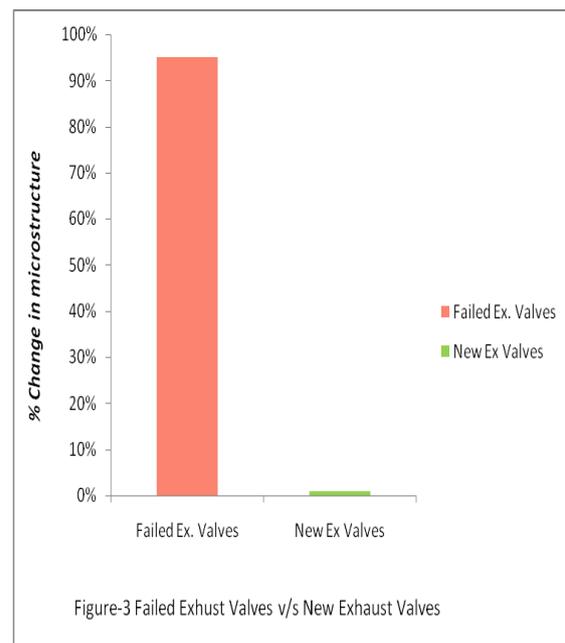
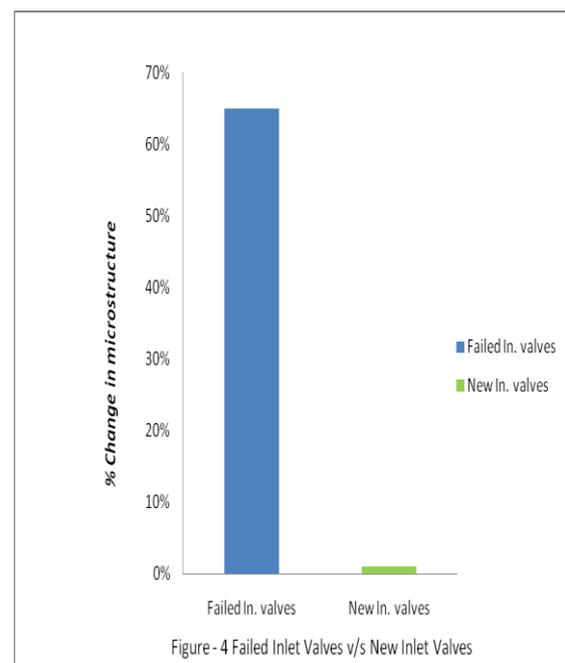
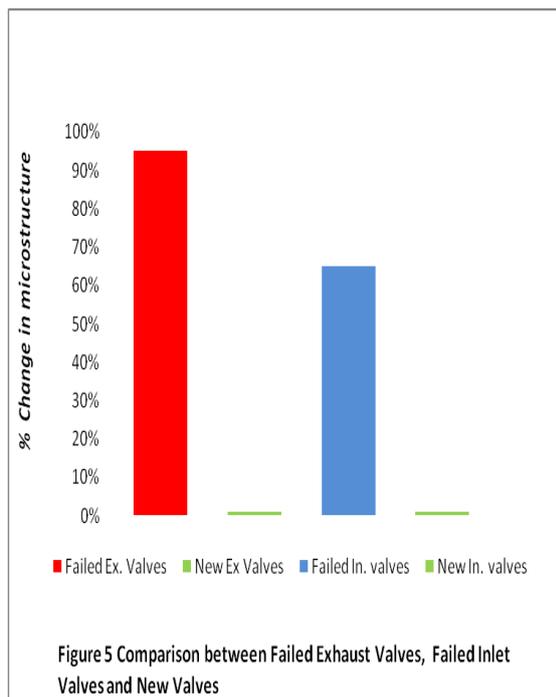
SEM images, taken at adequate resolution, are compared with the corresponding ones for new valves. The carbide distribution is expectedly regular with no observed shift towards grain boundaries, small sized grains are observed and no black holes are seen for the new valves. The images obtained for used valves indicate that the carbides present in the material get shifted to grain boundaries and distributed there, whereas the grain boundaries are also distorted and broken. Distorted / broken grain boundaries are also observed in the failed exhaust valves at X5000 resolution but carbides are absent here. The grain sizes as shown in the SEM images indicate that grain sizes vary from very small to very big, and are distorted too. This means that at high temperature the grain sizes of austenitic steel are changed with an accompanying distortion that is usually present. The study of microstructures of failed valves and its comparison with the new valves clearly indicates that the size of grains, grain boundaries and distribution of carbide particles is affected by high temperature.

1. A definite coarse distribution of carbide particles was observed in the SEM images of all failed exhaust valves.
2. In case of failed inlet valves, coarse distribution

of carbide particles was observed in some whereas fine distribution of carbide particles was observed in few others.

3. New valves were always characterised by fine distribution of carbide particles.
4. In both failed exhaust and inlet valves, a clear shift of carbide particles was observed towards the grain boundaries.
5. Broken and distorted grain boundaries were also observed in failed valves.
