Failure Analysis of 9%Cr-Mo Steel Component

Yogesh Mahajan, D. R. Peshwe

ABSTRACT

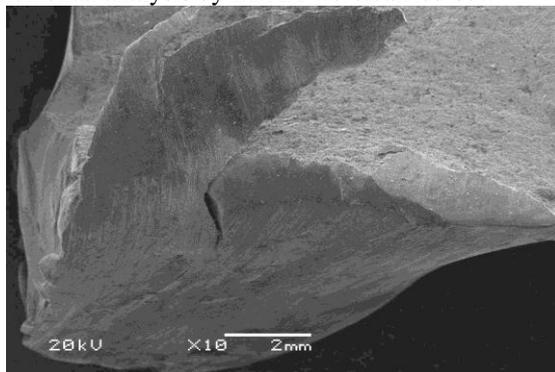
Fig. 2. Photograph of fractured surface at 10 X magnification

Visual examination of the sample revealed a generally smooth surface with small amount of deformation. However, the fractured portion of the sample revealed a brighter shiny surface typical of brittle fracture. The fractured sample is shown in the fig.2 at 10X. It is observed that the fracture follows the 45° direction of maximum tensile stress. A spiral type fracture surface of a brittle material can be clearly seen from the image presented in fig.2. The macroscopic investigation of the failed component did not show any surface abnormality and confirms to specification.

The fractured portion of the sample revealed a brighter shiny surface typical of brittle fracture. Presence of cleavage step including feather marks and fine grained fractured surface is indicative of brittle fracture. Fracture follows the 45° direction of maximum tensile stress. A spiral type fracture surface of a material is the indication of the torsion load acted on the component. These indications are usually obtained in torsion overload failure.

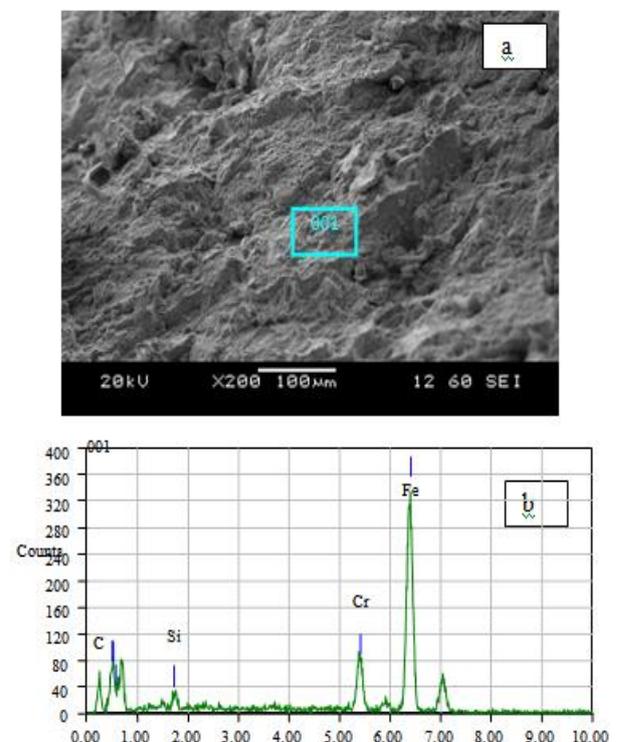
The scanning electron microscopy was performed using a JEOL SEM model JSM 6380A with an energy dispersive system. It is equipped with a light element detector and software for quantitative chemical analysis. Different fractured surfaces are shown in the SEM figures 3a, 4 and 5 at higher magnifications. Surface shows irregular bright facets of a cleavage type. SEM image at 3a is enlarged at 250X magnification and presented in fig. 4 indicate the presence of some foreign particles inside the steel. The size of the foreign materials embedded in the material are about 15-25 μm in diameter. The presences of foreign materials are suggestive indications for the possible reasons for the failure.

Fig 3. a. SEM photograph of the fractured surface at 30X with the b. EDS spectrum taken on the fractured surface

The Energy Dispersive Spectroscopy (EDS) spectrum of the entire scan area is displayed in digitized form with the x-axis representing X-ray energy. The ZAF standardless Qualitative Analysis indicates the presence of chromium about 8.5-9 mass% in the matrix. It shows the intense peak of iron and small peaks for the Silicon, Aluminium, etc.

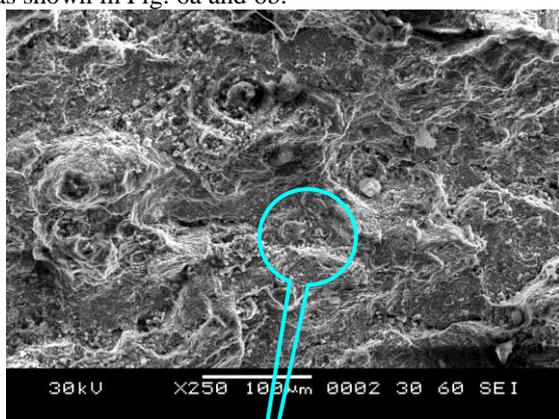
These suggestive indications are further analyzed at higher magnifications and presented in figs. 4 and 5. It confirmed the presence of foreign material or inclusion in steel which is subsequently analyzed by EDS analysis.

Fig. 4 SEM photograph of fractured surface at 250X magnification

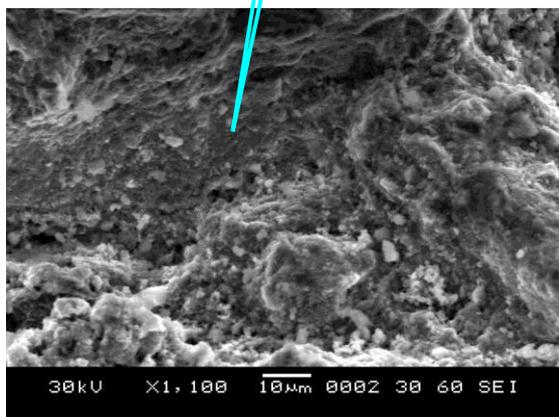
Fig. 5 SEM photograph of fractured surface at 1100X magnification

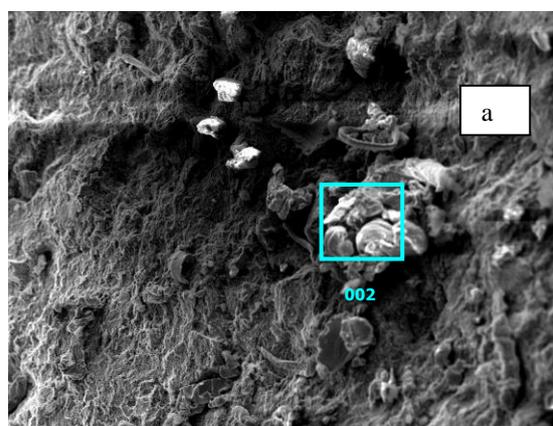
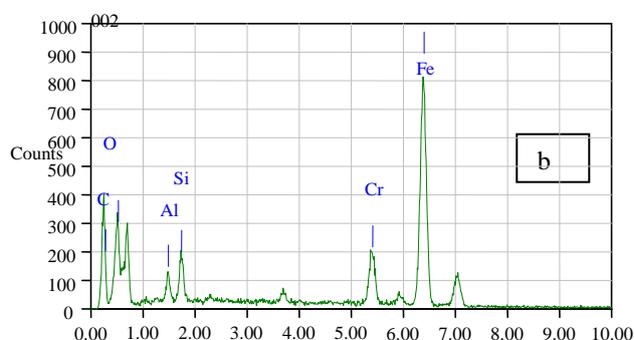
The Energy Dispersive Spectroscopy (EDS) spectrum of the selected area is displayed in digitized form with the x-axis representing X-ray energy. The EDAX analysis by ZAF Method Standardless Quantitative Analysis of the fractured surface shows the presence of major constituent elements such as Silicon, Aluminium, Chromium and also the Oxygen as shown in Fig. 6a and 6b.

It shows intense peak of iron and also peaks for the Silicon, Chromium, Aluminium and Oxygen. Oxygen peak is comparatively strong as compare to

the other three elements. This indicated that the fractured surface may have the oxides of iron, chromium, silicon and aluminum. This can be seen from the EDS graph as shown in fig.6b.

The EDS analysis by ZAF Method Standardless Quantitative Analysis of the fractured surface indicate the presence of major constituent elements such as Silicon, Aluminium, Chromium and Oxygen as shown in Fig. 6a and 6b. It shows the major peak of oxygen and chromium. This indicated that the fractured surface may have the oxides of iron, chromium, silicon and aluminum. This lowers the strength of the material. As the applied load exceeds the fracture strength of the material which is lowered due to the presence of inclusion, component failed in brittle manner.

Fig. 6a SEM photograph of fractured surface indicating the area of inclusion with the b. EDS spectrum taken on the inclusion
