Corrosion Mapping of Water Wall Tubes of Boiler using LFET

Gagan Kumar Gupta

(Manager, BPSCL, B. S. City, India

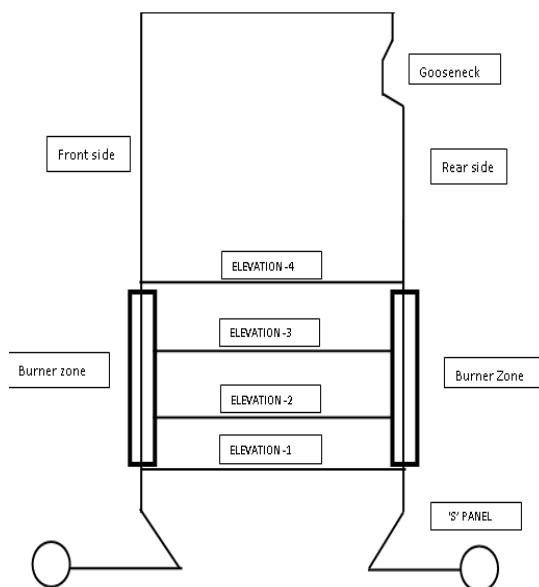
Fig. 3 - Inspected Region of water walls of boiler

Inspection of water wall tubes of boiler is carried out consisting of the scanned area corrosion mapping in burner zone, below & above burner zone and goose neck consisting of Front, Rear, LHS and RHS water wall panels.

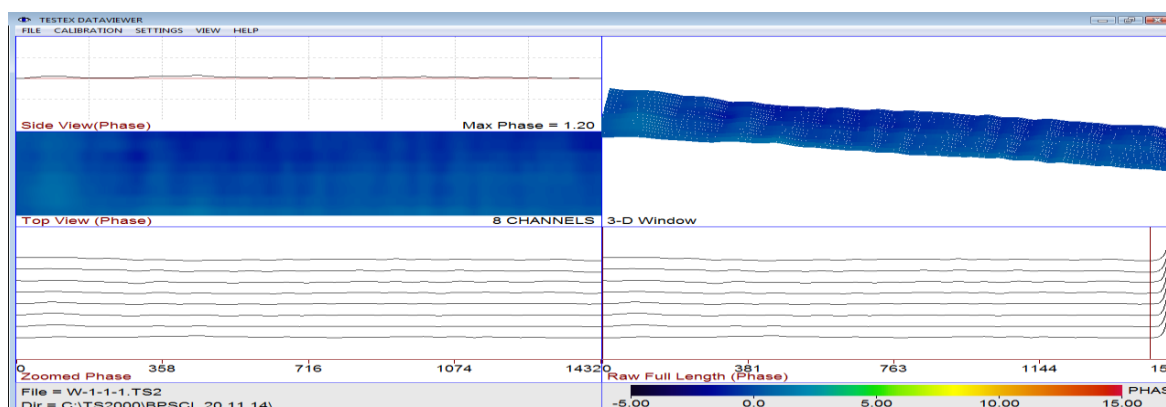
Fig. 6 shows the LEFT output of a water wall tube which provides the information of no defect. Fig. 7 shows the LEFT output of another water wall tubes which consists of a defect of metal loss from inside.

Fig. 6 LFET Waveform signal output indications for no defects

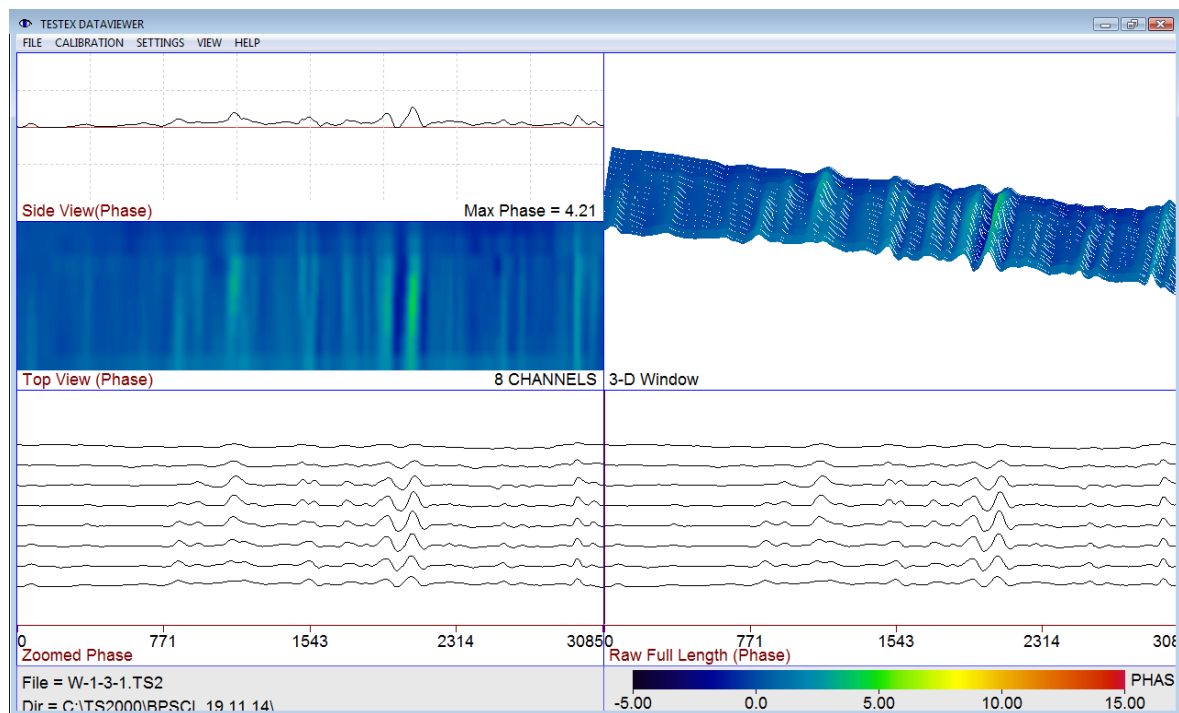
Fig. 7 - LFET Waveform signal indications for Tube No.48 with ID metal loss

Corrosion mapping of water wall tubes were carried out to verify the severity of the corrosion and internal metal loss of tubes. During scanning with the Low frequency electromagnetic, waves signals observed in some of the tubes were not uniform in nature with respect to base line. These water wall tubes which were found with ID metal loss due to corrosion were required to be replaced.
