An Examination of Surface Morphology and In-Situ Study on ASTM A106-Gr.B 'CUI' Piping in EDC Plant

A.C. Mariappan*, A. Ramesh**

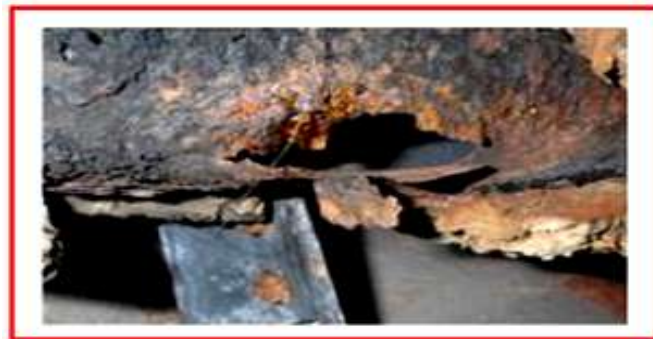
Fig – 4

that it will contain less than 0.1ppm water when it flows to the cracked quench column. 14" adiabatic line is made of carbon steel SA 106 Gr.70 with cellular glass insulation. The design conditions are 4300 kPa at 0°C to 219°C and 3700 kPa at 340°C. The quenched feed is at 15.6°C design (12.5°C in existing operation) and 3548 kPa with a molecular weight of 18.9. When the quenched tower spends 130 hrs in service or the percentage weight of water content reaches about 5 ppm, the tower will be isolated, regenerated, and purged. Then, tail gas (T. G.) heated to about 230°C is introduced into cracking furnace. A leak was observed during the unit start up on a 4" start up line coming from 14" adiabatic line. This leak was located at the top platform of the wet EDC tower. Visual inspection revealed damaged insulation with CUI. The depth of the CUI appeared to be very significant, down to paper thin at the vicinity leaky area while the nominal thickness was 10.0 mm as shown in Fig – 4. The 4" line was sometimes used as a step by persons on the plat form, which may cause bend contributing causes to the final failure of the pipe.

The leaky line was insulated by Cellular Glass, and coated by Inorganic Zinc. Moreover, numbers of probable root causes were found as follows:

- ❖ The line subjected to cyclic temperature. As mentioned above, there was tail gas introduced into the dryer at two different temperatures 230°C and 65°C other than the normal process gas temperature 12.5°C. This means that there was a cyclic temperature (12.5°C to 230°C).
- ❖ Due to cyclic temperature, moisture was generated under the thermal insulation and on the line surface. This moisture worked as a media connecting the anodic areas to the cathodic areas. As a result, corrosion under thermal insulation (CUTI) started.
- ❖ No enough CUI awareness

- ❖ Punctured portion of pipe up to acquire the nominal thickness was recommended to replace.
- ❖ Proper coating system was recommended for

cyclic temperature.

- ❖ All insulation shall be removed and recommended for RBI assessment and identify all susceptible CUI areas.
- ❖ Add all CUI lines in the piping monitoring program (RBI).
- ❖ Strip out the insulation when NDE result shows any problems.
- ❖ Prepare a plan to inspect all susceptible CUI lines, and
- ❖ Increase the awareness among the Inspectors & Operation personals.

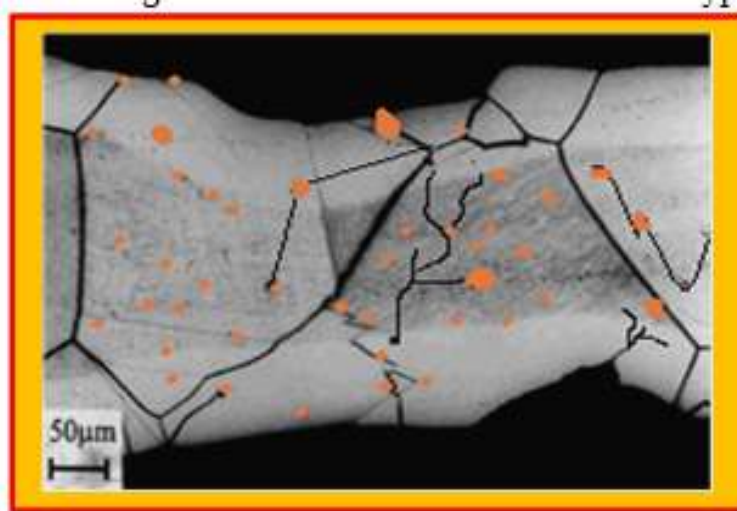
Fig – 5

After removal of insulation from the carbon and low alloy steel, CUI damage often appears as loose, flaky scale covering the corroded ASTM A 106

Gr. B piping. Damage was seemed to be highly localized as shown in Fig -5 and associated with carbuncle type pitting.

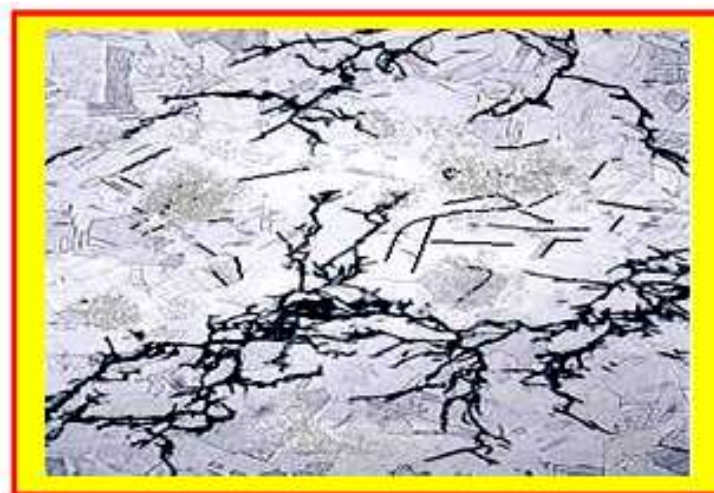
Fig – 6

For 300/400 series SS, specifically Stress Corrosion Cracking (SCC) that had seen at the removed window insulation where suspected as shown in Fig -6. Subsequently removal of the flaky superficial corrosion, the affected area was stringently

cleaned with 2 ½ Grid blast and inspected by means of In-situ metallographic which exhibits the initiation of SCC at the root of clustered pitted area due to CUI.
