An Investigation On The Slope Failure Of Bank Revetment Work Along Jamuna River At Chouhali, Bangladesh

Nabila Sumaia Hussain *, Mohammad Mashrur Fateh **

*(Bangladesh Water Development Board, Dhaka, Bangladesh

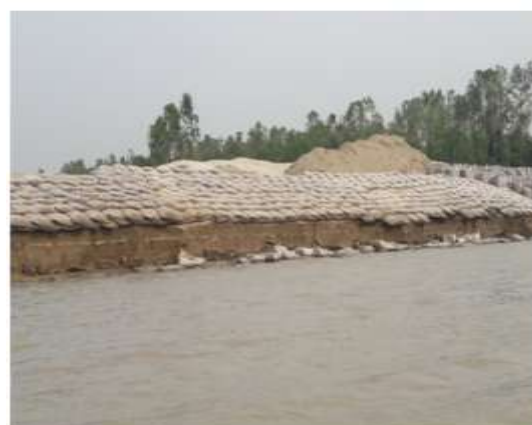
The first slope failures were observed in four locations with rising flood water levels in June 2016 and in another five locations thereafter during the recession from July until January 2017. All these slope failures occurred during first season when temporary wave protection covered the upper slope (Fig. 1.4). The majority of failures occurred during the flood 2017, at nine locations during the rising limb and at fifteen locations during recession. These failures occurred after the placement of the permanent wave protection layer (Fig. 1.5). A number of emergency repair work took place during the time 2016-2017 and the slope of the revetment work has been stable thereafter.

Figure 1.4: Slope failure after temporary wave protection, May, 2016

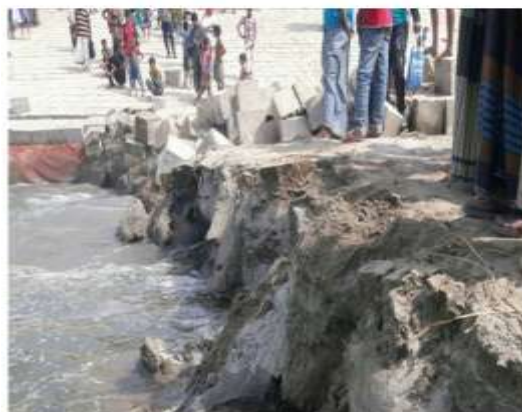
Figure 1.5: Slope failure after permanent wave protection, March, 2017

The field investigation revealed some other deviations from standard construction method which might lead to the failure of the revetment slope after the permanent protection was placed. The CC block at the toe of the slope was dumped on loose materials. These loose materials were most likely to be washed away with flood water during monsoon initiating the sliding of dumped CC blocks as well as the pitching material leaving the river bank uncovered and finally leading to slope failure. The sudden flood during the implementation period damaged the slope and also caused difficulty in the construction of the key at the toe of the pitching material which might cause the slope failure during monsoon.

The condition of the revetment work was monitored regularly and necessary measures were taken

accordingly which prevented further failure and ensured the safety of the work.

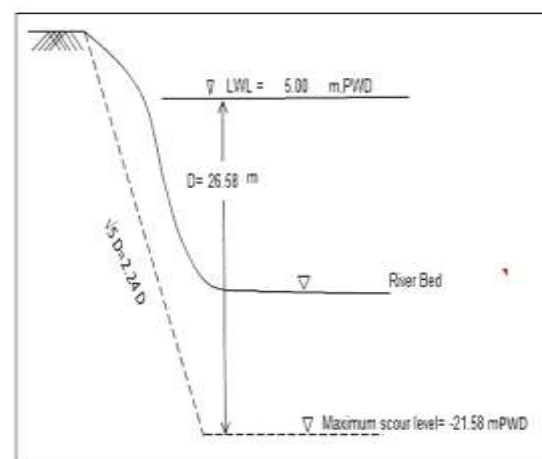
Figure 2.3: Anticipated scour depth

The observed scour level was less than -18.00m (PWD) for most of the length. (-) 18.00 to (-) 22.00 mPWD scour level was observed for about a length of 1400m. It indicates that calculated scour level (-21.58 mPWD) almost matches with the observed scour level.

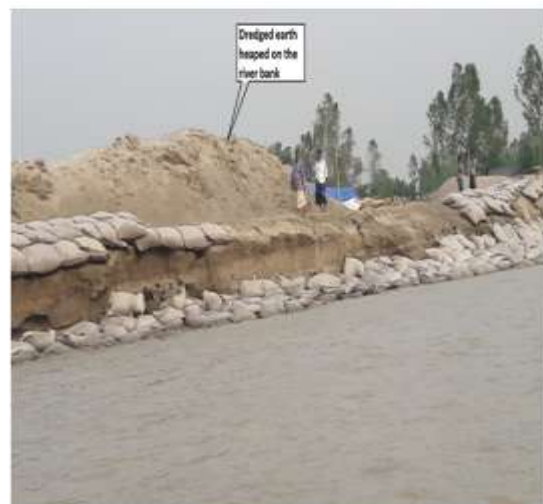
During the field visits, some anomalies were found in the implementation process. It was observed that at some places dredged sand was dumped on the bank (Fig. 2.7) and slope damage was noticeable at those particular places.

Figure 2.7: Dredged earth heaped on the river bank

The slope failure in Chouhali revetment was initiated due to some deviation from standard construction procedure and unfavorable natural circumstances. The initial slope failure during the first implementation phase occurred due to the heaped soil on the river bank which caused surcharge load and seepage on slope. And the failure during monsoon after the permanent protection took place due to the placement of CC blocks on loose material. Regular monitoring and prompt maintenance work saved the revetment from further failure and retained the integrity of the work.

1. There should be provision to manage the temporary wave protection and dredged soil. The excavated earth should not be heaped on the river bank or at the toe of the slope.
2. No concrete key shall be built on loose deposits.
3. The upper wave protection layer shall be anchored at the bottom with an anchor beam to avoid immediate sliding of the upper protection if the key is compromised.
4. There should be regular monitoring and provision for proper adaptive and maintenance work for the safety and sustainability of the work.

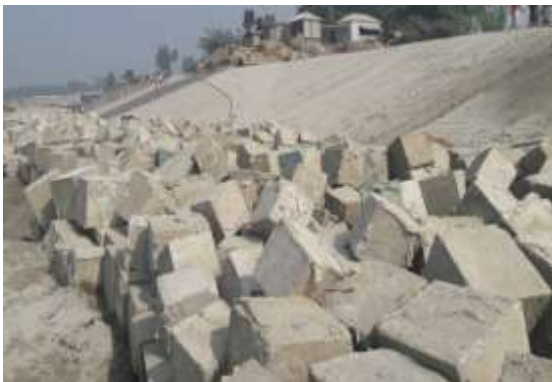
Excavated earth and temporary wave protection from slope was heaped at the toe of slope and CC block was dumped on this loose material (Fig. 2.8) which might have compromised the consistency of the cover layer.

Figure 2.8: CC blocks dumped on loose material

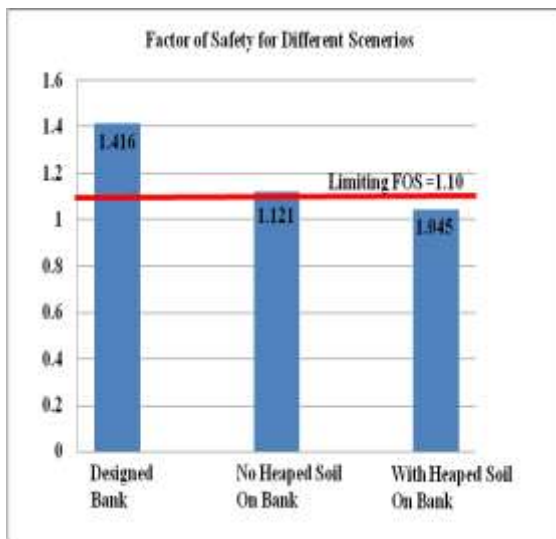
Figure 3.1: Factor of safety for different scenarios

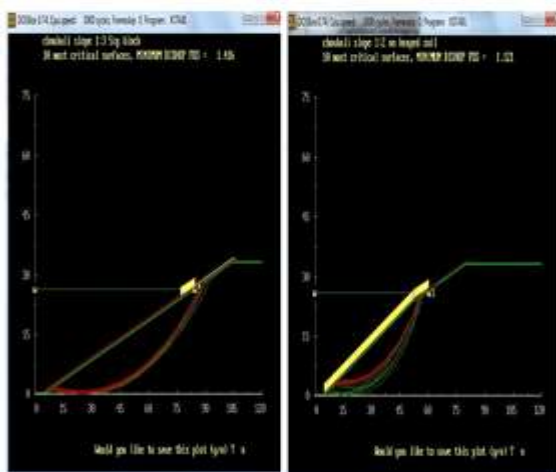
Figure 3.2: FOS for designed bank slope

Figure 3.3: FOS for river bank with no heaped soil
