The Fundamentals of Building Construction in the Flood-Plains of Ogbaru Local Government Area, Anambra State, Nigeria

F.O. Ezeokoli, *K.C. Okolie, *C.I. Onyia *

F.O. Ezeokoli "The Fundamentals of Building Construction in the Flood-Plains of Ogbaru Local Government Area, Anambra State, Nigeria" International Journal of Engineering Research and Applications (IJERA), Vol. 09, No.07, 2019, pp. 26-35

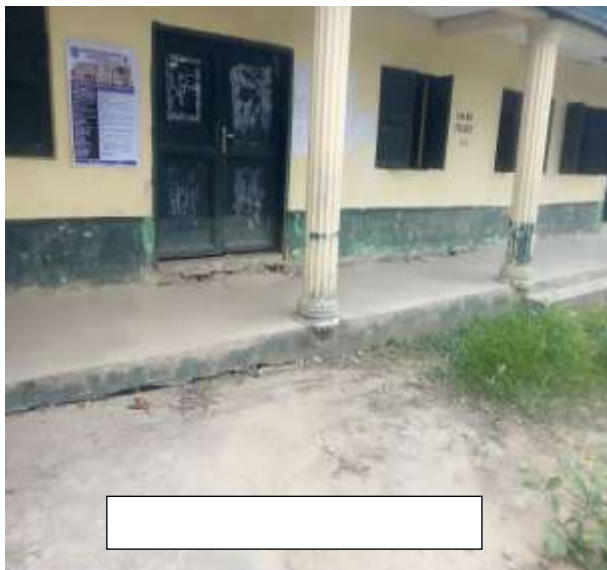
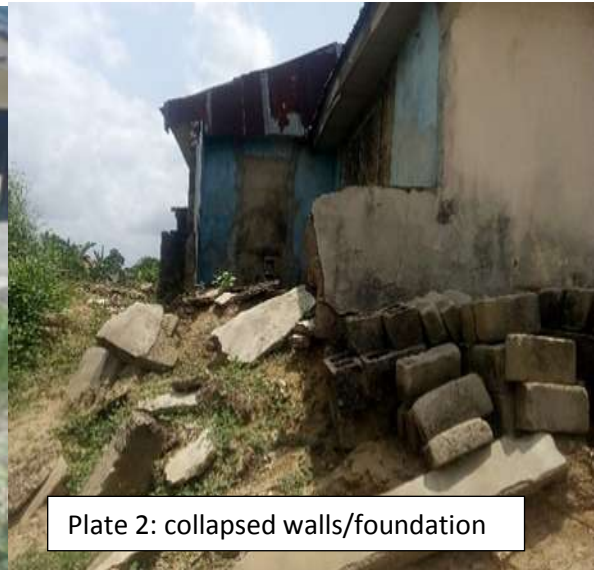
shows that foundations and floors are the mostly affected part while the least affected is the roof of the building. The findings of the walkthrough survey support the result in table 4 (see plate 1-6).

Plate 2: collapsed walls/foundation

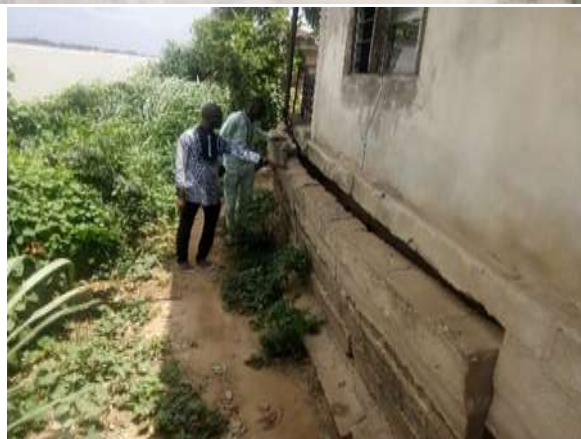
Plate 3: collapsed foundation wall

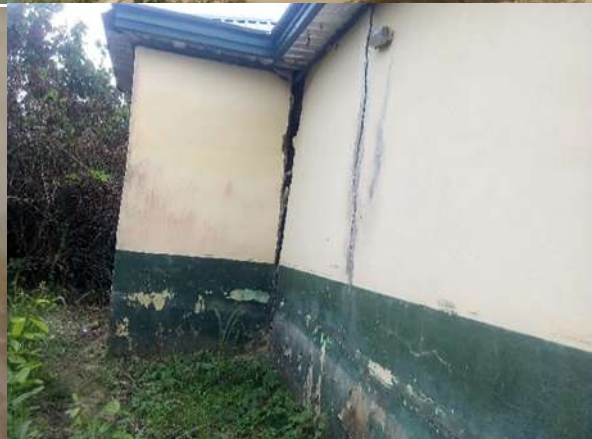
Plate 4: wall separation

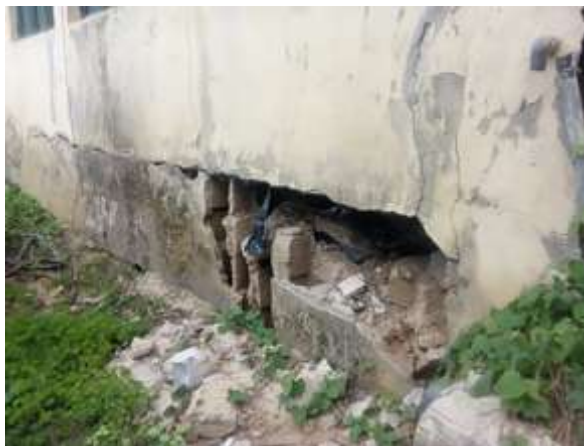
Plate 5: Collapsed foundation wall

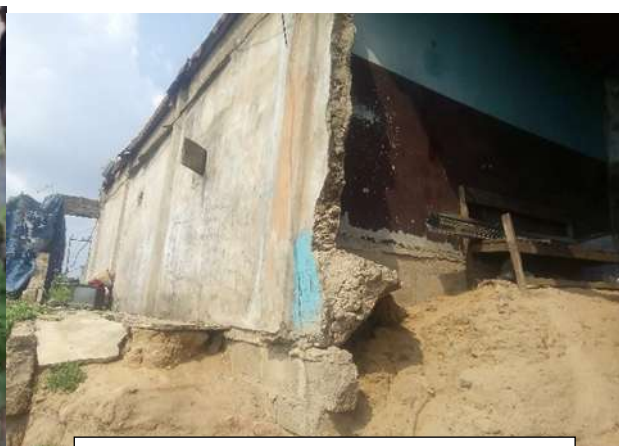
Plate 6: Collapsed wall and foundation
