## Investigation of Foundation Failure of a Residential Building – A Case Study

### ABSTRACT

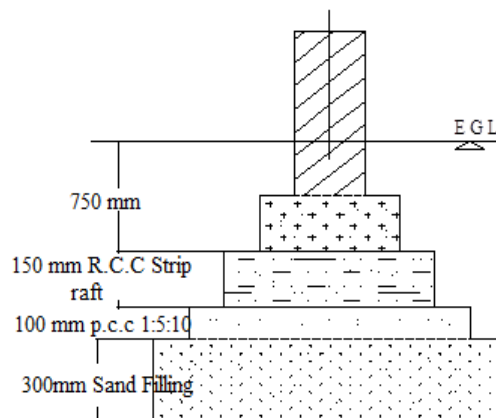
Fig.1 Foundation Details

The type of foundation is stepped continuous footing (wall footing). The depth of the foundation of the building is about 0.9m from the existing ground level. It is laid over 0.1m thickness of

plain cement concrete and 0.3m thick sand cushion. At the time of soil exploration, a trench had been excavated near to the front wall of the building to identify the type and depth of foundation. The foundation details of the distressed building are shown in Fig.1.

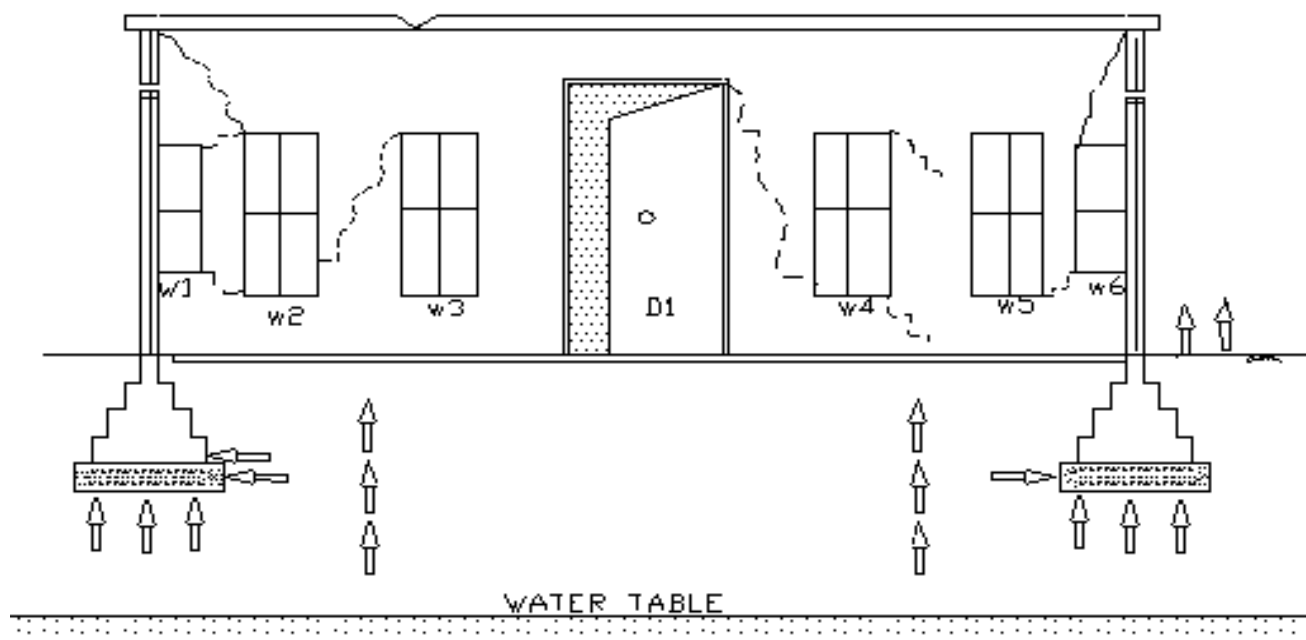
Fig.2 Sketch Depicting Cracks in Exterior Wall

The nature of the distress i.e. the typical crack patterns in the front wall of buildings that was observed are shown in Fig 2. The first crack was noticed during the year 2008 by the residents. There are a number of windows in the front wall

of the building and are marked as W1, W2 and etc. The Cracks were propagated from window to window and window to door. The width of the footing was about 3mm to 5mm. As per AS 2870-1996, the Residential slab and footing code, damage due to foundation movement, this building is classified under the category 3.

- ii. The severe distress in the front wall when compared to other distressed portion was due to the large openings provided in the form of doors windows especially in the corner

- Drilling the bore holes up to active zone or up to the water table around the building perimeter.
- Filling the bore holes with brick jelly with lime. The percentage of lime is to be added based on lime reaction with soil (4% to 6%)
- Saturating the lime brick jelly with water, so it will reach the sides of the bore hole and reduce the degree of desiccation. During rainy season, the rainwater can be diverted into the boreholes.
- Prevent the cycle of heave and shrinkage by protecting the foundation of the building from water content changes, it was recommended that, all the trees located at a distance ranging from 1 to 1.5m from the front wall were removed, if the distress are very severe in future.

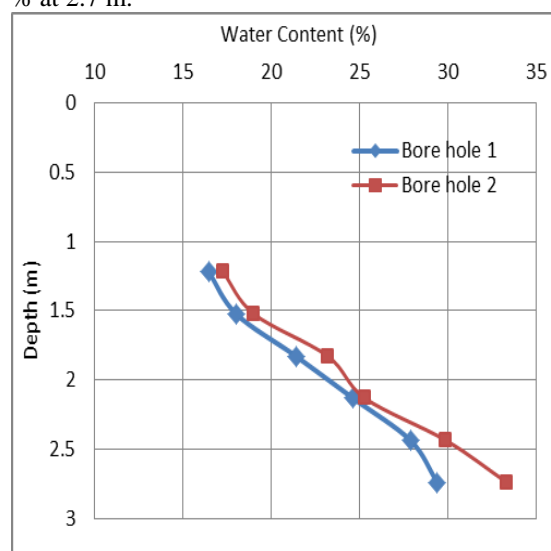
Fig.3 Variation of natural moisture content with respect to depth

the two boreholes. In the borehole 1, there is general increase in moisture content with depth, from 16.46 % in 1.2m to 29.39 % at 2.7 m. In borehole 2, also there is an increase in moisture content with depth from 17.26 % at 1.2m to 33.34 % at 2.7 m.

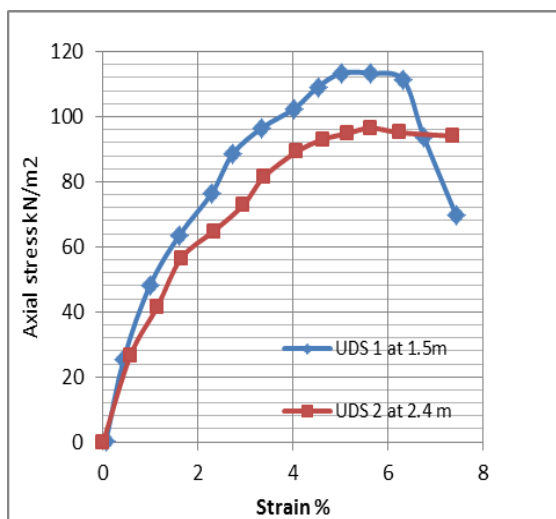
Fig. 4 Stress-Strain Curve for UDS of Borehole1

Undisturbed samples were collected from borehole 1 at 1.5m and 2.4 m depth and also collected from borehole 2 at a depth of 1.2 and 2.1m. In Borehole 1, the undrained cohesion obtained from the UCC tests are 84.8kN/m<sup>2</sup> and 48.2kN/m<sup>2</sup> at a depth of 1.5m and 2.4m respectively. The Stress-Strain Curve for UDS of Borehole1 are presented in the Figure 4 and Figure 4.

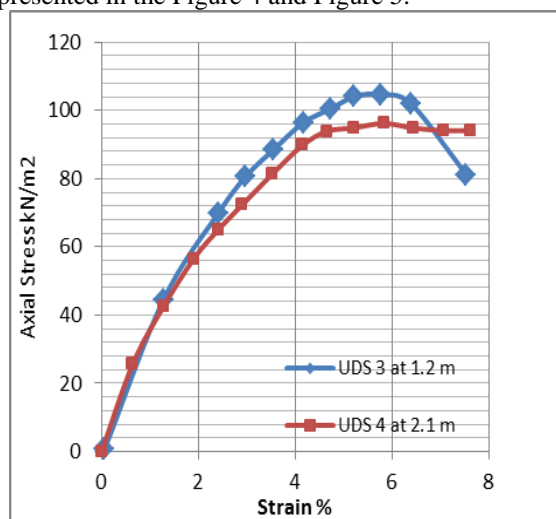
Fig. 5 Stress-Strain Curve for UDS of Borehole2

In Borehole 2, the undrained cohesion obtained from the UCC tests are 52.4kN/m<sup>2</sup> and 44.7 kN/m<sup>2</sup> at a depth of 1.2m and 2.1m respectively. The Stress-Strain Curve for UDS of Borehole1 are presented in the Figure 4 and Figure 5.

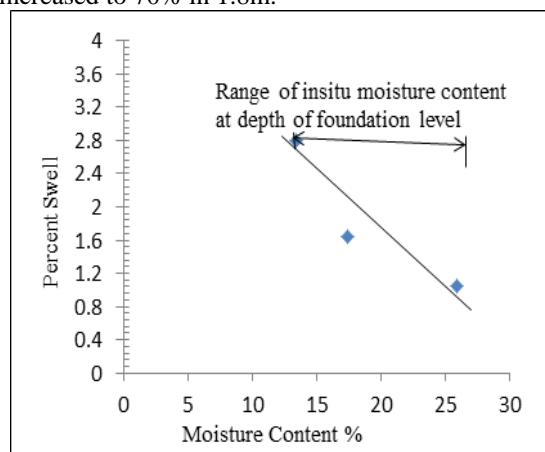
Fig. 6 Moisture Content Versus Percent Swell

The swelling potential and swelling pressure tests were conducted on soil specimens compacted to moisture content in the range of 12% to 28%. At shrinkage water content, the percent swell is 2.8%. For 26% water content, the swell was 1.2 %. The differential free swell is about 40 % in 1.2 m and increased to 70% in 1.8m.
