Mapping Gully Erosion Using Remote Sensing Technique: A Case Study Of Okigwe Area, Southeastern Nigeria

GEOSCIENCES RESEARCH TEAM,
DEPARTMENT OF GEOSCIENCES,
FEDERAL UNIVERSITY OF TECHNOLOGY, OWERRI, IMO STATE, NIGERIA

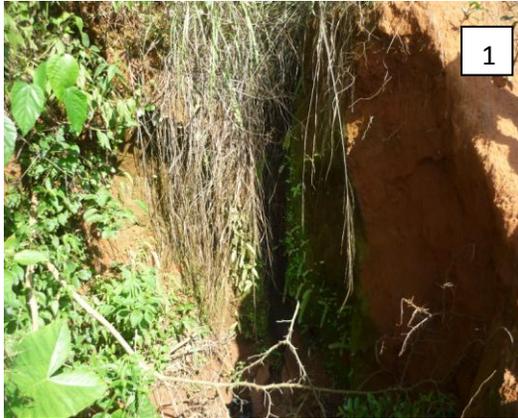
Plate 1: Active gully in Umuowaibu

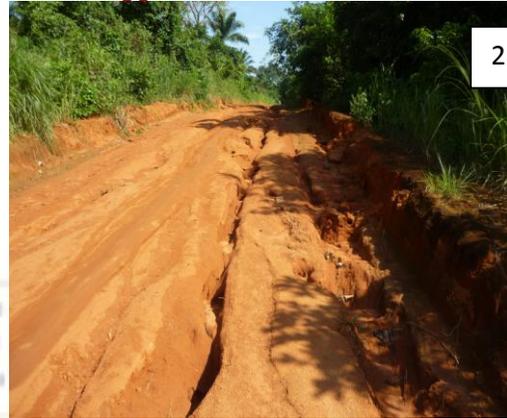
Plate 2: Road destroyed by gully in Umuowaibu 1 village

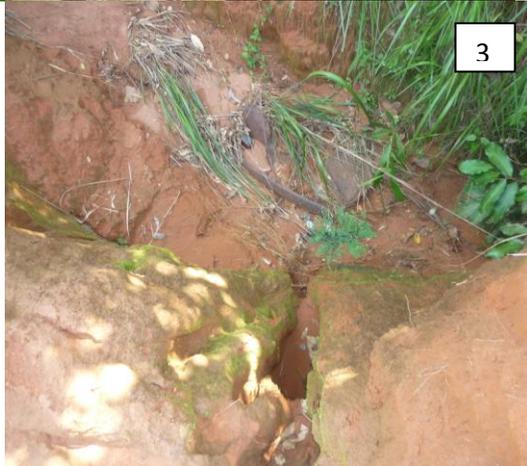
Plate 3: U-shaped gully in Umuowaibu

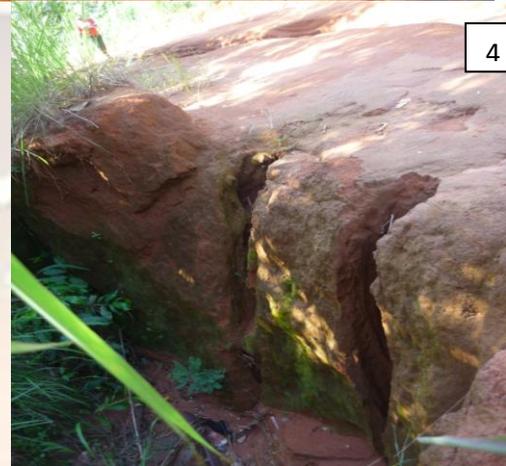
Plate 4: V-shaped gully in Umuowaibu

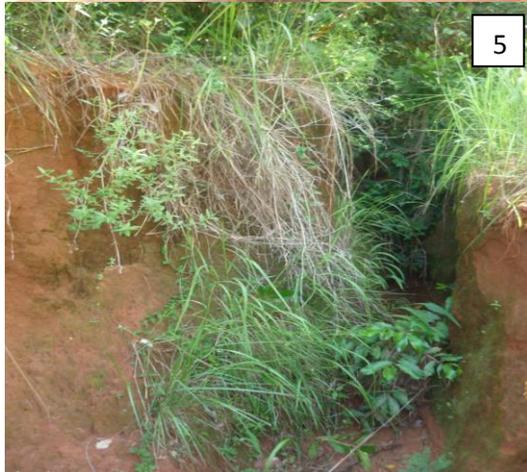
Plate 5: Gully site in Ekeibu

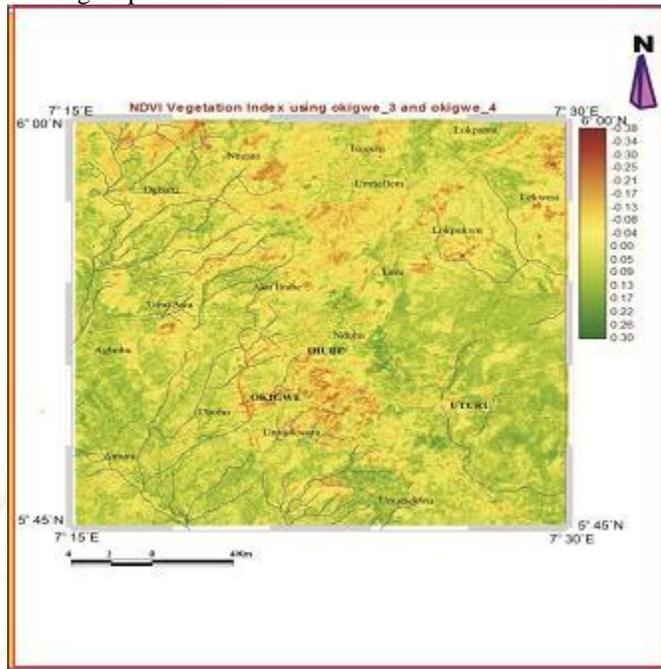
Fig. 3: The Normalized Difference Vegetation Index (NDVI) of the study area

The output of NDVI is a measure of vegetation richness of an area. Values of NDVI can range from -1.0 to 1.0, but values less than zero typically do not have any ecological meaning. Low NDVI values mean there is little difference between the red and near infra-red (NIR) signals. This happens when there is little photosynthetic activity, or when there is just very little NIR light reflectance (that is, water reflects very little NIR light from the NDVI of + 0.30 to - 0.38, which shows unhealthy vegetation. The area were much earlier in time protected by dense forest which the inhabitants removed in the process of urbanization and agricultural activities leading to an exposure of the fragile soil to the heavy downpour and concentrated runoff of the area. The high speed of the soil surface runoff culminates in rapid washing away of the soil surface weakening the soil strata which is the chief cause of gullies in the area. This fact is attested to by the findings of Egboka and Nwankwo 1985, Nwajide 1977, Igbokwe 2003 and Akamigbo 1988.

The Normalized Difference Vegetation Index (NDVI) is an index of plant “greenness” or photosynthetic activity, and is one of the most commonly used vegetation indices. Vegetation indices are based on the observation that different surfaces reflect different types of light. Different photosynthetically active vegetation, in particular, absorbs most of the red light that hits it while reflecting much of the near infrared light. Vegetation that is dead or stressed

reflects more red light and less near infrared light. Likewise, non-vegetated surfaces have a much more even reflectance across the light spectrum.

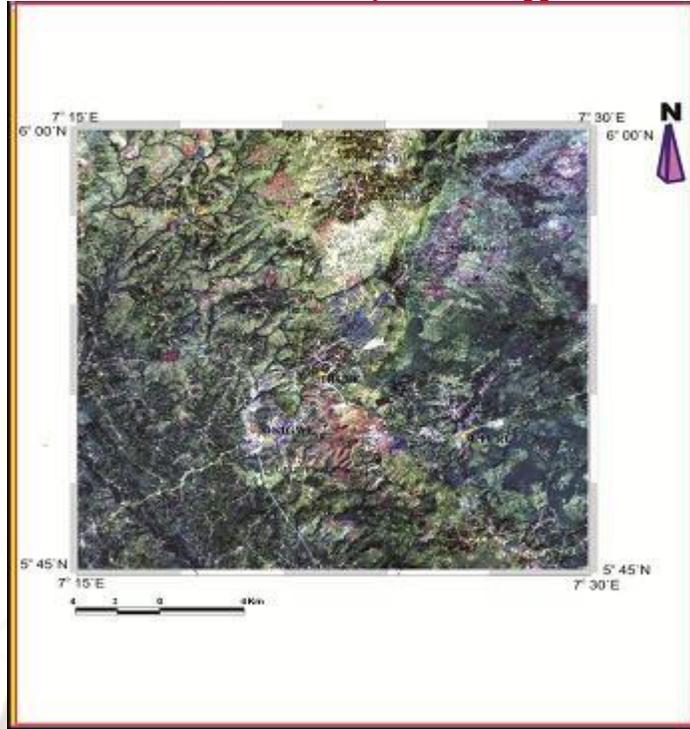
Fig. 5: RGB 752: False coloured Composite Image of the Study Area

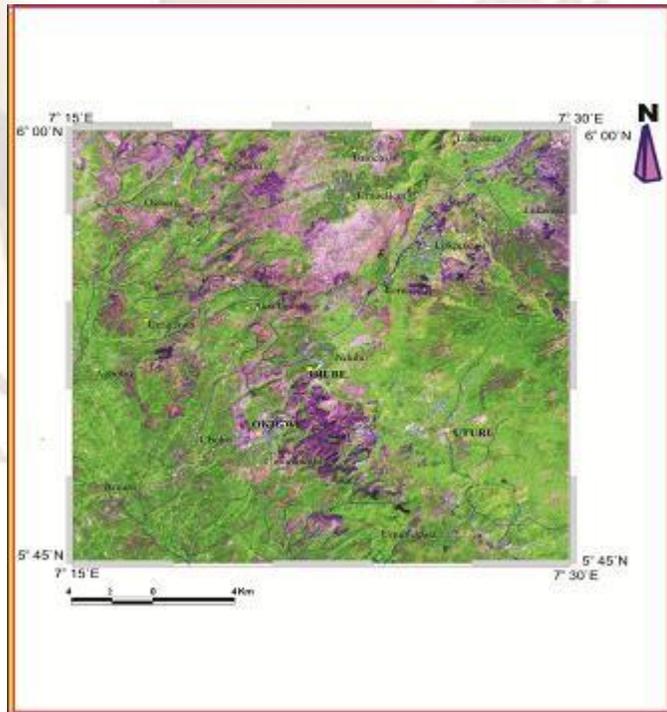
Fig. 6: RGB 543: False coloured Composite Image of the Study Area

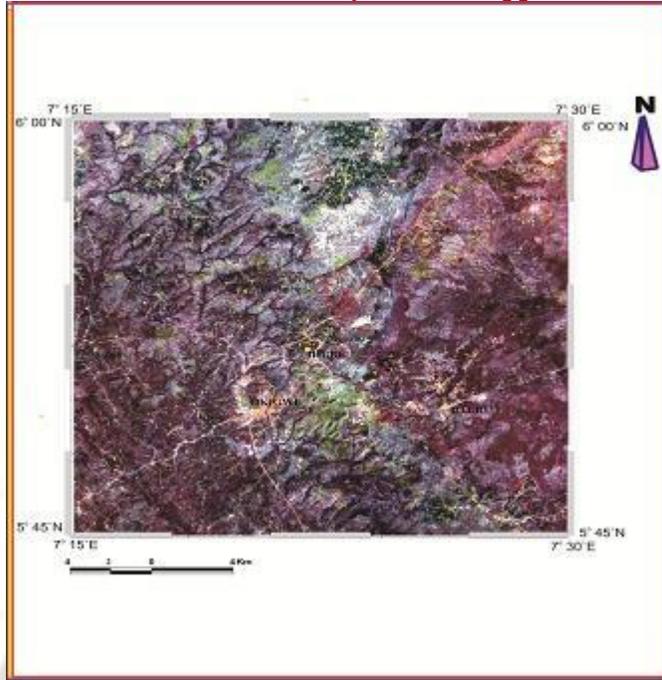
Fig. 7: RGB 275: False coloured Composite Image of the Study Area

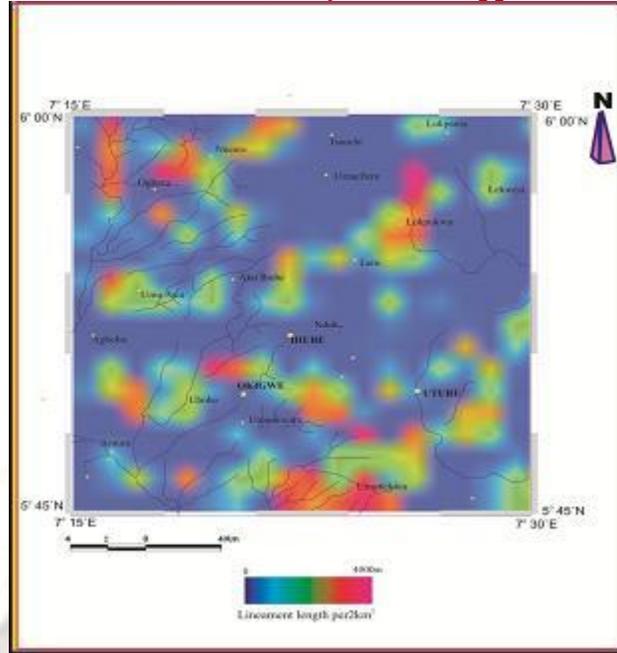
Fig.9: Lineament Density Map of the Study Area

trend is in the NE-SW direction which corresponds to the major lineament trend of the Anambra basin. This also shows that the area has a rugged topography and it is partly deformed by tectonic activities. The lineament trends are in line with the results of previous works which suggested that the south eastern part of Nigeria has a complex network of fractures trending NE-SW, NW-SE, N-S and E-W (Udoh, 1988, Chukwuike, 1977). The lineament trends corresponding to faults, geologic boundaries, folds and tectonically related joints in the area cause the ruggedness of the topography which the south eastern Nigeria has been interpreted to be a basic, associated with two major fault lines trending NE-SW and NW-SE (Ehirim, and Ebeniro, 2008). These findings show that the area is affected by tectonic activities and the effect of these tectonic activities on the geologic formation of the area is responsible for the increasing gully and landsliding in the study area. Results from the lineament analysis revealed that the lineament trend in the area correlated well with the measured strokes of the geologic formations. Similarly, a correspondence was found to exist between the lineament map, drainage density and occurrence of gullies and landslides. Lineament features are the surface expression of fractures affecting the bedrock. It is also defined as the most favourable structural conditions in control of various mineral deposits.

These features are clearly discernable on aeromagnetic maps and landsat images. It often indicates the form and position of individual folds, faults, joints, veins, lithologic contact and other geologic features. Lineament analysis helps to reveal zones of fracture concentration and identification of surface features. Linear features as seen on satellite images are usually the results of aligned morphologic rock or topographic relief of the basement. The measured variation are interpreted in terms of the probable distribution of magnetic materials below the surface, which in turn is the basis for inferences about the probable geologic condition.

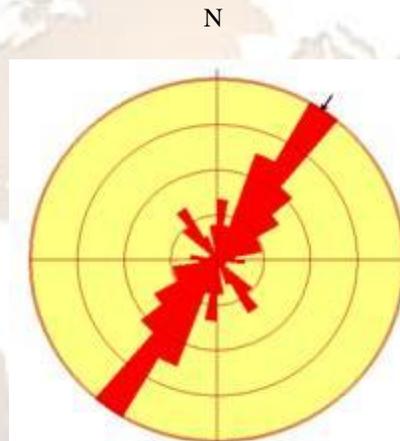
Axial (non-polar) data; No. of Data = 104; Sector angle = 10°; Scale: tick interval = 5% [5.2 data]; Maximum = 20.2% [21 data]; Mean Resultant direction = 034-214; [Approx. 95% Confidence interval = ±14.7°]

Fig.10: Rose Diagram of the study Area showing the dominant lineament trends

General conclusion can be drawn from this study that remote sensing techniques (landsat thematic imagery) are applicable in gully identification and characterization with high and desirable levels of accuracy. The processed data reveal several lineaments striking predominantly in NE- SW and NW-SE directions corresponding to the major lineament trend of the Anambra basin and the orientation of gullies in the study area.
