## Corrosion Monitoring Of Reinforcement in Underground Galleries of Hydro Electric Project

Nv Mahure<sup>1</sup>, Rp Pathak<sup>2</sup>, Sameer Vyas<sup>3</sup>, Pankaj Sharma<sup>4</sup>, Sl Gupta<sup>5</sup>  
<sup>1-5</sup> Central Soil and Materials Research Station, Hauz Khas, New Delhi-110016

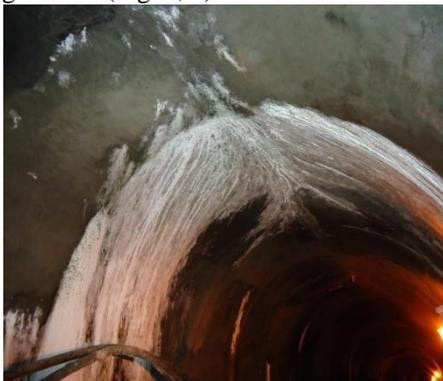
Corrosion problems are very common in almost all aspects of technology resulting in cropping of variety of problems. Post construction corrosion damage in the reinforcement is an enormous economic liability. The underground inspection galleries and drainage gallery of dams are constructed using concrete linings of different grades. The water in Himalayan Rivers is generally soft which causes leaching of lime (Fig. 1, 2).

Figure 1 White Leachate Deposit in the Concrete gallery

The continuous leaching of lime reduces the alkalinity of concrete [3] thus passivation of reinforcement is destroyed and permeated water leads to corrosion of reinforcement leading to weakening of structure. Diagnosis of the intensity of corrosion and its constant monitoring using Non Destructive Test (NDT) [1] will provide useful information for adopting suitable preventive measures. In this paper effort has been made to assess degree of corrosion of reinforcement in the gallery of one of the projects in Himalayan region using Half Cell Potentiometer.

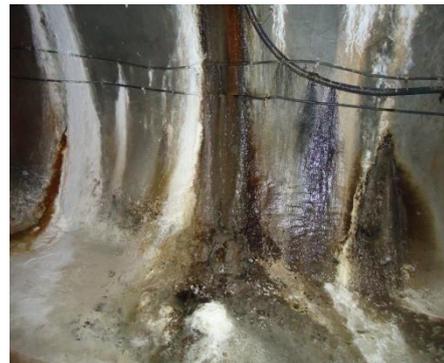
Figure 2 White Leachate Deposit in the Concrete gallery

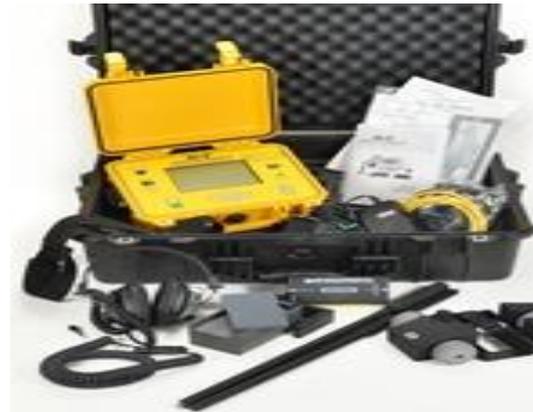
Micro Cover Meter

Figure 4. Equipments Deployed for Investigation

The micro cover meter has been used to locate the rebar [4]. The concrete surface was examined for the exposed rebars/or got exposed to get a reference point. Surface was made wet and observation locations were marked on the surface [7]. The pre -activated Cu-CuSO<sub>4</sub> Half Cell was used to take observation. The test results are categorized in 7 categories from A to G category in the typical map recorded on CORMAP II.
