Failure Analysis and Redesign of Shaft of Overhead Crane

This paper deals with the failure analysis and redesign of shaft of overhead crane having capacity 25 tonne. There is problem of failure of the shaft in gear box which is mounted on the crane. The shaft breakage occurred due to dynamic, alternating low tensile– compressive stresses and simultaneous torsional load.

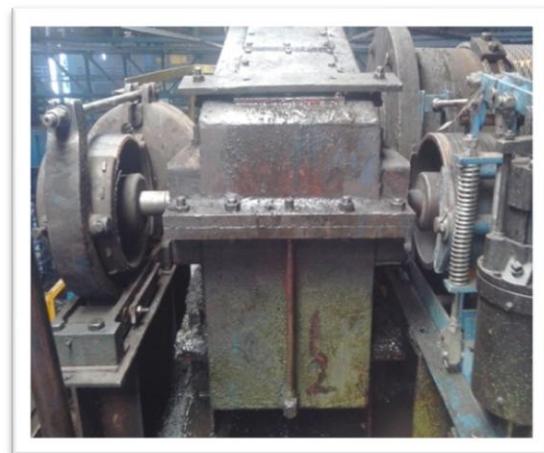
Figure 1: Shaft in the gear box of overhead crane

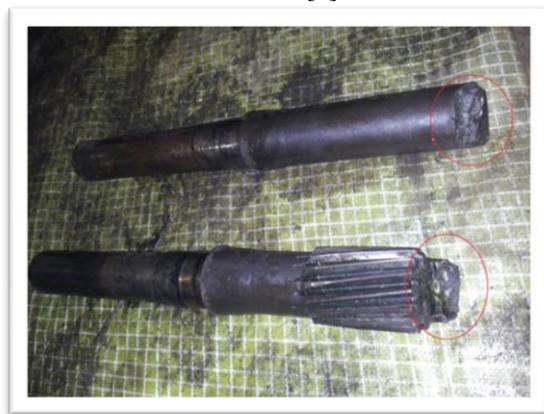
Figure 2: Failure of shaft
