Life Management Technique of Thermal Fatigue for SMST Boiler Tube at Different Heating Zone Using Smithy Furnace

Shekhar Pal, Pradeep Suman, Shri dk jain.gpc kota

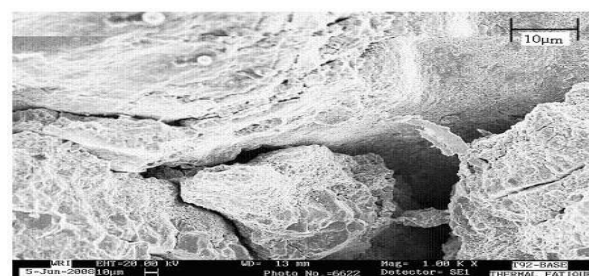
Fig.2 cracking along the grain boundaries

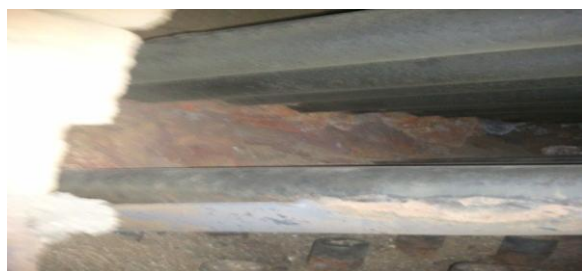
Fig.3 combustion chamber of boiler

Boilers apply the produce high pressure steam for the different kind of application at different type of steam as per application of industry. Production of steam in coal fired boiler coal converted big size to micron size with the help of the conveyor belt and grinder bled. Which injecting in combustion chamber in micron size and high temperature maintain pressurized air supply with help of blower due to striking of pressurized air and coal mixture the external surface of the tube randomly damage, scaling of the material at peripheral surface.

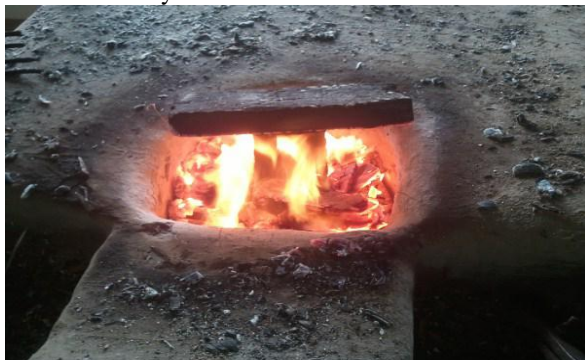
Fig.4 boiler tube heating in smithy furnace

The boiler tube of which is prepare for experimental procedure that is put in the furnace. Before the heating of the tube the furnace prepare with the wooden peaces and kerosene spraying in the furnace after that starting of the firing. After proper firing of the furnace blower start to supply of the air with proper velocity and supply more and more coal for firing.

The boiler tube heating temperature up to 600°C and to check the temperature with the help of thermocouple at every cycle of heating. For reaching this temperature 20 to 25 minutes taken.

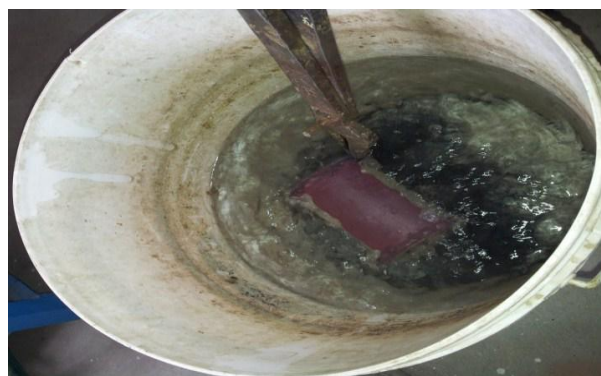
Fig.6 Quenching process

For the cooling of the tubes water tub used in which water filling up to ¾ portion of the tub. After the heating of the tubes and temperature reach at 600°C, tubes quenching in the water tub and the drop the temperature up to the room temperature.

To reduce the temperature 7 to 10 minutes required. After every cycle water change in the tub.

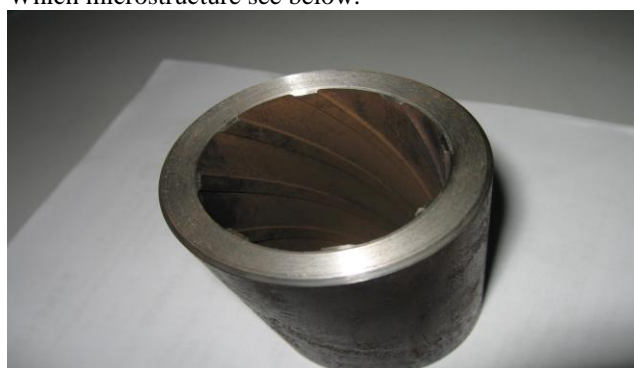
This is the parent material tube DMV 304 HCu. Which microstructure see below.

Fig.7 parent material tube

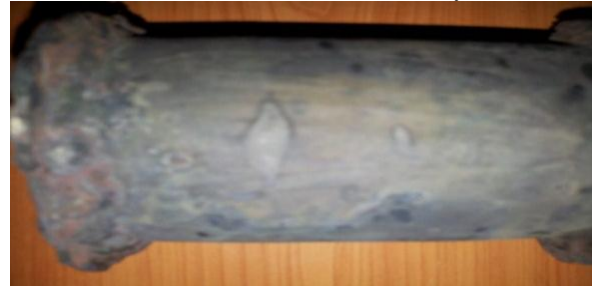
Fig.13 Tube after 50 thermal cycles

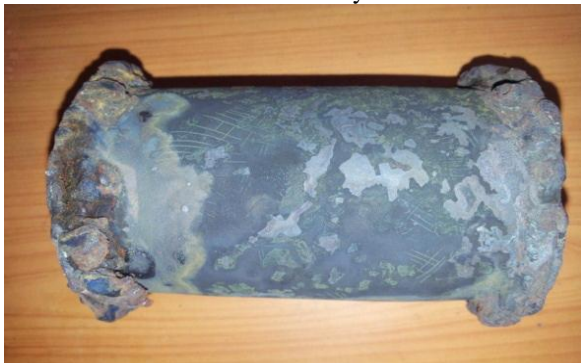
Fig.17 Tube after 100 thermal fatigue cycles.

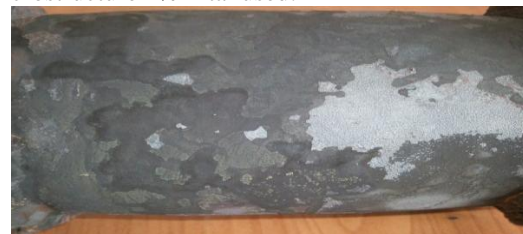
Fig.21 Tube after 150 thermal fatigue cycles.

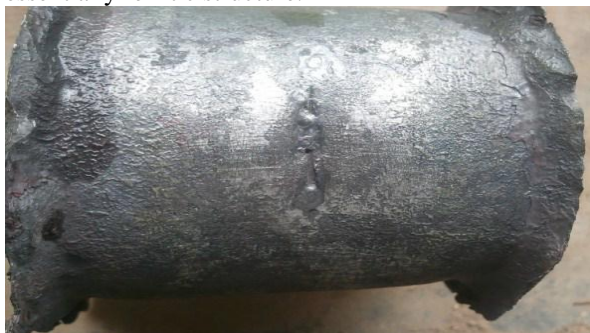
Fig.24 Tube after 200 thermal fatigue cycles.

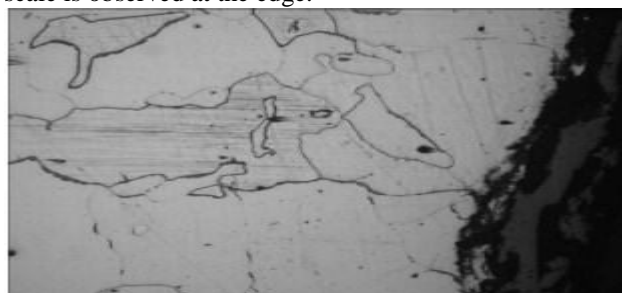
Fig.29 200 thermal cycles material of tube at internal side magnification of 400 X

Internal edge of tube after 200 thermal fatigue cycle microstructure having essentially coarse-grained ferrite structure. Presence of oxide scale is observed at the edge.

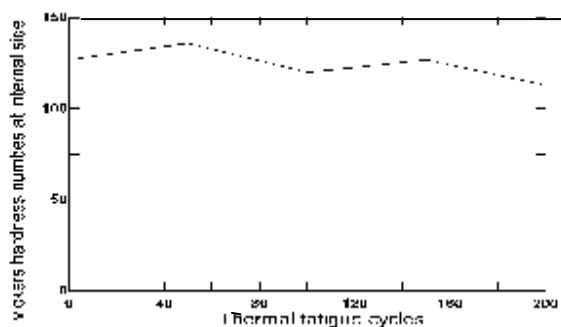
Graph-I Thermal fatigue cycles v/s Vickers hardness numbers at Id

The Vickers hardness numbers are vary cycles to cycles from the 128 to 131.

All the results shows and its discussion culminate that the grain side of the parent tube is fine ferrite and pearlite, and it is gradually change fine to coarse and rough size. Failure of the thermal fatigue at the 200 cycles at the 600° C of the operating temperature of the tubes, during the thermal fatigue cycles it is distributes at 5 stages and at all stage there grain size and grain boundary change up to till failure should not faced. Same as the harness is drastically

change and decrease at the internal side of the tube and the harness is drastically change at external side.
