Experimental Testing Of Partially Encased Composite Beam Columns

In This paper, Partially Encased Composite Beam Columns is introduced; experimental studies are made on five partially encased beam columns to investigate the behavior of eccentrically loaded partially encased composite columns using different parameters.

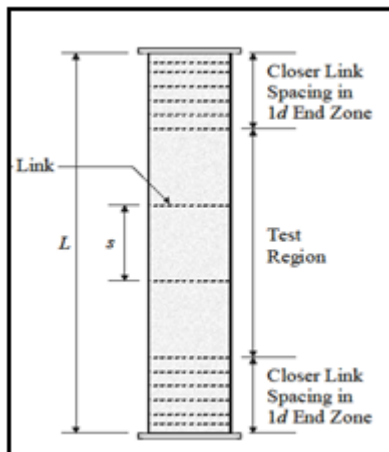
Figure (1) Typical PECBC Illustration

The partially encased composite beam columns (PECBC) configuration described in this paper is a relatively recent development in composite structures consisting of thin walled, welded H-shaped steel section with concrete infill cast between the flanges as shown in Figure 1. Transverse links are provided between the flanges at regular intervals to improve the resistance to local buckling. This new composite system was developed to overcome the limitations related to erection, connection design, and economy of more commonly used composite beam column. Studies about this new beam column system were limited; Brent S. Prickett and Robert G. Driver (2006) studied the behavior of partially encased composite columns made with high performance concrete some of the test specimens were loaded under eccentric loading; Mahboba Begum, Robert G Driver and Alaa E Elwi (2007) studied finite element modeling of partially encased composite columns using dynamic explicit method, eccentrically loaded specimens were modeled with different link spacing and load eccentricities and either with or without longitudinal reinforcement.; Saima Ali & Mahboba

was strengthened to prevent possible failure at these locations due to uneven loading. Additional links were added so that the link spacing was 50mm for the first 100mm of the end zone as shown in Figure (1).

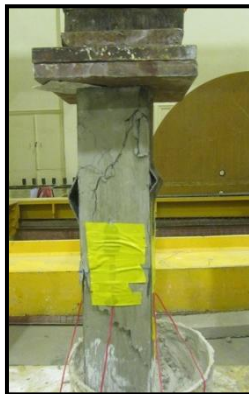
Figure (3) P-1 Flange Bucklin

confinement of the concrete no longer exists thus the concrete acts alone and cracks appear. By increasing the load the buckling increases and appears in different location of the flange as shown in Figure (3) and the cracks of the concrete appear everywhere as shown in Figure (4); when removing the cracked concrete the web plate also has buckled as shown in Figure (5).

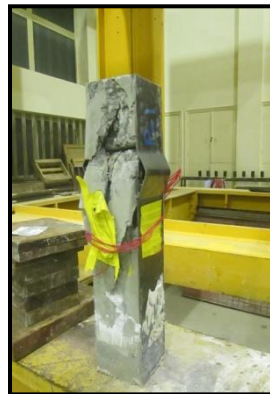
Figure (4) P-1 Concrete Crack

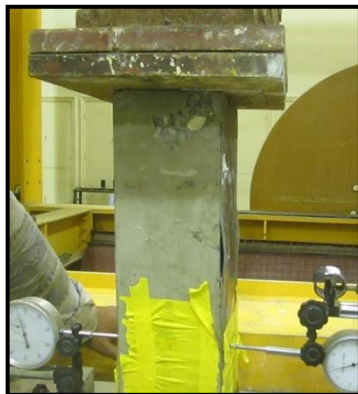
Figure (6) P-2 Flange Buckling

The failure load is 2 tons higher than specimen P-1 and this is due to the closer link spacing used; thus closer link spacing enhances the column load capacity and failure mode. Flanges buckling and concrete cracks happened at column mid height Figure (6) & (7).

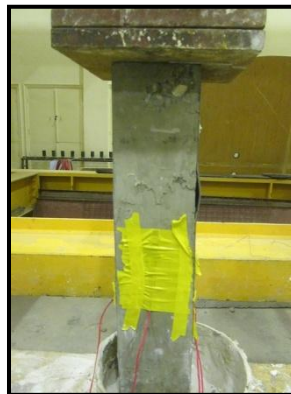
Figure (7) P-2 Concrete Cracks

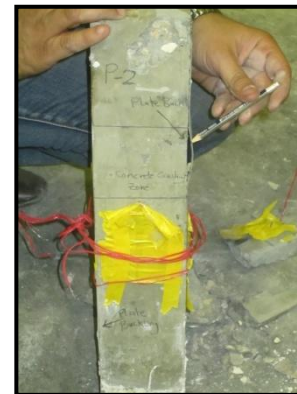
Figure (8) P-2 Failure zones

The column failure zones indications is marked out on the column showing flange plate buckling zone and concrete failure zones Figures (8).

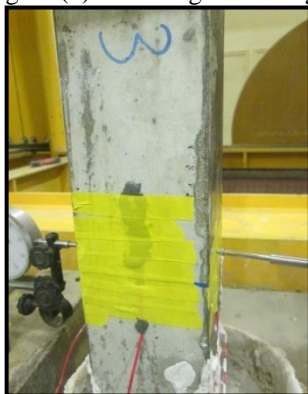
Figure (9) P-3 Flange separation

Specimen P-3 is used to study the effect of the second parameter the different concrete compressive strength (300 Kg/cm²). Loading was applied and increased gradually from 2 tons up to 38 tons; readings and observations are recorded every 2 ton. Up to 26 ton loading there are no observations of any flange buckling or concrete crushing. At 28 ton load separation between the concrete face and the flange plate at the right side at mid height of column is observed. At 30 ton; column flange buckling occurred at height of 330 mm (0.66H) from column top at the right side. Buckling continued to increase at this location up to 34 ton. The column buckling starts at 28 tons load; and 0.7 m.t bending moments; accordingly the failure load is 28 tons and the failure mode is buckling of flange plates associated with concrete crushing. The failure load was 2 tons less than specimen P-1 and the failure in both columns is due to buckling of flange plates; but it is obvious that the failure load decreased because of using lower concrete compressive strength thus lower confinement of the concrete to the steel flange plates thus faster buckling; also the failure load was less by 4 tons than specimen P-2 and this is due to the using larger link spacing and less concrete compressive strength. The separation between the concrete and the flange plates happened at the column mid height at the right side of the column Figure (9) (the same side where the load is applied) and the buckling happened at the same side but at 0.66 of the column height Figure (10); this separation is due to the using of lesser concrete compressive strength; this separation made the buckling happened faster than column P-1 or P-2 accordingly lesser column capacity. When buckling happens the steel plate leaves the concrete surface thus the confinement of the concrete no longer exists thus concrete acts alone and cracks appears Figure (11); in this specimen after appearance of flange buckling and of concrete cracks; test continued up to 34 tons and then stopped.

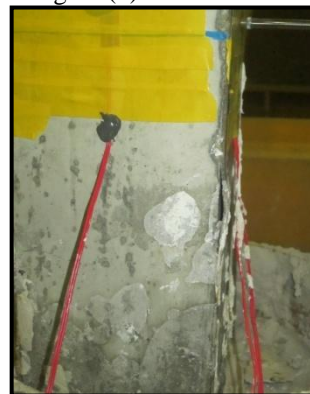
Figure (10) P-3 Flange Buckling

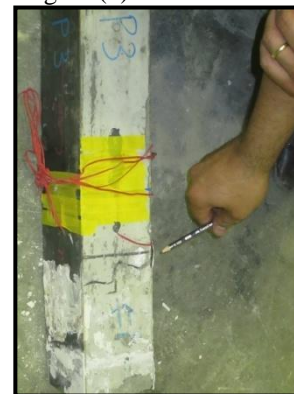
Figure (11) P-2 Failure zones

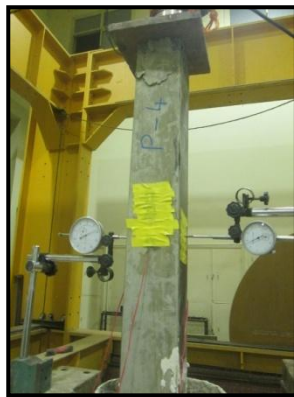
Figure (12) P-4 Flange Buckling

Load was applied and increased gradually from 5 tons up to 15 tons; readings and observations are recorded every 5 ton. Then loads was increased from 15 tons to 25 tons gradually; readings and observations are recorded every 2 tons. Up to 23 ton loading there are no observations of any flange buckling or concrete crushing. At 25 ton load; column flange buckling occurred at height of 300 mm (0.375H) from column top at the right side; along with concrete cracks at height of 120mm from column top; then test stopped. The column buckling starts at 25 tons Load; and 0.625 m.t bending moments; accordingly the failure load is 25 tons and the failure mode is buckling of flange plates associated with concrete crushing. The failure load is decreased by 5 tons than specimen P-1 and this is due to using longer column ($H/d=8$); the flange buckling happened faster due to the usage of longer column Figure (12); the failure mode is similar to previous studies failure mode ; column flange buckling starts and hence concrete cracks appears. When buckling occurred the flange steel plate leaves the concrete surface thus the confinement of the concrete no longer exists thus the concrete acts alone and cracks appears Figure (13).

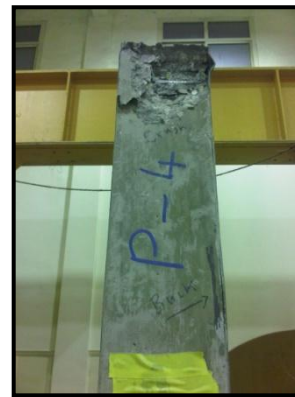
Figure (13) P-4 Concrete Cracks

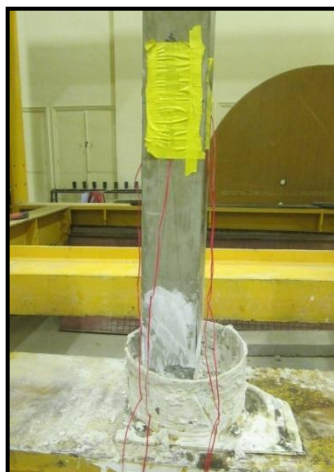
Figure (14) P-5 Flange Buckling

Specimen P-5 is used to study the effect of the third parameter the column height to depth ratio but with ($H/d = 10$) on the behavior of PECBC. Load was applied and increased gradually from 5 tons up to 15 tons; readings and observations are recorded every 5 ton. Then loads increased from 15 tons to 24.5 tons gradually; readings and observations are recorded every 1 tons. Up to 24 ton loading there are no observations of any flange buckling or concrete crushing. At 24.5 ton load; column flange buckling occurred at height of 150 mm (0.15H) from column bottom at the right side Figure (14); along with concrete cracks at height of 200 mm from column top Figure (15) and bottom; then test stopped. The column buckling starts at 24.5 tons Load; and 0.61 m.t bending moments; accordingly the failure load is 24.5 tons and the failure mode is buckling of flange plates associated with concrete crushing; the failure load is decreased by 5.5 tons than specimen P-1 and this is due to using longer column ($H/d=10$); which is similar to P-4 with only difference of 0.5 t which is due to increasing the column height to depth ratio from 8 to 10. The flange buckling happened faster due to the usage of longer column; the failure mode is similar to previous studies failure mode; column flange buckling starts and hence concrete cracks appears. When buckling occurred the flange steel plate leaves the concrete surface thus the confinement of the concrete no longer exists thus the concrete acts alone and cracks appears.

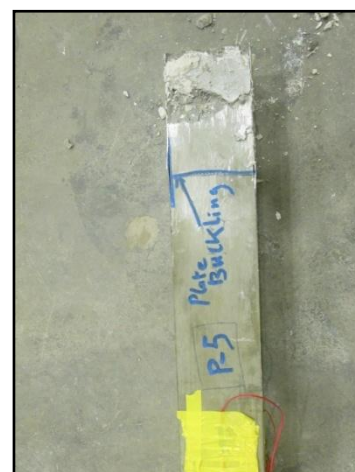
Figure (15) P-5 Concrete Cracks

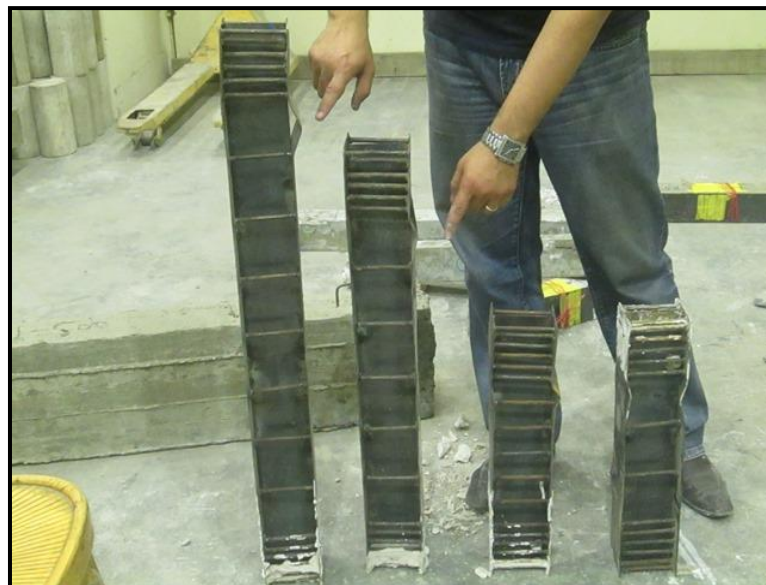
Figure (16) Bare Steel Specimens after Failure

Four Bare steel columns measuring 100x100 in cross section were constructed two of them with height 500mm, one of 800mm height and one of 1000mm height; with specimen properties as shown in table 2 same properties as the PECBC; and five reinforced concrete columns measuring 100x100 in cross section were constructed, three of them with height 500, one of 800 height and one of 1000mm height; with specimen properties as shown in table 3 below. The longitudinal reinforcement used was with same yield strength and area as of the steel plates used for the PECBC and the steel columns. All the specimens were tested using the same machine and under the same conditions as the PECBC specimens; loading was applied and results were recorded. Figure (16) & (17) shows the steel and RC specimens after testing.

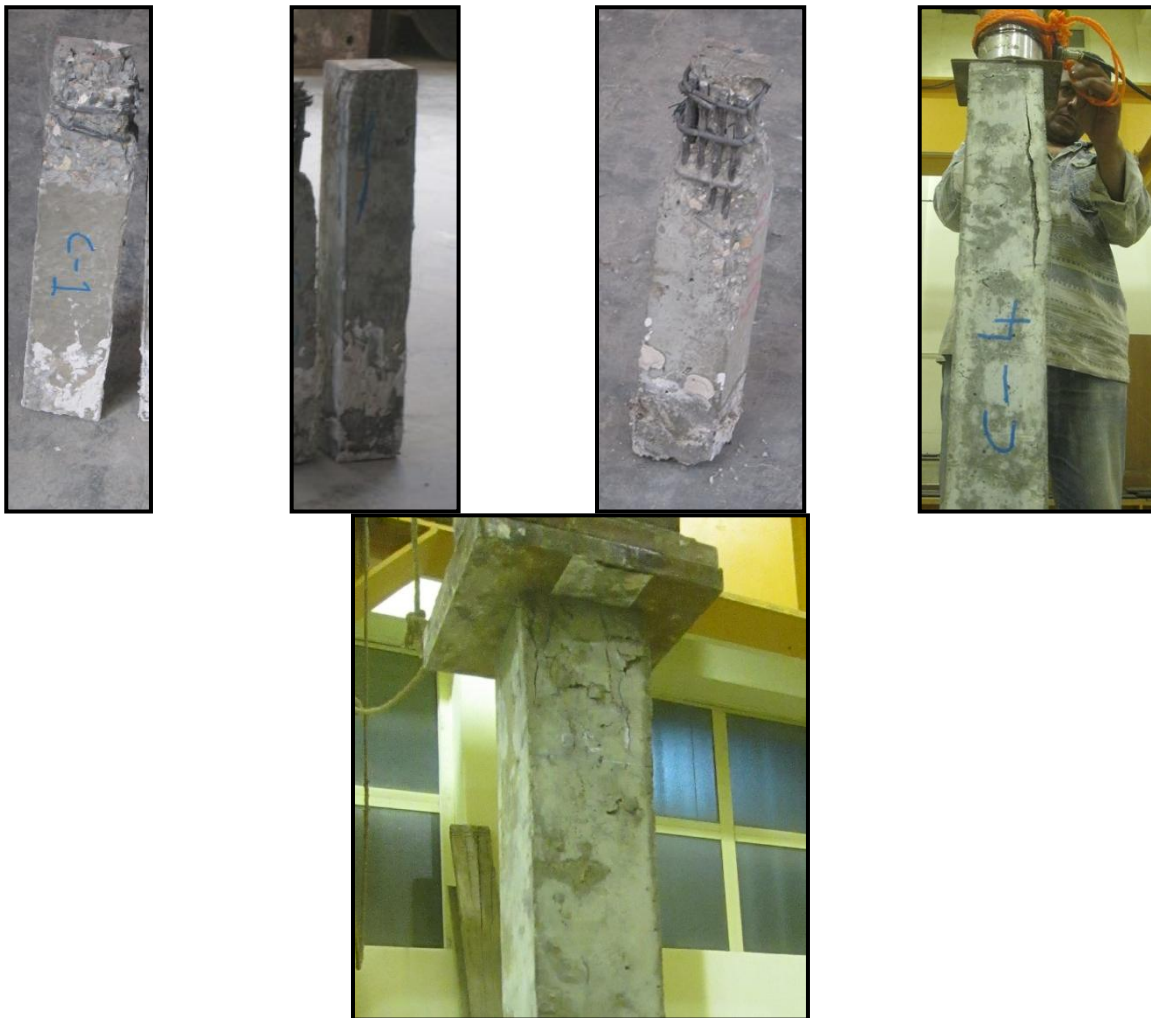
Figure (17) Reinforced Concrete Specimens after Failure
