The decay of portuguese facade azulejos: a comparaiso between south Brazil and Lisbon

Keywords: Azulejos, glazed tiles, facades, decay, Brazil, Lisbon.

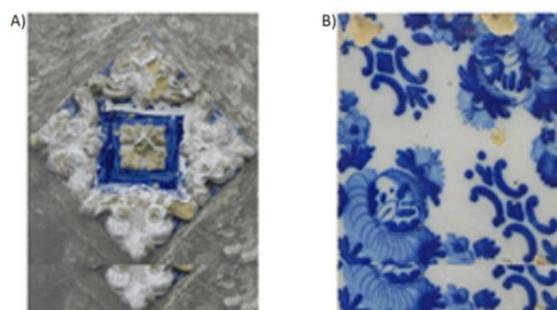
It is interesting to highlight the presence in significant quantity of tiles in salient patterns (picture "A") and tiles of cat's beard pattern (picture "B") coming from Porto and surrounding, according to the author (Figure 1).

Figure 1: Picture "A" and "B": salient pattern and cat's beard pattern, respectively.

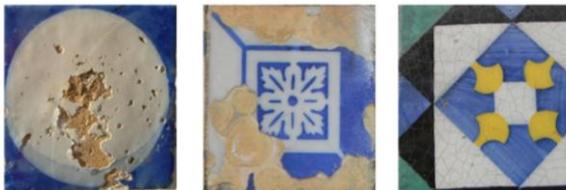
Figure 2: Different levels of degradation of tiles of facades with falling of glazed in Lisbon.

Aiming to demonstrate the several types of the physical degradation that happened to the tiles of facades in the quoted cities, we present, as following, a comparison between the different levels of degradation of the tiles of facades, in different places of the quoted cities (Figures 2 and 3).

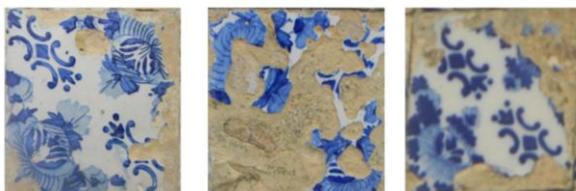
Figure 3 : Different levels of degradation of tiles of facades with falling of glazed in Brazil.

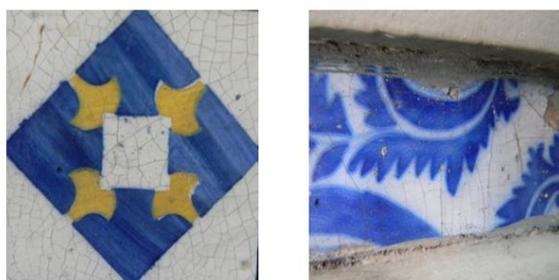
a) The glaze cracking. Caused by the inconsistency of expansibility between baked clay and glazed, known as crackle. Crackle that is found in facade tiles does not occur at the manufacturing moment, but when it is associated to another phenomenon due to the support humidity, the expansion only of the baked clay and not in the glazed in the presence of water.

Thus, it is impossible to say that the presence of the visible crackle in tiles of facades does not occur very often in Porto Alegre, Jaguarão and Rio Grande cities, differently from Lisbon (Figure 4).

Figure 4: Crackle tiles from Lisbon and Rio Grande, respectively.

Most of the cases analyzed in Brazil present crackle almost unnoticed by the human eye. In some cases it is noticed the gentle presence of crackle in tiles next to more humid zones but it was observed its presence in all analyzed facades, even though it was necessary a magnifying glass to diagnose some of them.

The established relation between these two countries is that in all analyzed cities crackle occurs because there is often harder gravity in areas next to the ground, where rising humidity is greater or, then, under windows. Both cases occurred in every of the analyzed facades.
