Evaluation of the Habitated Risk Area and Indication of Solutions for the Shangrillá and Vila Formosa Districts in Anápolis

Welvis Furtado da Silva, Leonardo Viana Silva, Antônio Jorge de Oliveira and Ernane Rosa Martins.

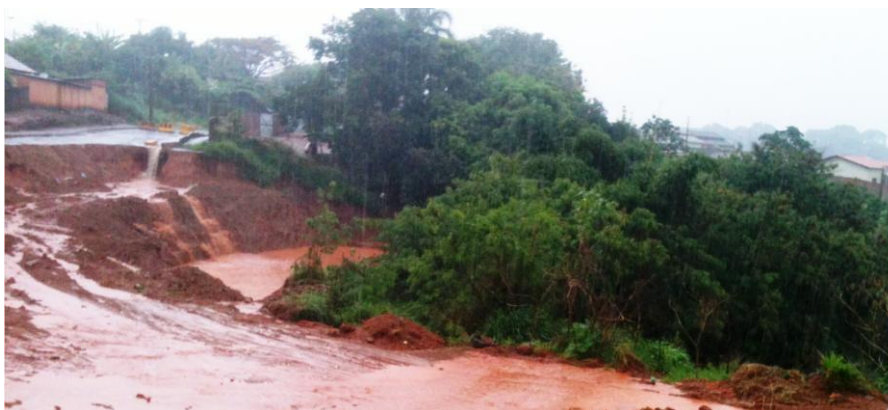
Figure 2: Area affected by advanced crawling causing calamity in 2016.

The emergence of the mass crawling has a strong relation with the half-slope launch of rainwater captured upstream of the tributary of the stream Góis. These water flows did not receive dissipation of the energy and with this they infiltrated with ease in the little thick soil existing in the place, as shown in Figure 2.

In fieldwork, he observed that no landfill was cut for housing construction and this contributes to slow movements in the relief, of the creeping type. Trees with exposed roots, signs of soil loss, as well as sloping trees, signs of mass movements were also identified at the site, as shown in Figure 2.

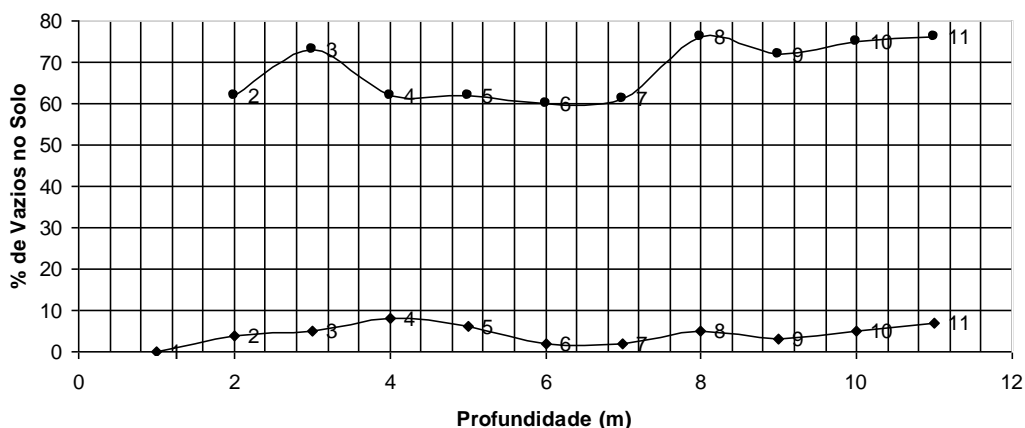
Figure 7: Soil study (Voids vs. Depth).

clay layer. It obtained water presences at 2.0 m. The number of Percussion Drills (NSPT) for the organic clay layer varied by <2 to 4 strokes, denoting that the soil is of very soft consistency as well as the high voids index as shown in Figure 7.

Gráfico I: Índice de vazios vs Profundidade (m)

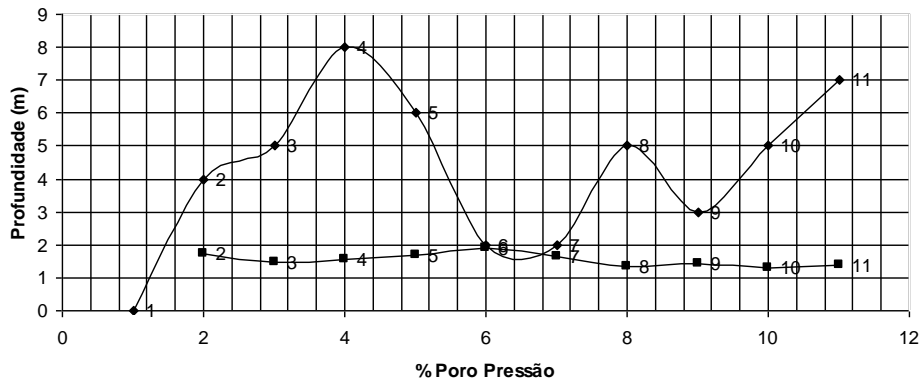
Figure 13: Soil study (Pressure vs. Depth)

Gráfico III: Poro Pressão vs Profundidade no solo (m)
