Disaster Management for Cooling Tower- Case Study.

¹Deshmukh Azhar A, ²Prof.P.P.Bhangale

^{1,2}Department of Civil engineering , HSM's Sant Gadge baba college of engineering and technology, Bhusawal (M.S) India

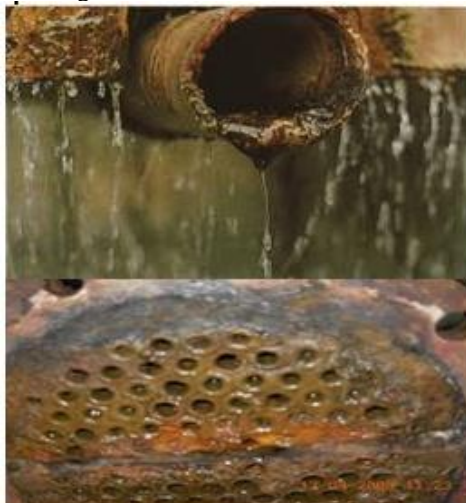
- **Chemical Threat:** The accidental leakage of chemicals in the cooling tower system can trigger the process of fouling and corrosion. In refrigerant from the refrigerant side to the water side, which often circulates in cooling tower loops. Since large amount of inversely-soluble minerals, such as calcium and magnesium contained in the water loop, due to the evaporation process, water became concentrated. When the concentrated water is heated up by the refrigerant inside condensers, the solubility of the minerals decrease and precipitation occurs. Aside from precipitation, other fouling mechanisms are particulate fouling, biological fouling and corrosion fouling. Cooling tower water is often pre-treated with biological and corrosion inhibitors, so the last two types of fouling mechanisms might be controlled. Minerals concentration, especially calcium concentration was reported to be a main driving force of fouling in heat exchangers.

Figure 1: Fouling in Cooling Tower

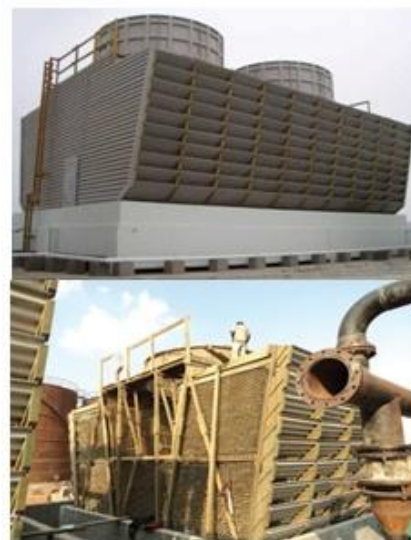
Cost Saving Intention: The cooling towers are huge devices with sizes. The structures are made of reinforced concrete or wood. In most of the refineries and fertilizer plants in India wooden cooling towers are being used due to lowest capita cost.

Figure 2: Wooden Cooling Towers

Cooling towers are most critical utility elements as the complete process cooling water requirement depends on them. Wooden cooling towers can be attributed to collapse for following major factors:

- Failure of wooden support structure: The sheer weight of the huge distributor pipe (Approx. 80 meters in length, Diameter ranging from 52" to 24") running over the deck with the mass of water in it can lead to collapse in case of failure of the wooden support structure.
- Failure of vertical riser pipe/joint due to corrosion: The corrosion can weaken the vertical riser pipe leading to the collapse of cooling tower.

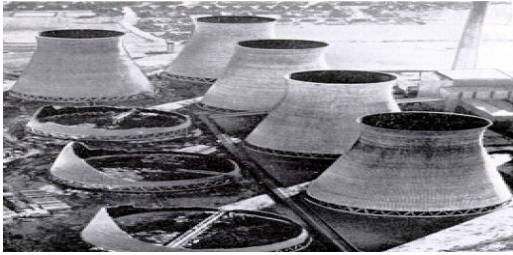
A strong wind blew against the cooling towers at the Ferrybridge power station on November 1, 1965 creating a windward and a leeward row of towers. This wind was later estimated to have travelled at 76 to 84 miles per hour at 33 feet above the ground, and at 93 to 104 miles per hour at the upper rim of the towers. As the wind pushed past the towers in the windward row, it was funnelled through the spacing between them

onto the windward faces of the second row of towers.

Figure 3: FerryBridge Cooling Tower Collapse

This pressure caused the leeward towers to lean away from the windward towers, stretching their windward sides in the way that leaning from the waist stretches muscles on one end. At the same time, updraft through the towers created a force that tended to lift the towers off their foundations. This lifting action reduced the effective weight of the towers and increased the stretching of the concrete shells. The resulting vibration of the enormous concrete towers produced a high pitched whine that was reported by observers to resemble “someone rubbing a finger round the rim of wineglass.”

The wind eventually stretched the windward sides of three of the second row cooling towers beyond the strength of the steel reinforcing in the concrete shells. The towers lost their structural integrity and could no longer hold their shape. Initially, the upper rims of the three cooling towers buckled into the tower centres. The windward sides collapsed into the tower centres in turn, dragging in the adjacent side sections of the structures.

Three leeward towers collapsed in the fashion. Although the failures were sudden, they were not simultaneous. The first tower failure occurred at 10:30 A.M, the second about 10 minutes later and the third at about 11:30 A.M. A spectacular photograph was taken from the windward side of one of the towers during collapse, showing the overstretched windward side of the tower dragging and twisting the adjoining sections inward.
