## Structural Analysis for Rehabilitation of Reinforced Concrete Structure

The structural element – basement raft of the Beach resort started showing symptoms of distressed within 10 years on its completion. This deterioration has aggravated further during next 3-4 years and the basement floor became obsolete functionally. Therefore, it was decided to identify the cause of failure of the structural element in terms of inadequacy of the structural element. The failure may be due to inadequacies in the design and detailing or defects during construction. This study dealt with the analysis of existing structural member for its design adequacy and to ascertain defects during construction. Design adequacy was ascertained using computer aided software- (STADD -Pro). Defects during construction have been ascertained by establishing the Sectional details of the As built basement raft in terms of dimensional parameters, noted on site as well as quality parameters confirmed in laboratory testing. On analysing these cases, the actual cause of the structural failure of the basement raft has been concluded.

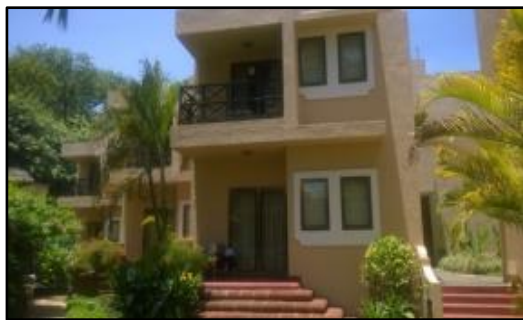
Major underground water leakage through raft foundation at basement of Beach Resorts in Goa was leant in September 2015. When contacted to understand about the site, the General Manager, of Resort has informed that the construction of the Resort was completed in year 2001 (Fig 1).

**Fig 1** Photo showing the building at the resort & access to the basement

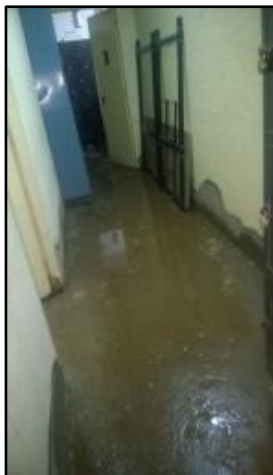
The subject building has basement, Ground and first floor. The basement of the building was being used as a Conference hall, administrative offices, Maintenance and House Keeping Sections for during last 10-11 years. However, in year 2010, the Conference Hall area of the basement floor started showing dampness (Fig 2), which further deteriorated years ahead.

**Fig 2** The basement passage started showing ground water dampness in 2010

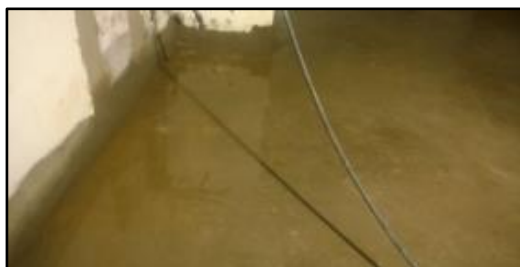
The major leakage through basement floor commenced from year 2014. This has resulted in water pool up to the height of 1 ft in the basement during last two monsoons (Fig 3). As such, the basement floor became obsolete functionally. RCC raft treated with injection grout and waterproofing treatment in 2014(Fig 4).

**Fig 3** Ground water table up to depth of 1 ft. in year 2014 monsoon

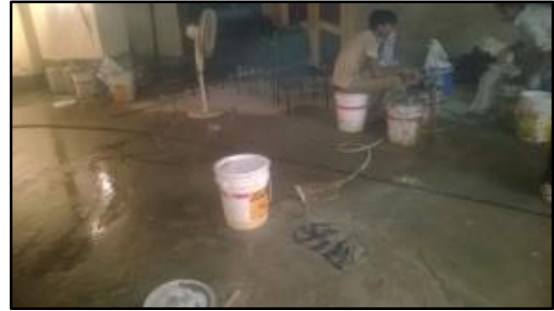
**Fig 4** RCC raft treated with injection grout and waterproofing treatment in 2014.

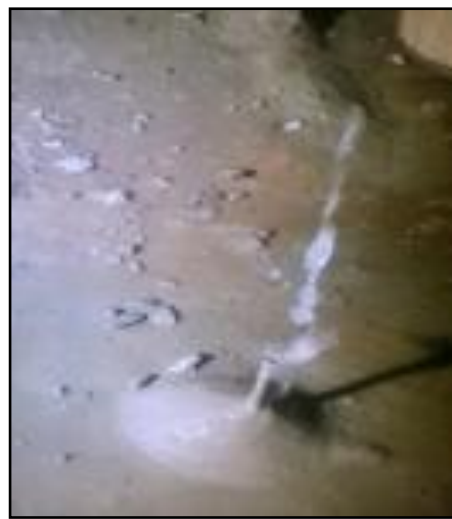
In year 2015, the site conditions was further deteriorated when underground water fountain out up to the height of 900 mm (Fig 5)

**Fig 5** Underground water fountain out up to the height of 900 mm in Sept' 2015

In October 2015, Beach Resort has called for structural rehabilitation of the basement foundation. As a post-graduate student and the thesis project work, I have approached Resort with the written request to allow to carry out in-depth site investigation, review and interpret all available details, sub-soil investigation, analysis of existing structure and causes for the failure of basement raft and to propose rehabilitation scheme of the basement foundation. Beach Resort had given the consent to carry out this assignment under the direction of Project Management Consultant (PMC), which is already appointed. PMC has also given consent to this project assignment, which is to be carried out by me independently with the pre-condition that the approval shall be obtained for each & every step being performed by me.

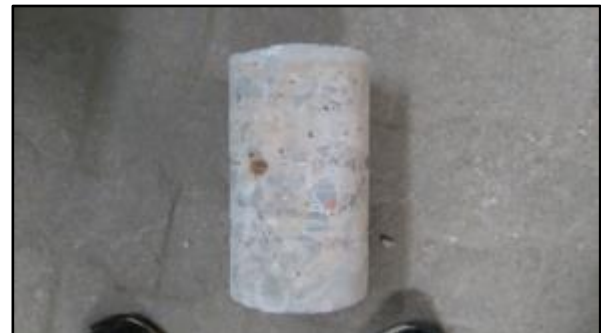
**Fig 8** Concrete core from existing raft slab

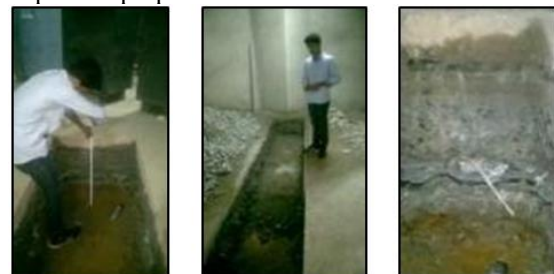
**Fig 9** Inspection of open trench made in raft

The trial pit made in the existing raft to get the sectional details of the existing RCC raft. The observations made by me are tabulated below,

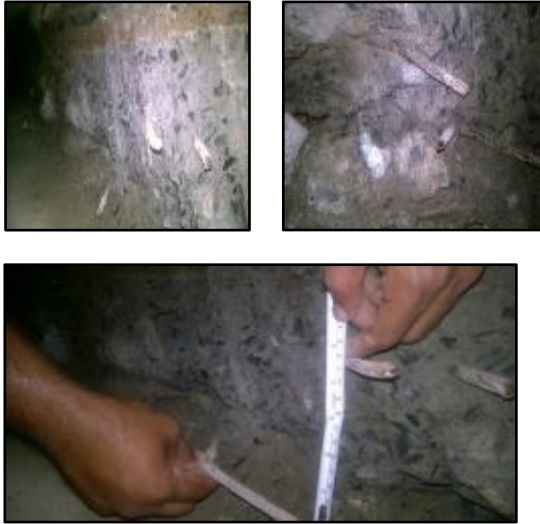
**Fig 10** Raft sectional details noted from open trench

1. Comments:RCC raft slab sectional details observed on site differ from the relevant RCC drawing.
2. Further, reinforcement steel in existing RCC raft is much less than nominal steel of 0.2% required in reinforced concrete as per IS 456-2000<sup>(B)</sup>.
3. Therefore, raft failure may be the case of defect in construction. As such, it is decided to discard existing RCC raft and rehabilitate the basement raft by introduction of new RCC raft with micro piles.

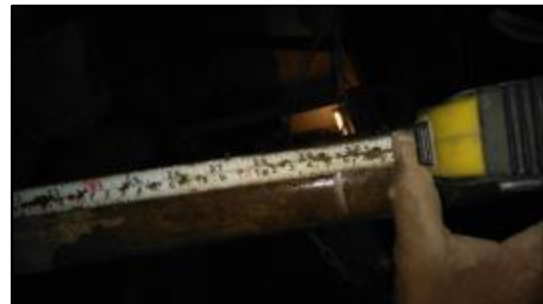
**Fig 11** Marking (75mm) on the sample extraction pipe/tube from that height weight has to be released

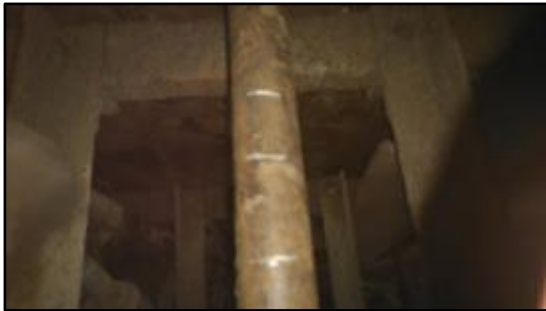
Fig 12 Marking on the SPT tube (150 mm)

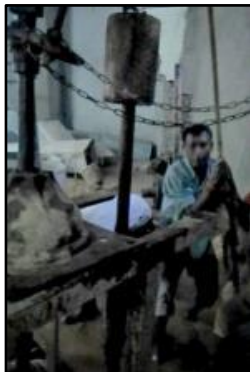
Fig 13 Release of weight for the extraction of soil sample

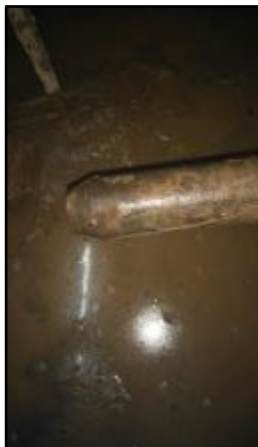
Fig 14 Soil extraction pipe/tube (Soil sampler tube)

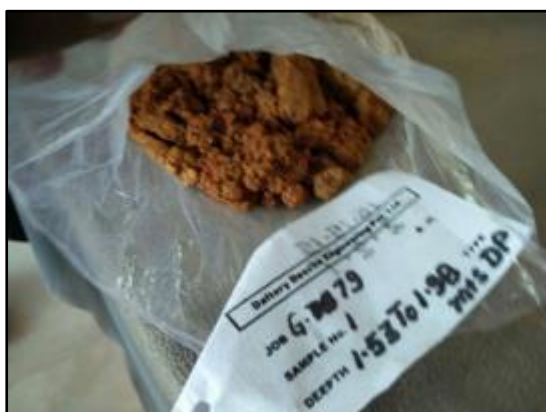
Fig 15 Extracted soil sample at the depth of 1.53-1.98 mt

- 1) From bore log exploration, it is observed that columns have individual footings to disperse building load to suitable strata below basement level. RCC raft at basement level forms a structural member to sustain uplift of underground water of head 2m
- 2) Concrete core from RCC raft and soil samples obtained from bore logs were tested in Civil Engineering laboratory of Govt. College of Engineering, Goa

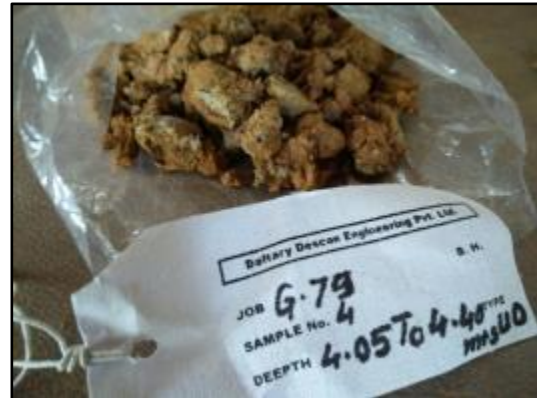
Fig 16 Extracted soil sample at the depth of 4.05-4.40 mt

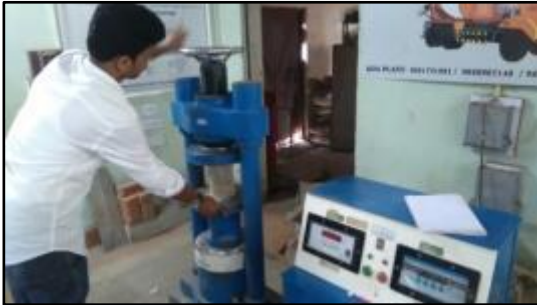
Fig 17 Placing the concrete core of existing RCC raft

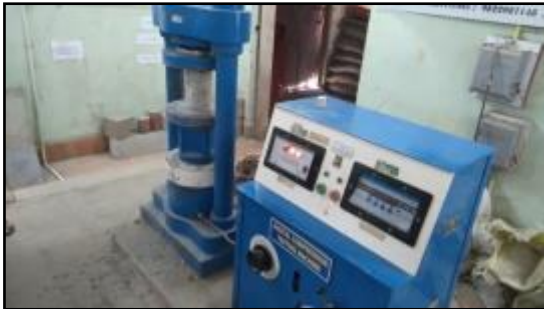
Fig 18 Application of the load

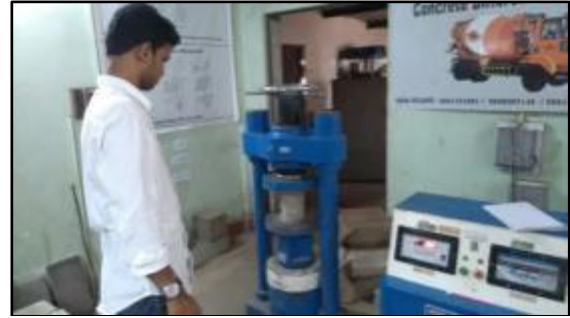
Fig 19 Maximum loading on the concrete core

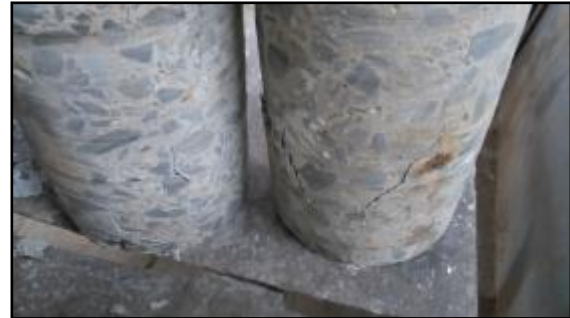
Fig 20 Failure of concrete core

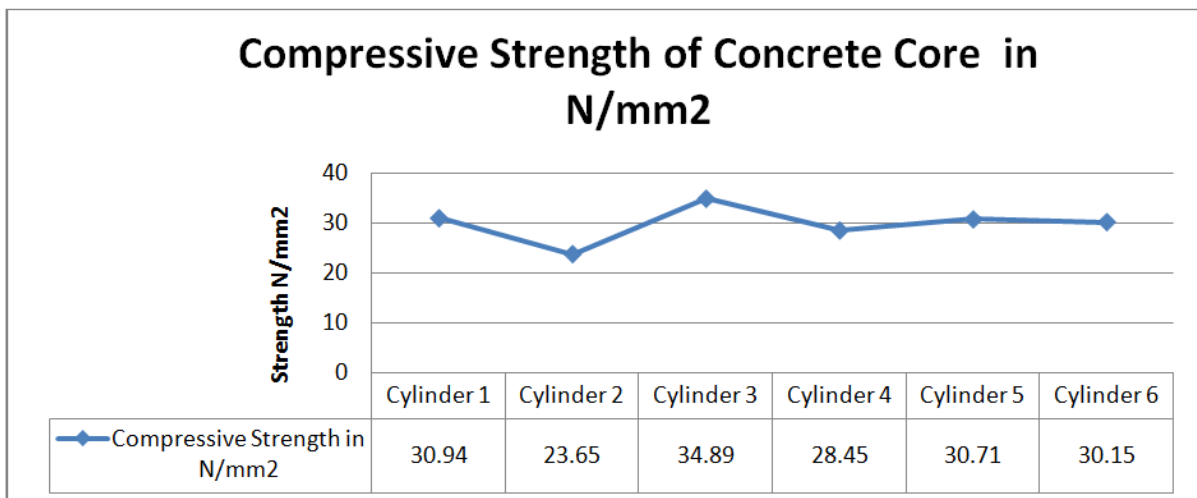
Table no 4 Compression test on the concrete core from existing raft (Refer Fig 21)

Fig 21 Graph showing the compressive strength of concrete core

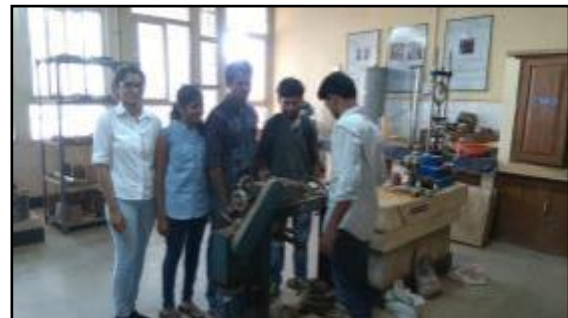
**Fig.22** Recording the readings from the dial gauges

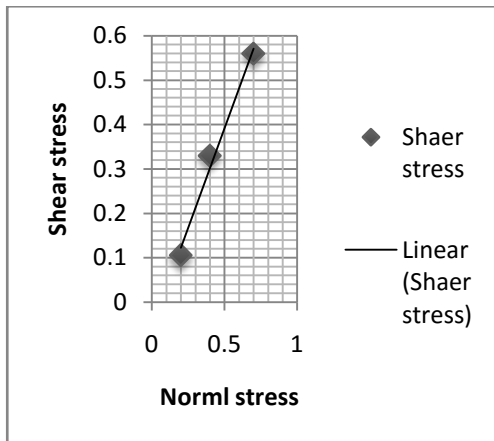
Fig.23 Graph showing reading of shear stress vs. normal stress

From the graph plotted by using the shear stress vs. normal stress we got the value of,

$C = 0$

$\theta = 37 \text{ deg}$
