## Experimental Evaluation of Metal Composite Multi Bolt Radial Joint on Laminate Level, under uni Axial Tensile Loading

C Sharada Prabhakar\*, P Rameshbabu\*\*

\*Scientist, Advanced Systems Laboratory, Dr A. P. J. Abdul Kalam Missile Complex DRDO, Hyderabad, Telangana, 500058, India

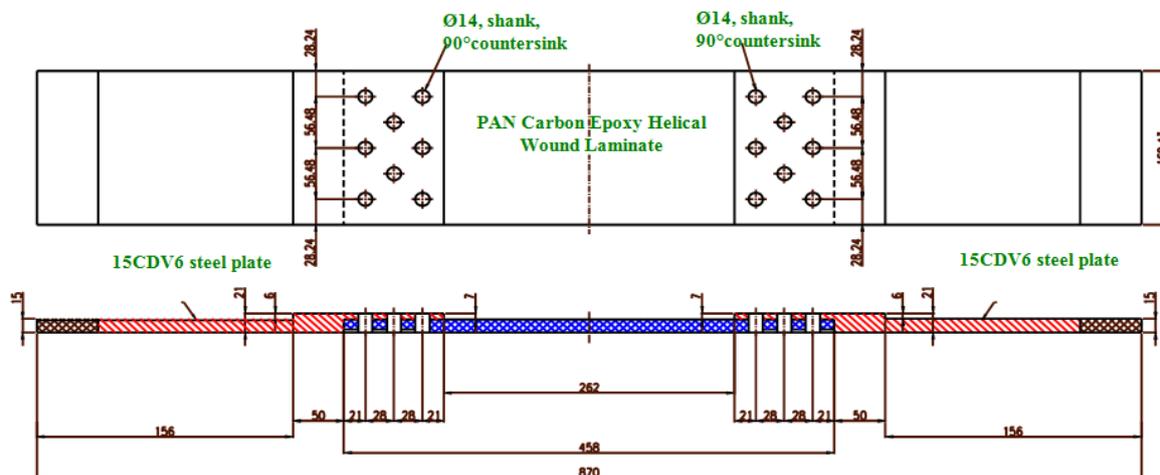
Metal composite multi bolt radial joint configuration on flat laminate level considered for uni-axial tensile load testing is shown in figure-1 (drawn not to scale).

**Fig.1.** PAN Carbon epoxy-15CDV6 steel, multi bolt radial joint assembly on flat laminate level

Width of composite laminate and metallic plates, was considered as 169.43mm and it was necessary to accommodate 5 rows of fasteners in transverse direction with required pitch distance. Length of composite laminate was considered as 458mm and length of each metallic plates were considered as 304mm. Length of the joint on both ends was 98mm, required to accommodate 3 longitudinal rows of fasteners with required pitch distance and edge distance. Total length of metal composite multi bolt radial joint flat laminate assembly test specimen was 870mm. Total thickness of proposed metal composite bolted radial joint portion of cylindrical sections was considered as 21mm. Out of 21mm, 18mm was structural thickness and 3mm thickness was provided for innermost thermal protection layer and leak proof layer. 18mm structural thickness includes 11mm PAN carbon epoxy laminate thickness and 7mm metal thickness. Structural thickness at shell portion of proposed composite section was 15mm (11mm helical and 4mm hoop). Hoop layers will not contribute in longitudinal load transfer and hence not considered for laminate level test. Only 11mm of helical thickness was considered for laminate level test. Angle of winding for helical layers was  $\pm 22.5^\circ$ .

Joint design depends on fastener diameter, number of rows, thickness of metal and composite (helical layers), at the overlap region. Metal composite bolted radial joint on laminate level was realized with 8 number of fasteners. Following are the details of fasteners:

- Fasteners: Special screw and nut.
- Material of fasteners --EN24 10.9 property class.
- Diameter of holes in laminate and metallic plates=14mm.
- Shank diameter of fastener =14mm.
- Internal threads on nut=M6.
- External threads on screw=M6.
- Countersunk angle on nut and screw=90°.
- Number of fasteners=8.
- Number of Rows of fasteners in longitudinal direction =3.
- Number of fasteners in 1<sup>st</sup> and 3<sup>rd</sup> row in longitudinal direction =3 (in similar way).
- Number of fasteners in 2<sup>nd</sup> row in longitudinal direction =2.
- Longitudinal pitch distance = 28mm.
- Longitudinal edge distance = 21mm.
- Transverse pitch distance = 28.24mm.
- Transverse edge distance of fasteners = 28.24mm.

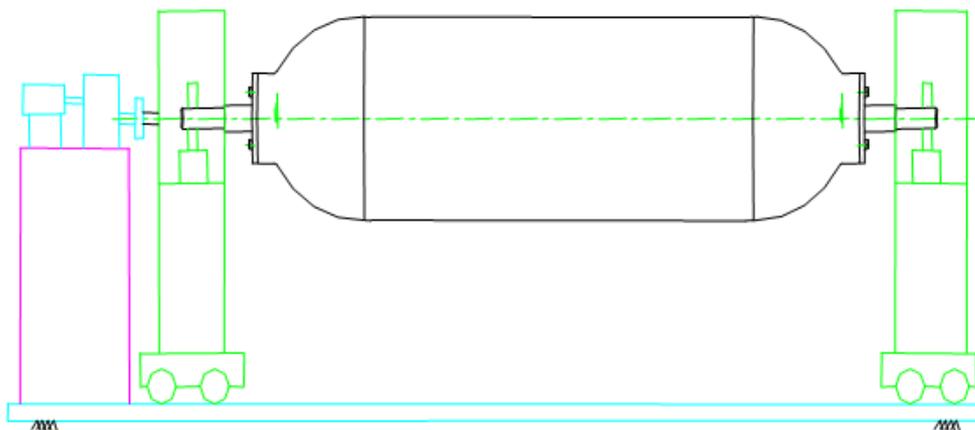
Carbon epoxy thick, flat laminates were developed by wet helical winding method, with low helical angle of winding as  $\pm 22.5^\circ$ . Metallic cylindrical mandrel with hemispherical end domes was used for helical winding. CNC program for helical winding with  $\pm 22.5^\circ$  as angle of helical winding, was generated and one helical layer of 1.5mm thickness, with PAN carbon epoxy was wet wound. Schematic of mandrel, loaded on CNC Filament winding machine is shown in figure-2.

Fig.2. Mandrel loaded on CNC Filament Winding machine

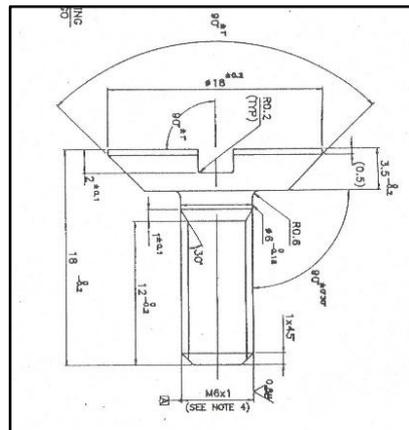
Special screws and nuts were machined from EN24 Steel alloy, hot rolled and heat treated rod. Fasteners of 10.9 property class were used. These fasteners were cadmium plated and inspected for dimensions and mechanical properties. Duly accepted fasteners were used for joint. Drawing of special screw and photograph of special nut are shown in figure-3 and figure-4.

Fig.3. Special screw

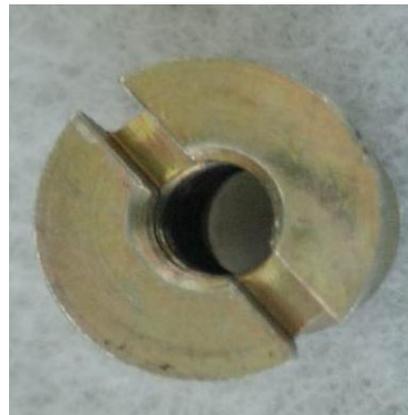
Fig.4. Special nut

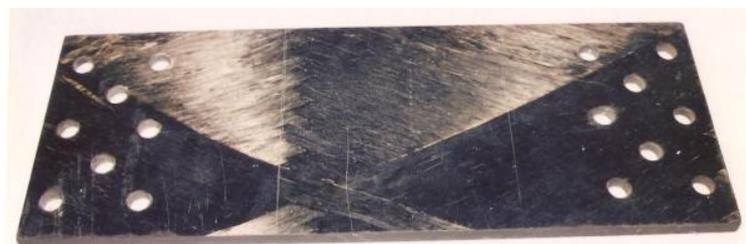
14mm diameter straight holes with 90° countersunk on top surface (18mm diameter), 8 numbers were drilled on 15CDV6 plates (in three rows: - 3 holes in 1<sup>st</sup> and 3<sup>rd</sup> row, 2 holes in 2<sup>nd</sup> row). For drilling of 14 mm diameter holes on composite test laminate specimens, centre of hole was transferred from metallic plates and holes were drilled with 90° countersunk (18mm diameter) on top surface of laminate. Composite test laminate specimen was having metal back up during drilling. PAN carbon epoxy composite laminate, after drilling is shown in figure-5.

Fig.5. Drilling of holes on composite laminate

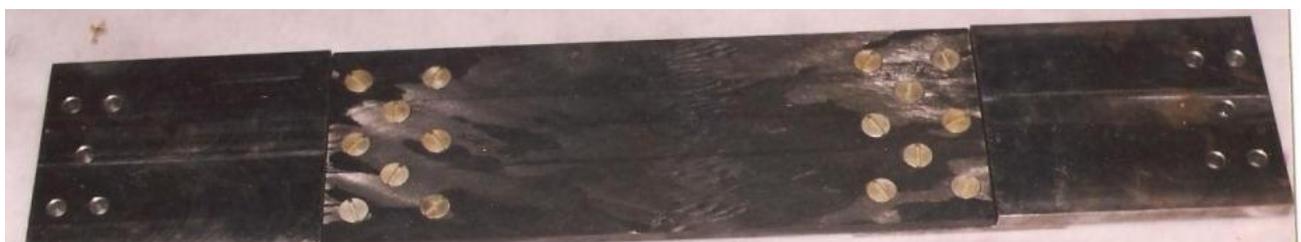
Fig.6. Metal composite multi bolt radial joint assembly test specimen

diameter. Thus metal composite laminate test specimen was made ready for test. Assembly of metal composite multi bolt radial joint assembly test specimen is shown in figure-6. Enlarged view of joint is shown in figure-7.

Metallic plates and carbon-epoxy composite test laminate specimen were assembled with M6 special screws and nuts with 14mm shank

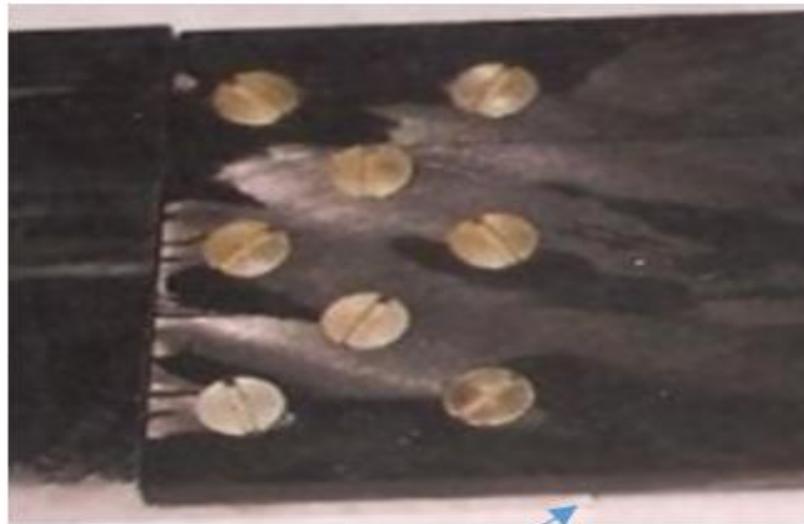
Fig.7. Enlarged view of metal composite multi bolt radial joint, to show overlap region on metallic plate

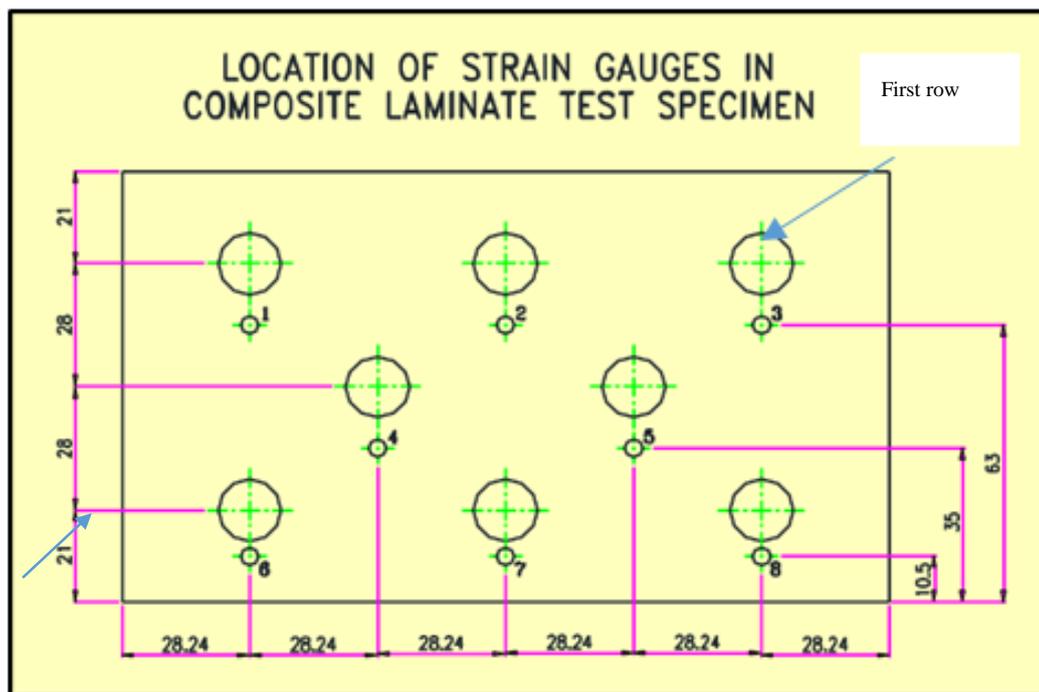
Fig.8. Location of strain gauges in composite laminate

Strain gauges were placed near each fastener hole, in the PAN carbon epoxy helical wound laminate, to measure crushing or bearing failure of loaded (contact region) portion of holes as well as strains in stress concentration zone. Location of strain gauges near each fastener hole in composite laminate test specimen is shown in figure-8. Strain gauges in 1<sup>st</sup> row (farthest from edge of laminate) are located at 63mm from the edge of the laminate. Strain gauges in middle row are located at 35mm from the edge of the laminate and strain gauges in 3<sup>rd</sup> row (last) are located at 10.5mm from the edge of the laminate. Location of strain gauges in 1<sup>st</sup> and 2<sup>nd</sup> row is 7mm from the edge of the respective fastener holes. Location of strain gauges in the 3<sup>rd</sup> row is 3.5mm from the edge of the fastener holes.

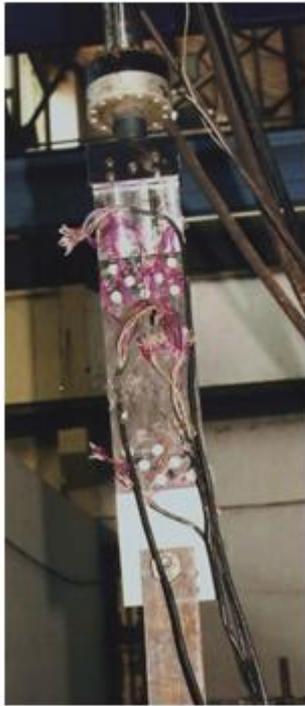
**Fig.9.** Test set up with test specimen

Strains and displacements were measured during test. Test set up with test specimen for experiment is shown in figure-9.

Test specimen is loaded up to 10T of tensile load in steps of 1T. At each discrete loading, strain and deflection values were recorded. Load was brought back to 0. Residual strains were also recorded.

After that, test specimen was loaded continuously up to 18T (to the capacity of loading device). At 18T load there was no visual failure observed in the test laminate and at the joint portion. Expected failure load was also 18 tons.

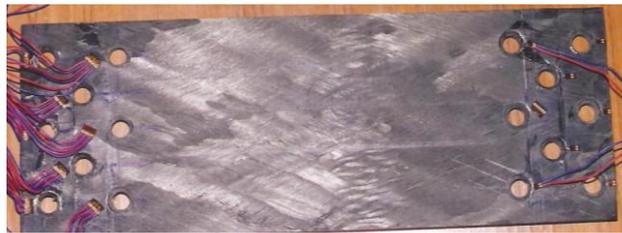
- Countersink hole side, straight hole (14mm) side and enlarged view of straight hole side of laminate test specimen, after test are shown in figure-10, figure-11 and figure-12 respectively.

Fig.10. Countersink hole side of laminate test specimen, after test

- In the composite laminate test specimen, at all holes, initiation of bearing failure was observed. At end hole of end row (8<sup>th</sup> strain gauge), shear out failure was also initiated. Edge distance, 1.5D is maintained. Shear out failure can occur because of low transverse tensile strength and shear strength also.

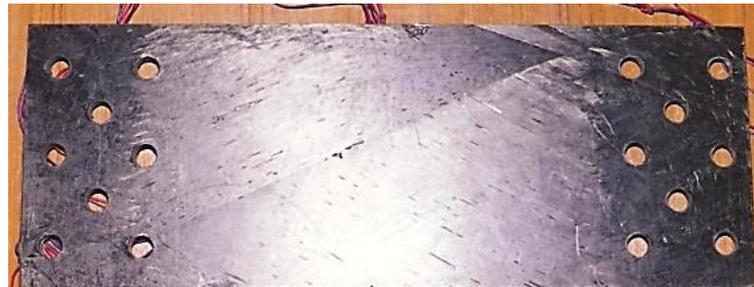
Fig.11. Straight hole side (14mm) of laminate test specimen, after test

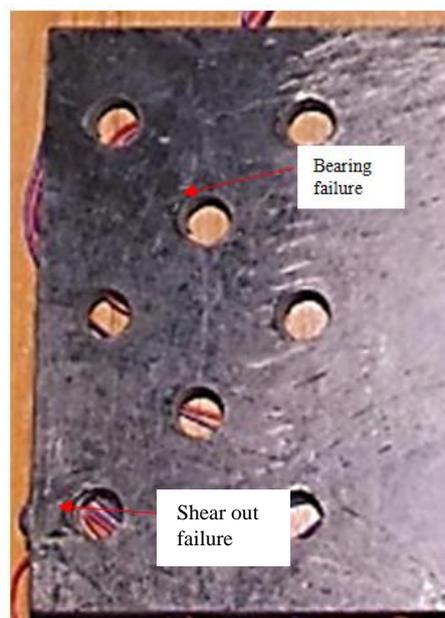
Fig.12. Enlarged view of straight hole side (14mm) of laminate test specimen, after test

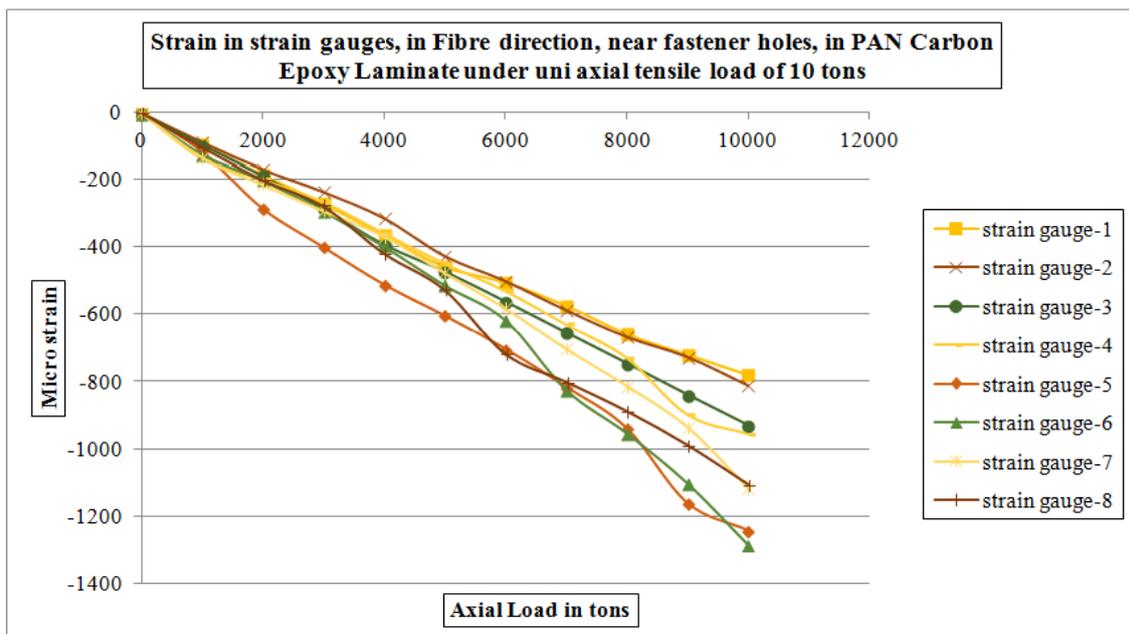
strain gauges are given in table-2. Strain at strain gauge-6, strain gauge-7 and strain gauge-8, for all loadings and residual strain values at these strain gauges are given in table-3. Strain plots at fibre direction in all 8 strain gauges are shown in figure-13. Maximum strain in fibre direction, is recorded as **-1285** micro strain near fastener hole-6, at 3<sup>rd</sup> (end) row.

**Fig.13.** Strain plots at fibre direction in all 8 strain gauges

- At 10T of load net deflection was **1.90**mm and max strain value was **3234** micro strain near hole of fastener no. 4 in middle row. Maximum compressive strain in contact region was observed as **-1423** micro strain near hole of fastener no.7 in last row.

- Max residual strain measured was **-136** micro strain. It was compressive strain.
- Ultimate strain of PAN Carbon (T300) epoxy of the laminate is app 13000 micro-strain.
