An Experimental investigation of the damaged B.F.I. Beam repaired by CFRP under the Static and fatigue loads

Dr. Hala M. R. Abusafa*

Lecturer, Civil Department, Faculty of Engineering, Benha Univ., Egypt

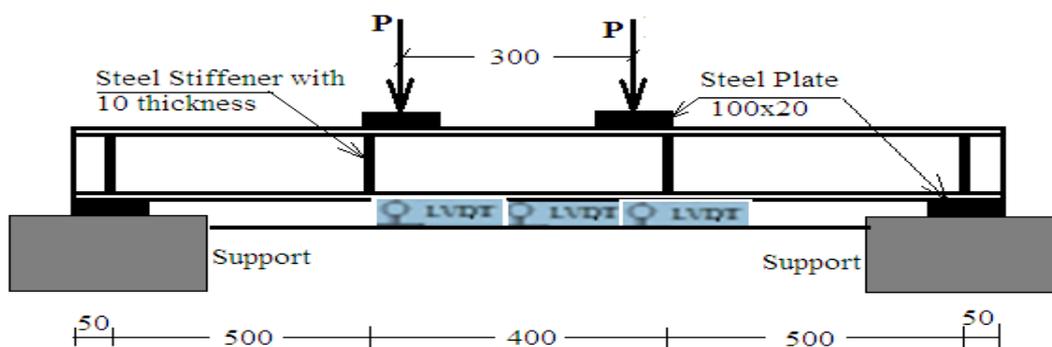
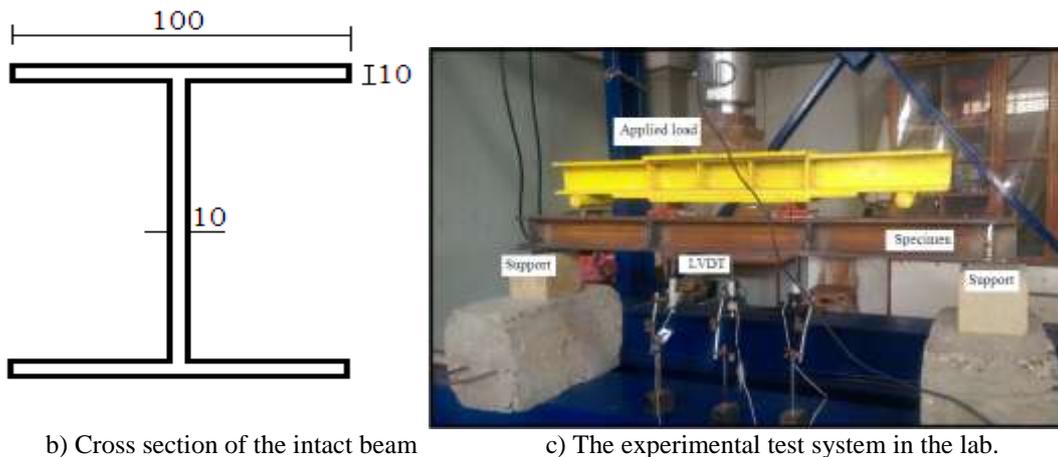
Fig. 1: The details of specimen in the lab.

a) Details of The intact beam

b) Cross section of the intact beam c) The experimental test system in the lab.

The details of the experimental program and the test machine in the lab were provided in Table.1. and fig .1. (a, b, c). We tested ten B.F.I. beams with dimensions 10x10x1500cm. They tested under two points in the center of the beam and far from together by 300mm as shown in fig.1. We tested five beams under static load and the other five beams were tested under fatigue load (repeated load). There are two control beams the first was tested under static load and the other beam under fatigue load, also two beams were notched 4mm in the tension flange and tested under static and fatigue loads (case one). There are two beams had been notched in the tension flange 4mm and rehabilitation by three layers of CFRP strips 10x100cm fixed in the center of the bottom flange (tension flange) and tested under the static and fatigue loads (case two), the other two beams were tested under the same loads but we put extra eight strips of CFRP fixed and distributed to the length of the web (the strips distributed in the two faces) (case three), the two control beams which damaged after the testes and were reinforced by three layers in the tension flange (10*100cm) and four strips fixed to the every face of the web (10x8 cm) (case four).The CFRP strips(10x100cm) (sika Wrap-230C) Table.2. and Fig.2.showing the CFRP (in the vertical sec (a,b) and 3D sec) which fixed in a three layers in six beams at the center of the tension flange, and for the two sides of the web (4strips 10x10) for four damaged steel beams . The three rehabilitations reinforced specimens were subjected to static loads and the other three beams under fatigue loads at the laboratory.

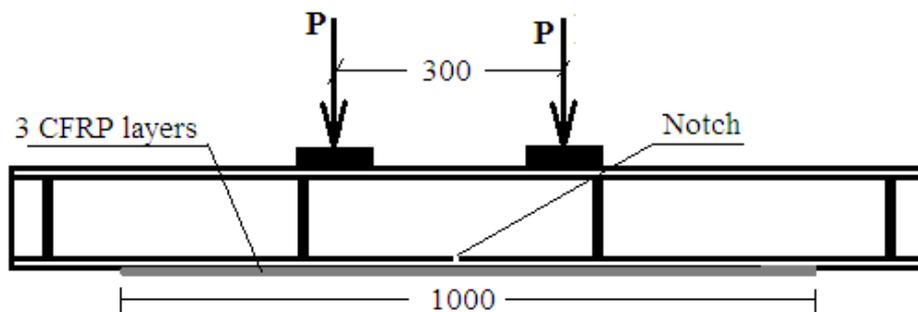
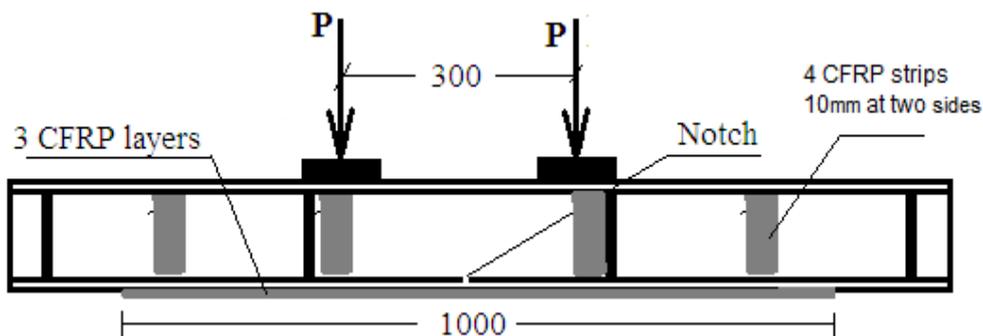
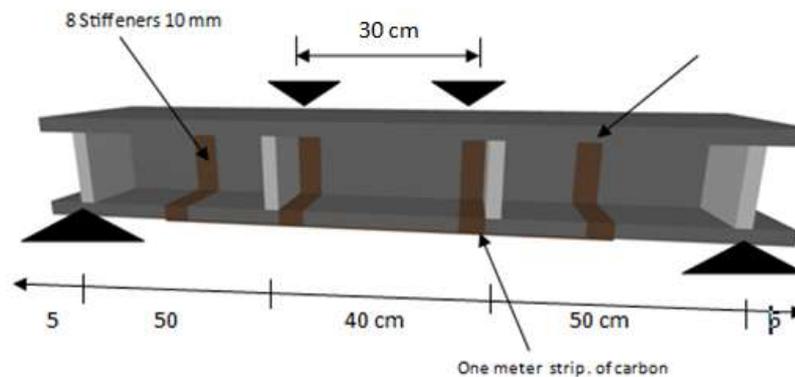
Fig. 2: (a,b,c) Showing the repaired method

a) The CFRP fixed to the tension flange.

b) The CFRP strips fixed to the flange and the two sides of the web.

c) The repairing CFRP strips fixed at the flange and the web (3D).

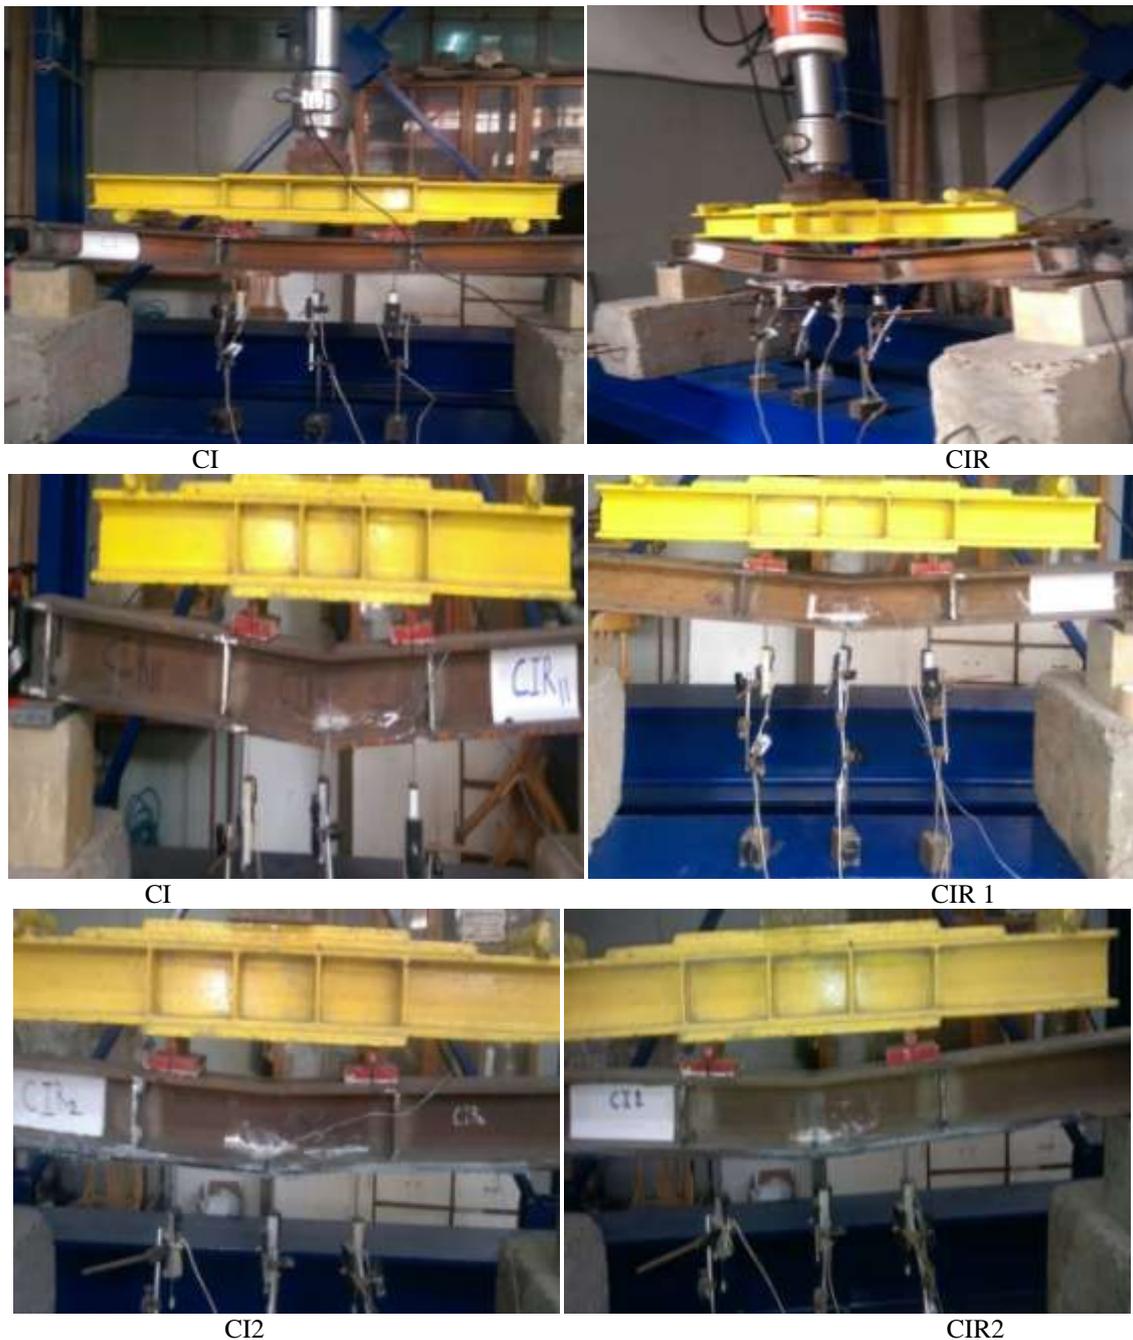
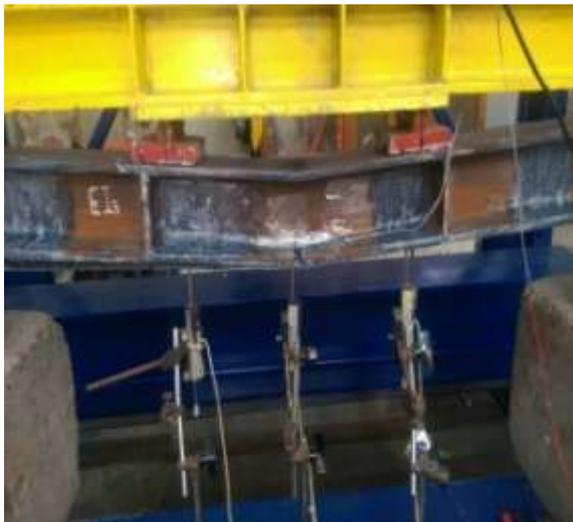
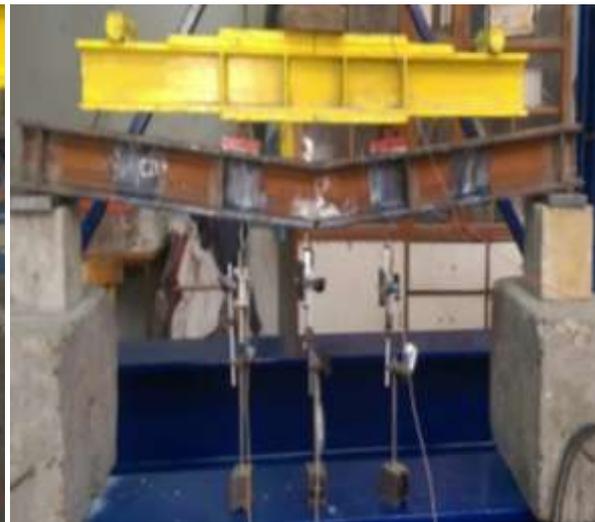
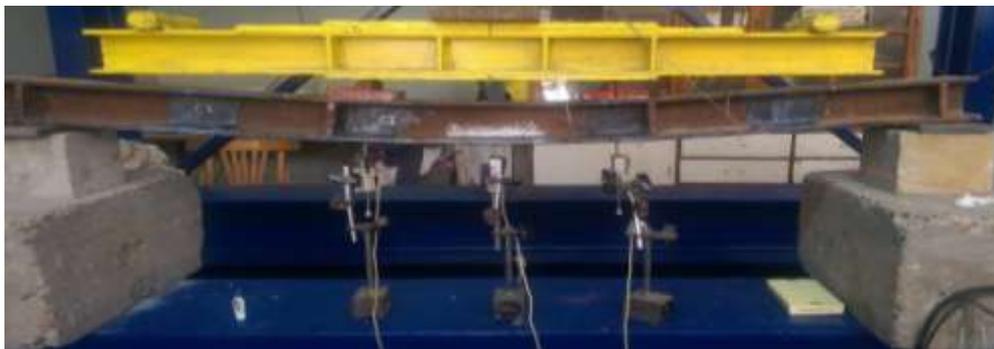
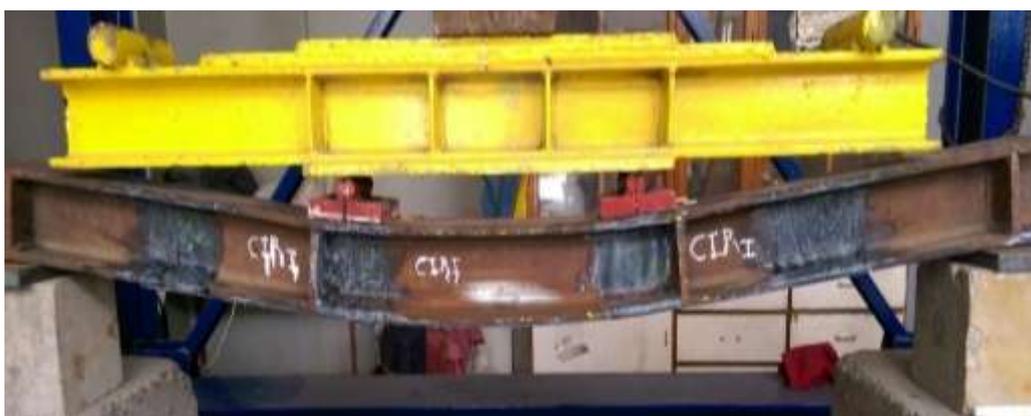
Fig.3. the experimental programs for the all beams under the static and fatigue loads.

CI3

CIR3

CI repairing

CIR repairing

In the table1. and Fig.3. (the experimental test in the lab) we noticed that the deflection was 30.3mm in (CI) and 34 mm in (CI2), 38.6mm in (CIR2), 40mm in (CI3) which indicated to the good ductility with increasing the strengthening by CFRP in the static cases, also helping the beams to be stable under repeated loads and increase the cycles in the fatigue load. The CFRP reinforcements do not significantly improve the elastic structural response from the global point of view. The composite materials improve the local structural response through a significant increment of the local stiffness and strength .also the deflection decrease in the CI repairing to 12mm and to 16mm in CIR repairing which indicated to the steel stiffeners and CFRP strips on the web.

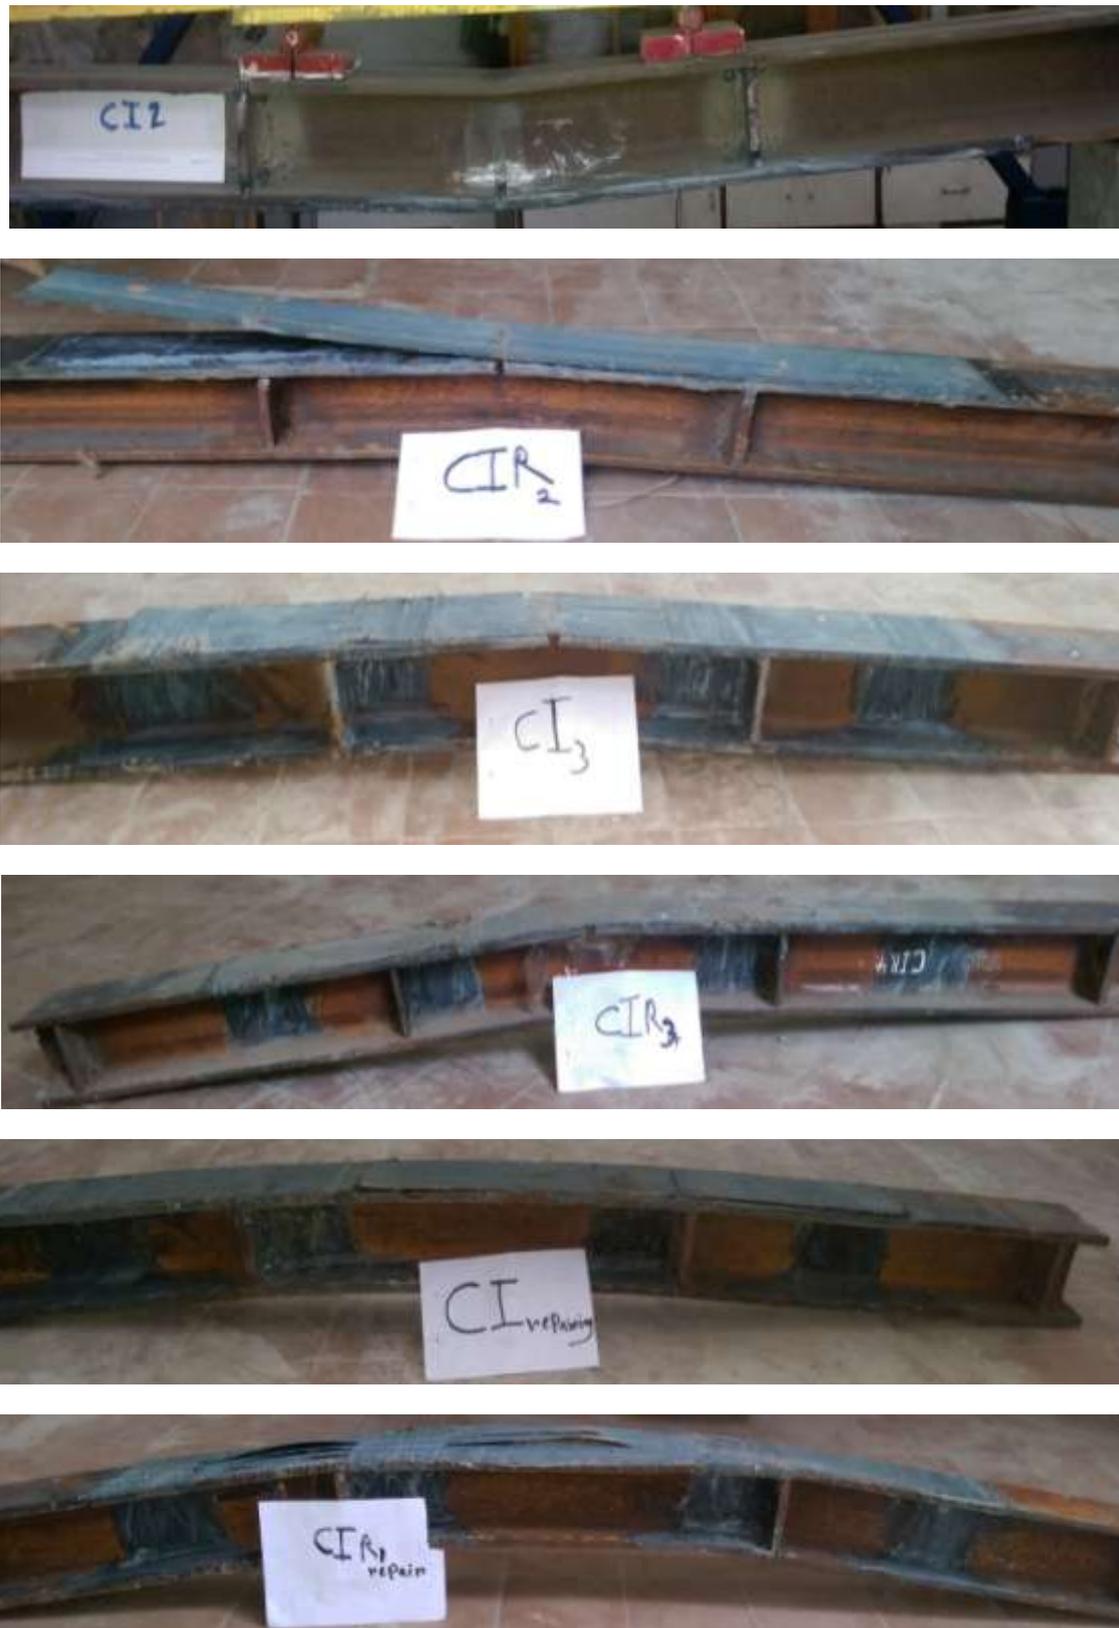
Fig.4. the shape of failure for the carbon under static and fatigue loads in the repairing cases.

Fig.4. Showing that the failure shape of the carbon. It must be taken into account that the CFRP reinforcement is usually bonded to the steel substrate by epoxy adhesive. Due to the high strength of the reinforcement and the steel substrate the adhesive layer is usually the weakest point of the system. Failure modes are associated to cohesive failure in the adhesive joint (generally at the steel–adhesive interface) and CFRP de bonding. Galvanic corrosion is also a potential problem since, when the carbon fibers are in contact with the steel surface, they produce a galvanic cell. On the other hand, FRP reinforcement cannot be efficiently applied to a non-smooth surface, as in the case of riveted girders due to the high rivets density. Finally, a critical point for heritage structures is due to the fact that reversibility of the strengthening system is highly recommended. The crack repair of fatigue damaged steel beams by using CFRP materials can be achieved in three different ways, the high reinforcement stiffness results in the reduction of the stress range around the crack tip. Besides, the use of CFRP strips bonded to the crack has an effect in bridging the crack lips, reducing the crack opening displacement and thus promoting crack closure.

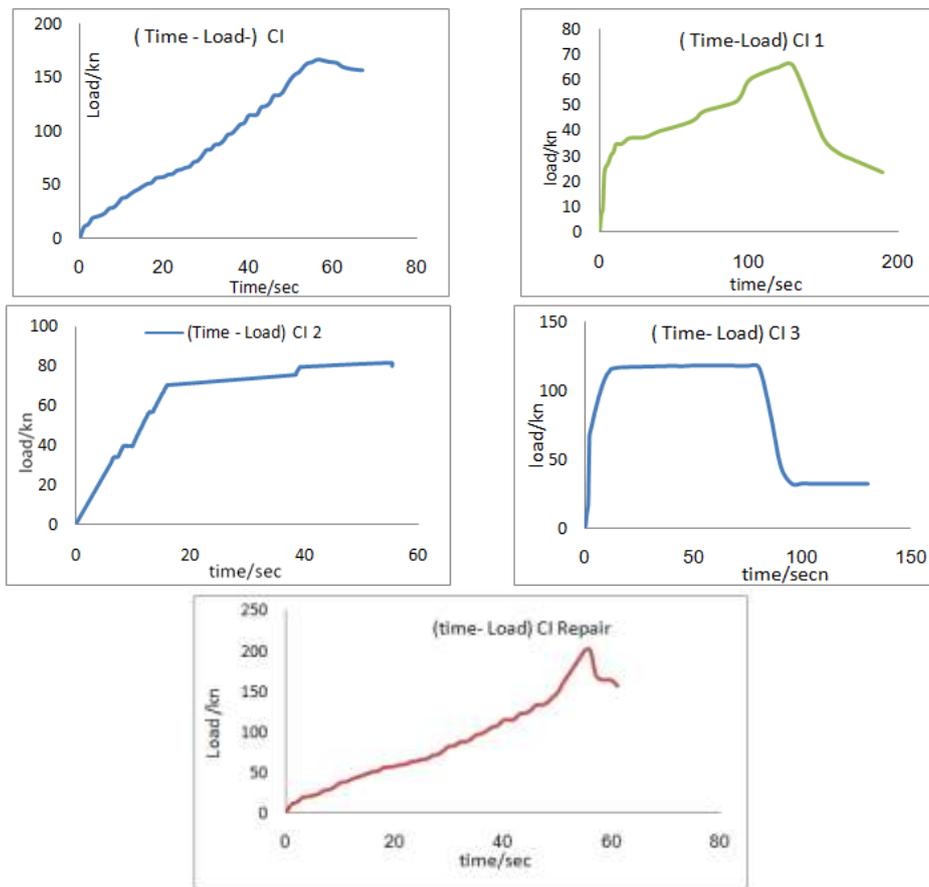
Shape1. The time – Load comparison of the behavior for the beams in the static case.

The curves in the shapes 1, 2,3,4,5,6,7,8, explained the behavior of the beams with its four cases under static and fatigue loads, making a good comparison between them in the static and fatigue cases. Shap1. Time – load curves in the static loads. The load in CI1 less than the control beam by 0. 39% , but CI2 increased by 1.23% than CI1,and CI3, CI_{repairing} increased by 1.8% and 3.1% respectively than CI1 for the affecting of the CFRP. Shape2. Time –load curves in the fatigue loads which explained the number of the cycles to the time, which decreased in CIR1 by 63% than CIR, but increased in CIR2, , CIR3, CIR_{repairing} by 6.5% , 7.4%, 7.7% (respectively) than CIR. Shape.3,4 are the time- deflection curves for the beams under static and fatigue load. In the static case the rate of the deflection increased by 1.1, 1.3% in CI2, CI3 than CI, but decreased by 40% in CI_{repairing}. In the fatigue loads. the deflection increased in CIR2 which has reinforcing in the tension flange by 1.03% but it decreased by 1.41%, 3.5% in CIR3, CIR_{repairing} which had extra reinforcing in the web. Shapes.5,6. are the load- defl. curves in the static and fatigue loads. Shapes.7,8. Explained the comparison of the time-stresses curves in the two cases of loads.

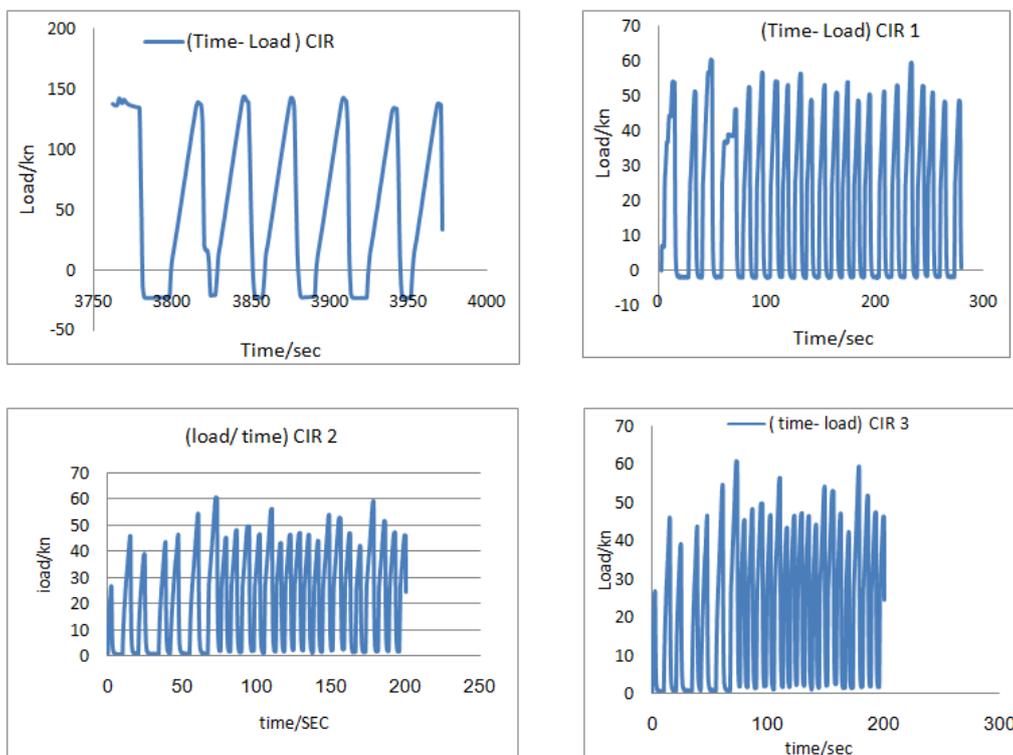
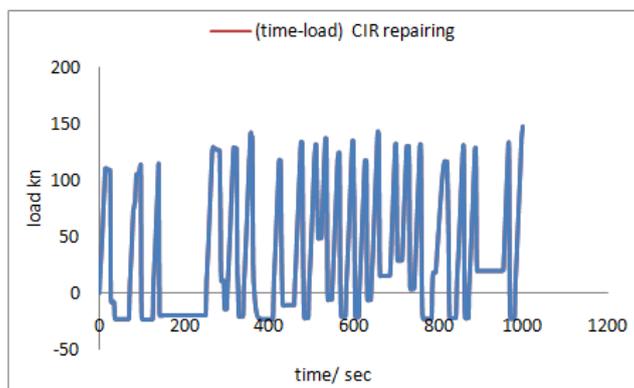
Shape2. The time – Load comparison of the behavior for the beams in the fatigue case

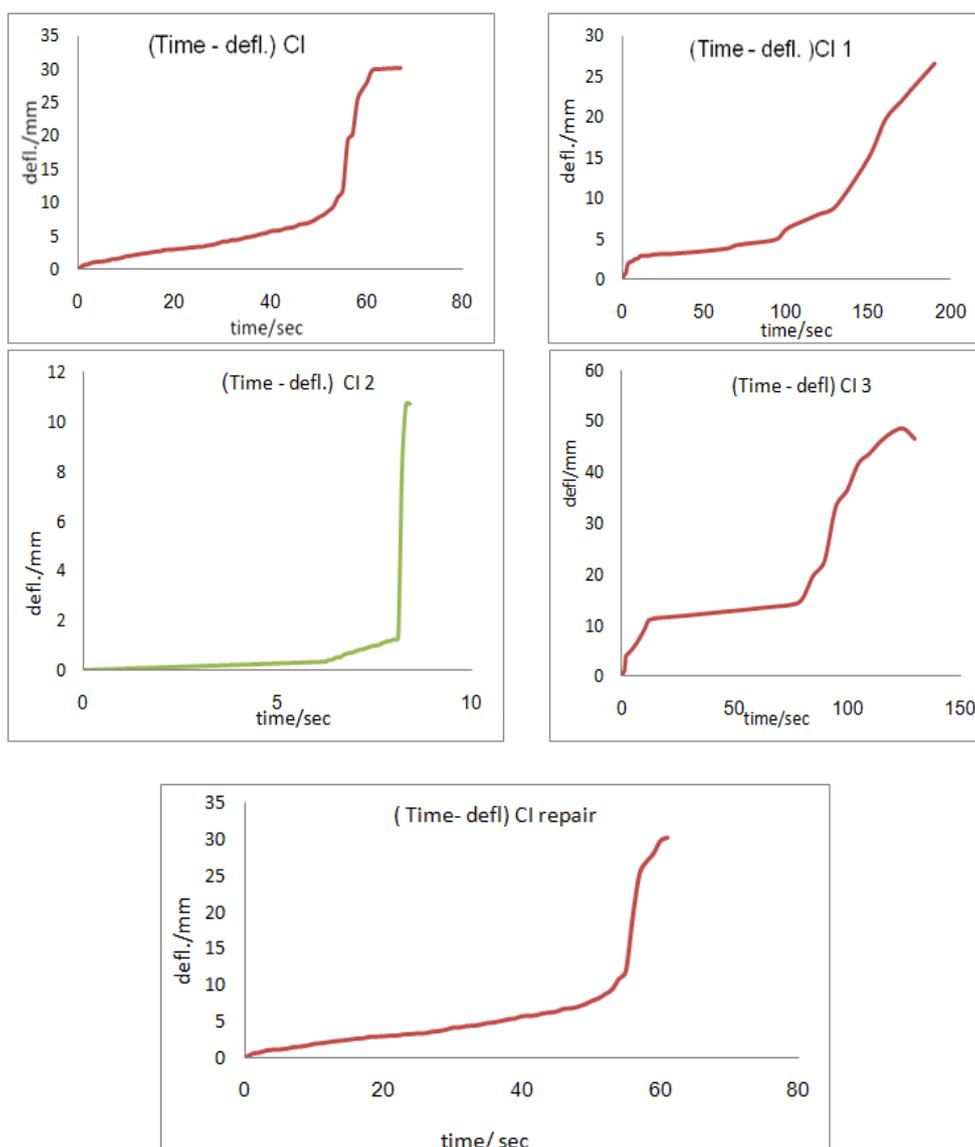
Shape3. The time - defl. Comparison of the behavior for the beams in the static case

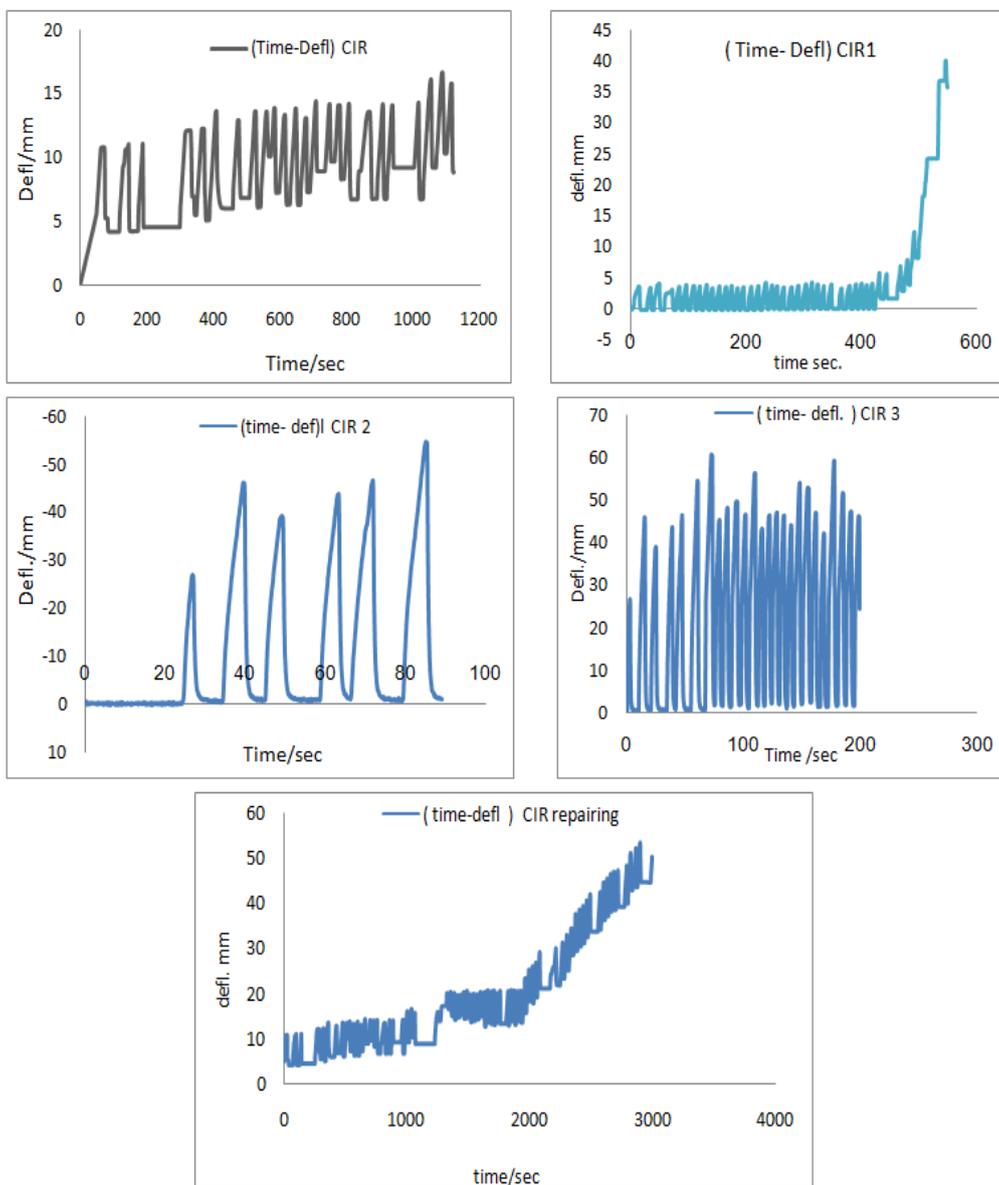
Shape4. The time - defl. Comparison of the behavior for the beams in the fatigue case.

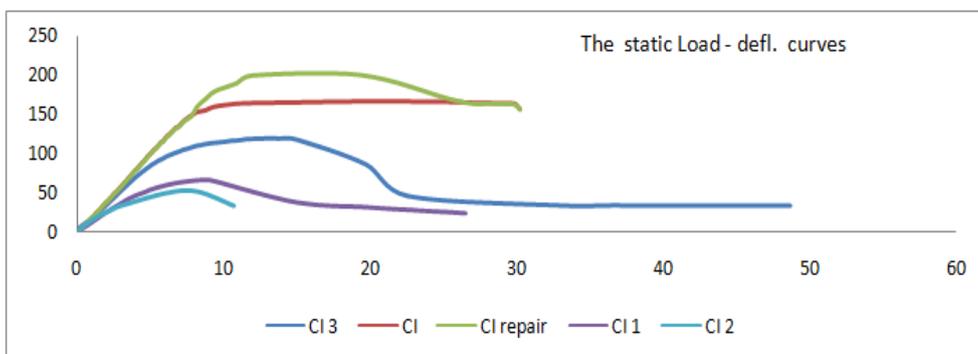
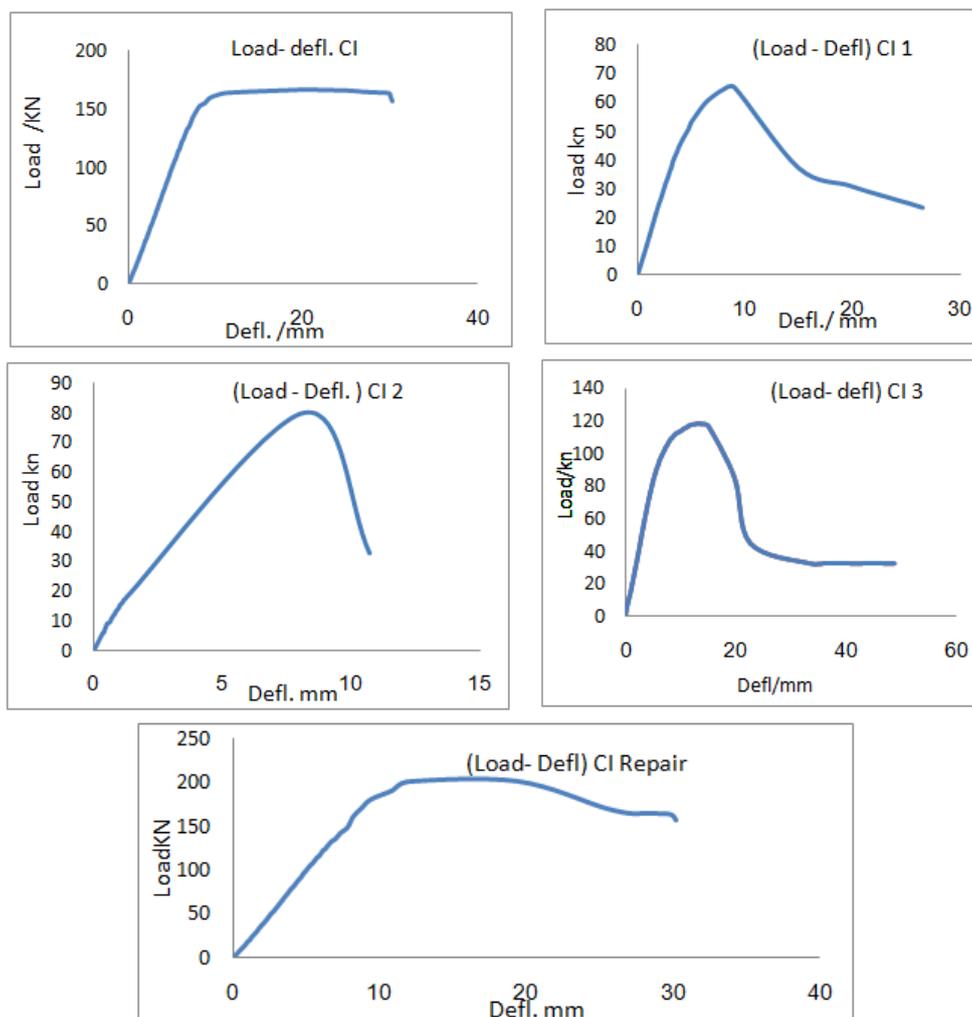
Shape5. The Load – Defl. Comparison of the behavior for the beams in the static cases.

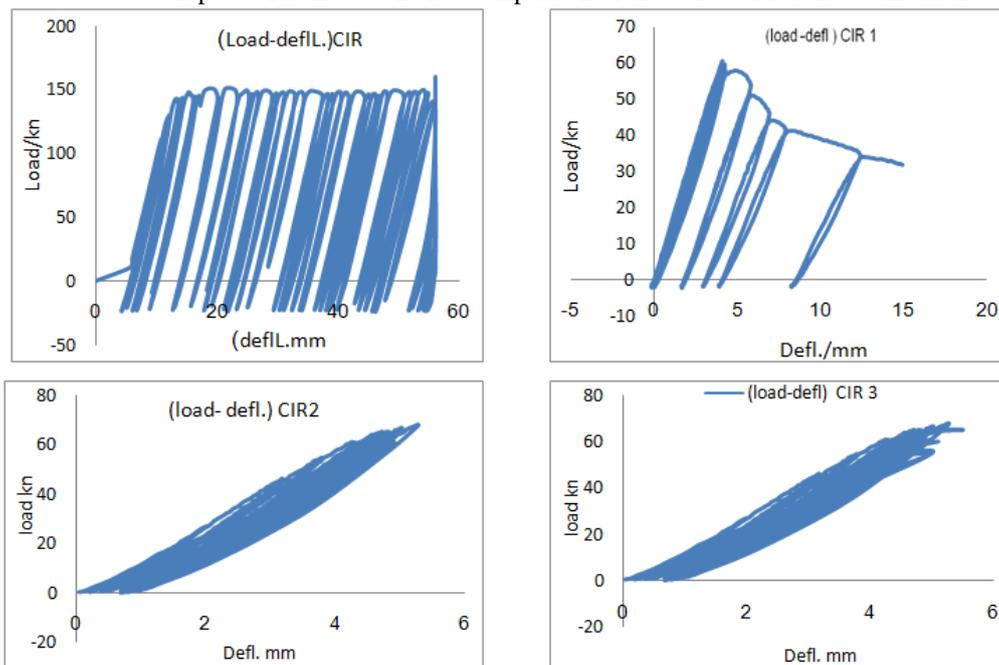
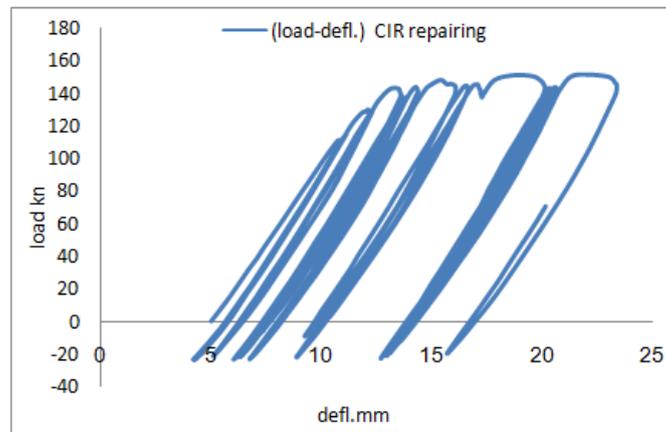
Shape6. The Load – Defl. Comparison of the behavior for the beams in the fatigue case

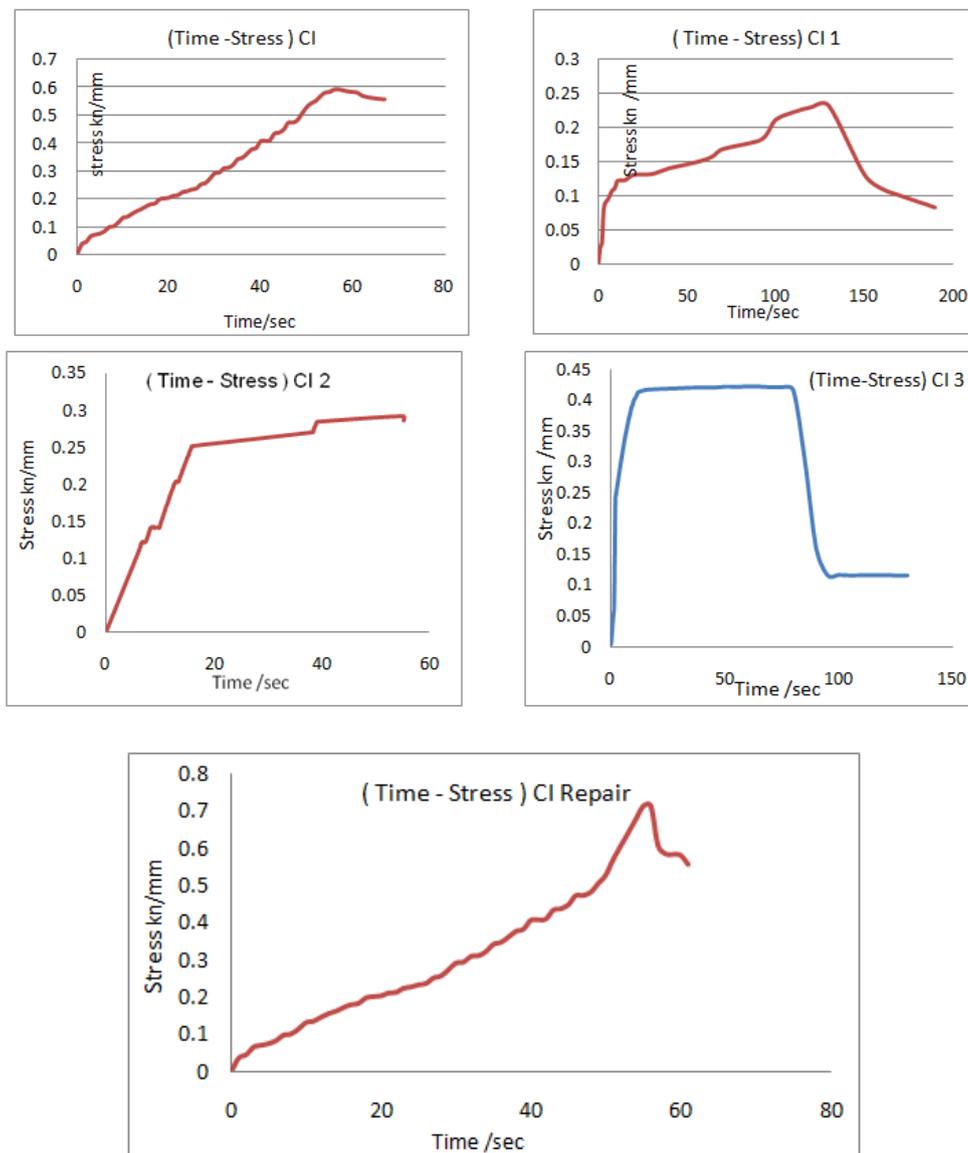
Shape7. The time- stresses Comparison of the behavior for the beams in the static case.

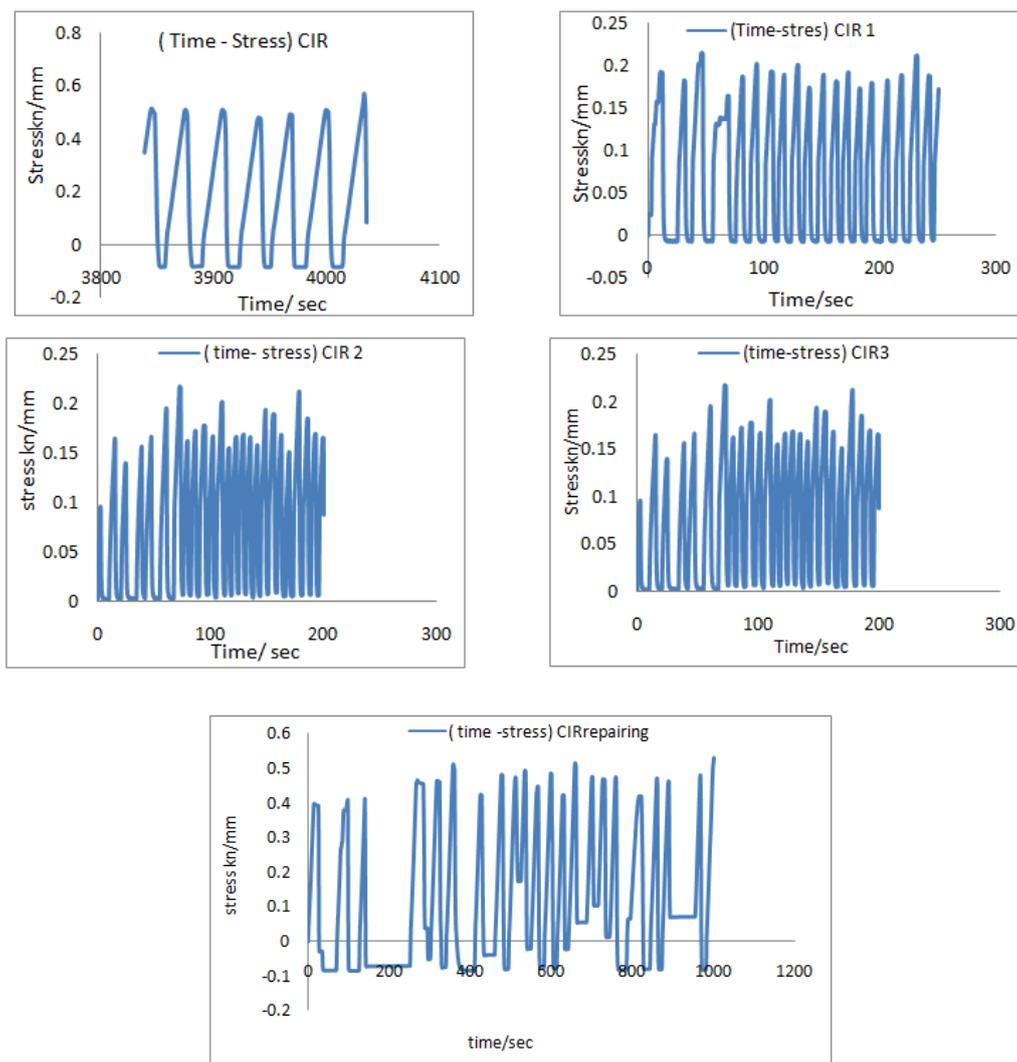
Shape8. The time- stresses Comparison of the behavior for the beams in the fatigue case.
