An Evaluation of the Restoration Techniques of the Atik Valide Sultan Dârüşşifâ

Asist.Prof.Dr. Sibel Onat Hattap "An Evaluation of the Restoration Techniques of the Atik Valide Sultan Dârüşşifâ "International Journal of Engineering Research and Applications (IJERA) , vol. 8, no. 02, 2018, pp. 22-26

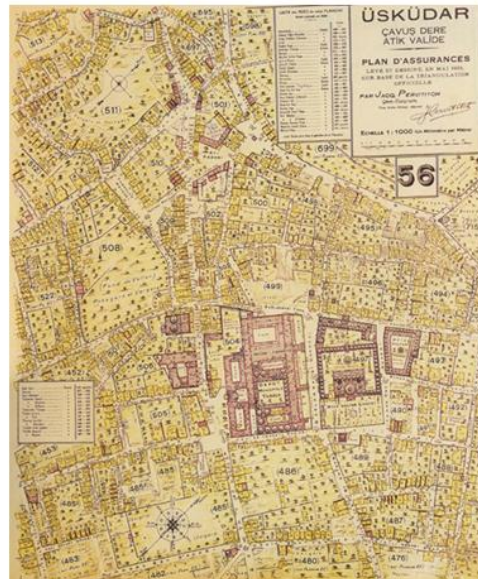
Figure 3. The Atik Valide Sultan Külliye on the Pervititch Map (1922-45) [8]

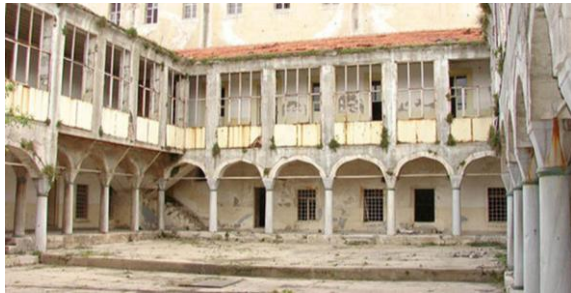
Figure 3. Before Restoration -Atik Valide Sultan Darüşşifâ [1]

It is understood from the existing traces that the original version of the building is single-story and domed. The first floor, estimated to be have been built during the Asakir-i Nizamiye period, was constructed as a brick arch floor under the cut dome. This floor is reached from staircases in the north and south corners of the porticoes. However, these stairs close some doors and windows in the corners where they exist, and they distort the originality of the structure. In the walls and domes, for cracks larger

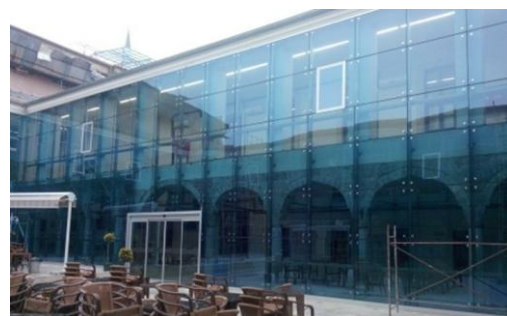
Figure 5. The current condition of the Dârüşşifâ after improper restoration [6]

In 2010, during the restoration work initiated after its transfer to Fatih Sultan Mehmet University, which was affiliated with the Prime Ministry General Directorate of Foundations, automatic doors for the inner garden's entrance and exit were installed, and the front sides of the porticos overlooking the inner garden were enclosed with glass. This was seriously criticized for the loss of its originality [6] (Figure 5). Thus, the glass from the floor to the bottom of the eaves was removed, and glass was only used on the upper floor (Figure 6-7).

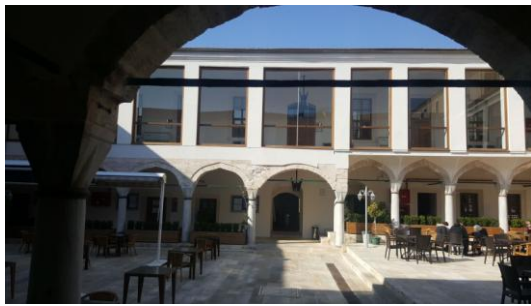
Figure 6. Removal of the glass from the bottom portico after criticisms (Hattap, S. 2018)

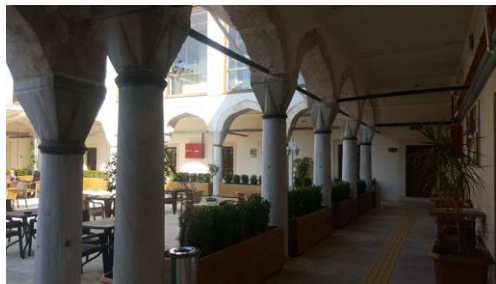
Figure 7. Removal of the glass from the bottom portico after criticisms (Tarım, A. 2018)
