## Structural Audit on RCC Water Tank Resting On Ground

Pratiksha Pawar, et. al. “Structural Audit on RCC Water Tank Resting On Ground.” *International Journal of Engineering Research and Applications (IJERA)*, vol.11 (6), 2021, pp 51-55.

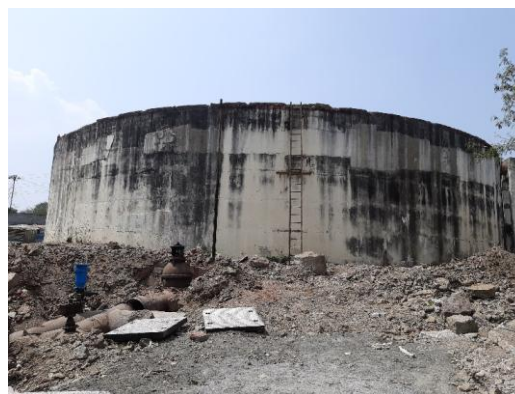
The storage tank on which rehabilitation is to perform is situated near Parvati Paytha which is resting on ground of 4.5ML capacity. This tank is located on high level that's why known as high level reservoir water tank. Diameter of tank is 32m and comprises of dome shaped slab. There are 3 ring beam of size (230mmx300mm) provided on column (300mmx300m).The raft of 600mm is provided on PCC .The wall of tank is of 150mm thickness.

FIG.1 Circular Water tank resting on ground

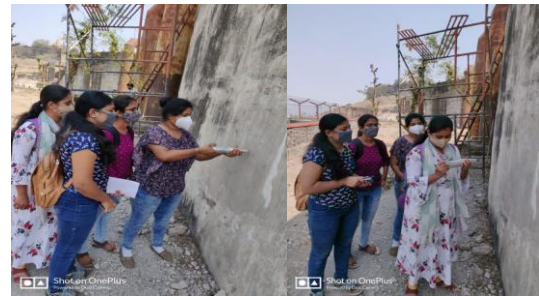
**Fig.4 Performing Rebound Hammer Test**

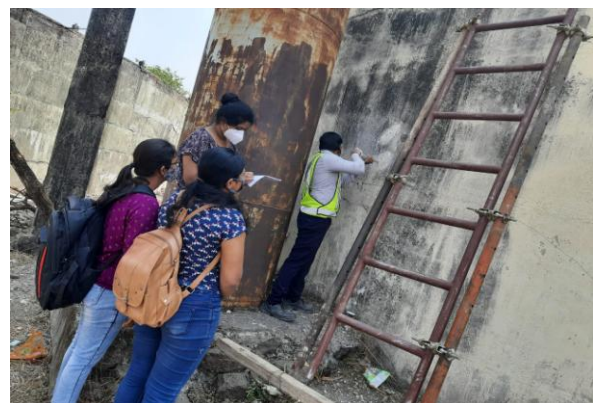
**Fig.5 Recording readings of Rebound Hammer Test**

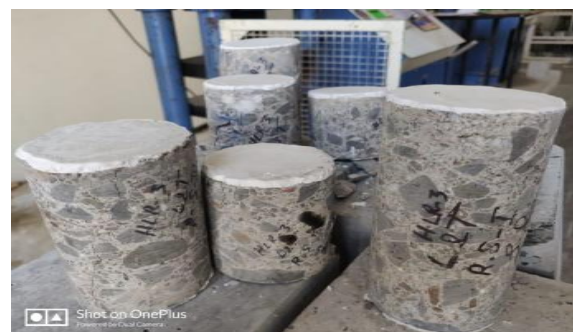
Core test is also used for finding the compressive strength of concrete. It gives accurate result as compared to rebound hammer test. Take the core samples from the tank and with the help of CTM machine loads are calculated. Then compressive strength is calculated by the formula

**Fig.6 Core Sample**

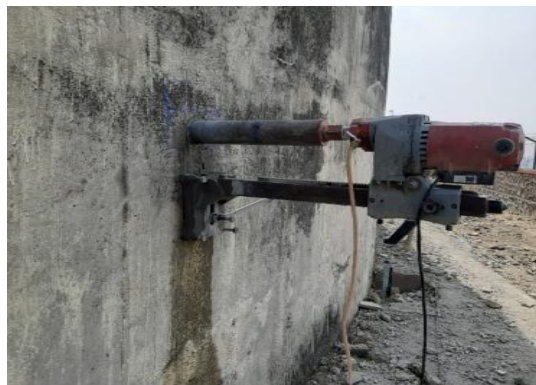
Fig.7 Core cutter machine

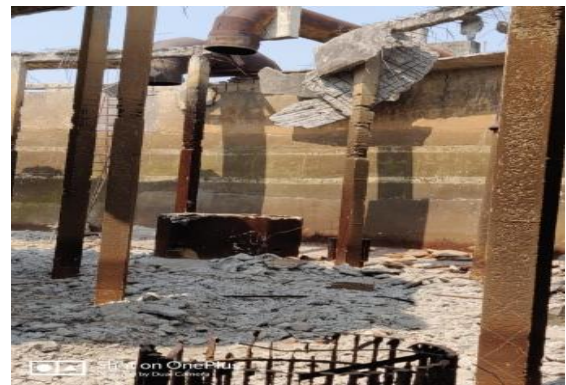
Fig. 9 Column and Slab reinforcement is exposed due to Chlorine attack

From inside of tank Columns and Slab Reinforcement is exposed due to presence of chlorine in water we have observed.

From above result, we conclude that there is no need of demolition of whole structure. As water tank is in well condition only demolition of Column and Slab are necessary. As raft of old

structure is strong enough it can be used as base foundation and re-raftering can be done on that. RCC walls of tank are good enough in strength but to bind the reinforcement of slab with wall reinforcement, the walls should be cut to open the reinforcement up to lap length i.e. about 0.6m. Rather to demolish the whole structure. Rehabilitation of tank would be cost worthy and can attain the desired strength and durability. So the for “Repair and Rehabilitation of water tanks” result into a fruitful outcome.

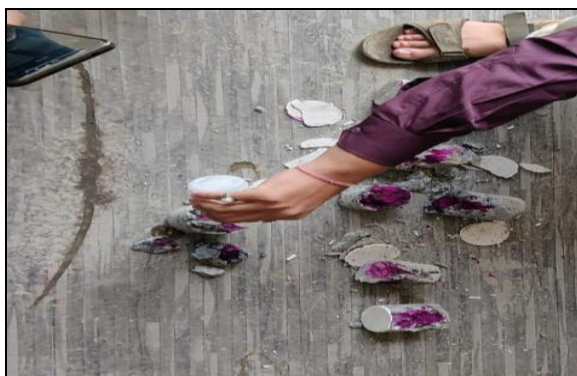
When the moisture gets contact with the steel reinforcement it started corroding. To find out the rate of corrosion carbonation test is needed. It is simple and easy process which is carried out on core sample by spraying the Phenolphthalein solution on it.

Fig.8 Spraying of Phenolphthalein on core sample

This is the final result of Core Cutting and Rebound Hammer Test. The Core Test was more reliable. The average Compressive Strength of Raft was considered as 44.87 N/mm<sup>2</sup> and for Wall is considered as 32.73 N/mm<sup>2</sup>. Hence the Compressive Strength was good enough. All samples appear Purple so there was no Carbonation hence the reinforcement was safe from corrosion and concrete was well alkaline.

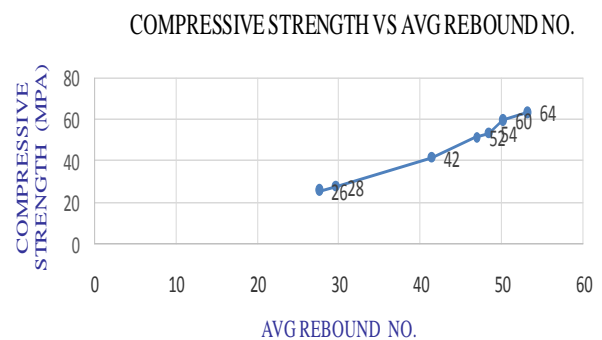
Graph1. Compressive Strength Vs Average Rebound Index /Rebound Number

Graph1 indicates the final output of Rebound Hammer Test. The graph plotted is a Compressive Strength Vs Average Rebound Number. The same is reflected in the tabular form .As Rebound Index increases, Compressive Strength also increases.

Table 1 show that Average Compressive Strength and Average Rebound Number for wall and raft. From Rebound Number we can predict that the Concrete quality of Raft is fair and for wall it is very

good. The average strength for raft comes out to be 27 MPa and that of wall is 54.6MPa. The test cannot be held very accuracy of prediction of concrete strength in structure is 25%.

This graph signifies that the compressive strength of raft as well as wall is good enough and quality of concrete was also good.

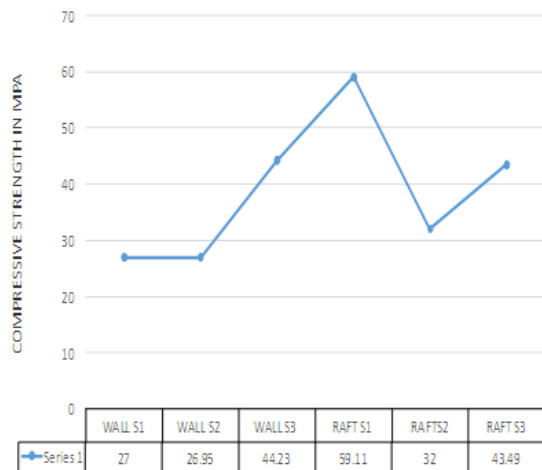
**Graph 2: Parvati HLR 3 Core Cutting Test**

**Table 2** Where W means wall and R means raft. This table shows that samples of wall and raft which gives average compressive strength. This test gives very accurate result. The average Compressive Strength of Raft was considered as 44.87 MPa and for Wall is considered as 32.73MPa. Hence the Compressive Strength was good enough.

**Graph 2** showing the compressive strength of concrete core
