A case study on Application of Geopolymer in Treatment of Efflorescence affected Masonry Walls

T. Raghunathan*

T. Raghunathan "A case study on Application of Geopolymer in Treatment of Efflorescence affected Masonry Walls" International Journal of Engineering Research and Applications (IJERA), vol. 9, no.1, 2019, pp 38-41

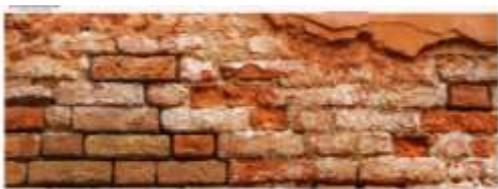
Fig -1: Efflorescence in Brick wall

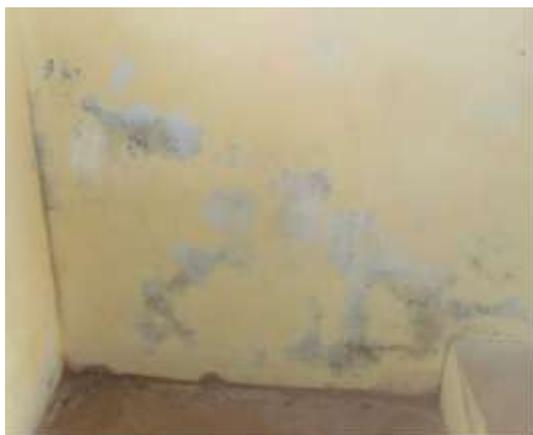
The masonry wall considered in our case study was exposed to water, urine, cleaning phenols and bathroom cleaning acid on the Toilet side. This resulted in peeling of distemper and exposure of plaster in the class room side of the wall.

Fig -2: Peeling of distemper in wall

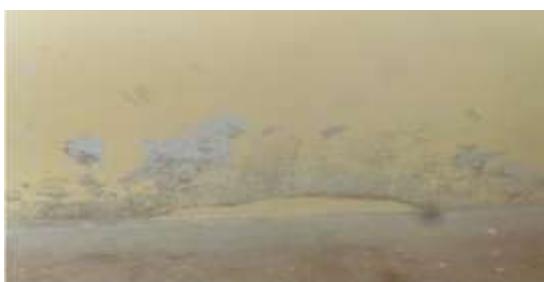
Fig -3: Peeling of distemper and exposure of plaster

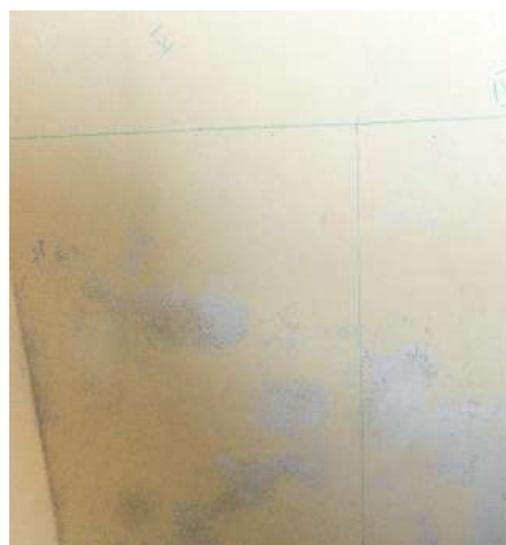
1. Efflorescence affected wall is divided into 5 portions from slightly affected portion as I to worst affected as V, in January 2016.

Name of the Portion	Breadth (in mm)	Height (in mm)	Area (in mm ²)
I	1.00	0.46	0.46
II	0.80	0.46	0.37
III	0.85	0.46	0.39
IV	0.55	1.10	0.61
V	0.65	1.10	0.72

Fig -4: Wall divided into portions

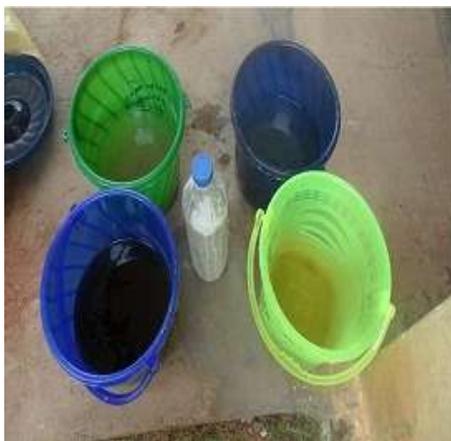
Fig -5: various moles of Sodium hydroxide

2. Scrub the efflorescence wall portion with emery sheet
3. Prepare sodium hydroxide solution for each portion of wall as in table 2.

PORTION NAME	CONCENTRATION OF NaOH SOLUTION(moles)
I	6
II	8
III	10
IV	12
V	14

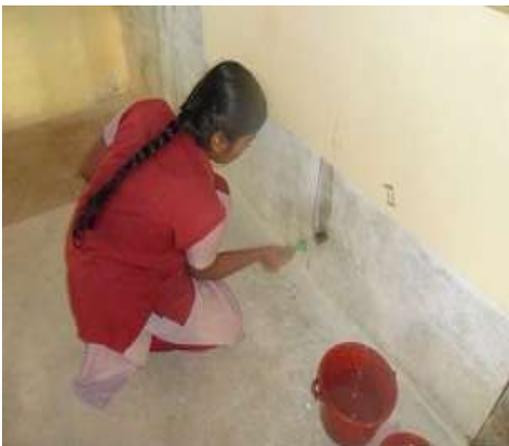
Fig -6: Application of sodium hydroxide solution

4. Apply sodium hydroxide solution to each portion.

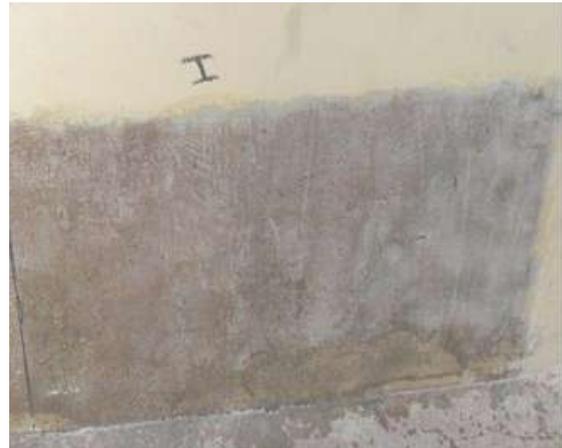
Fig -7: Appearance after sodium silicate coats

5. Sodium silicate is painted on all the portions. Three successive coats are applied so that strong binding is created and porous portions are fully filled by sodium silicate. Sodium silicate forms a glossy surface on wall.

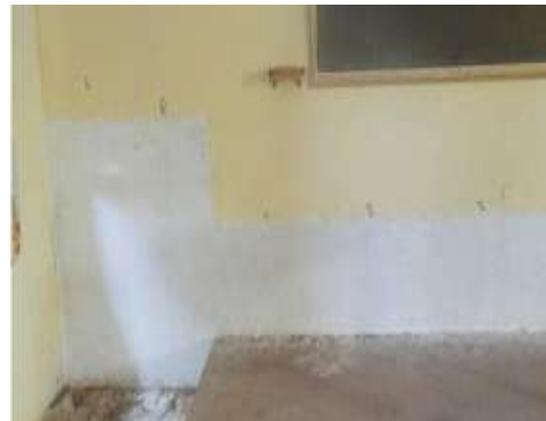
Fig -7: Appearance after white cement coat

6. To apply primer coat for distemping, roughening by emery sheet is necessary.
7. White cement is applied as primer coat.

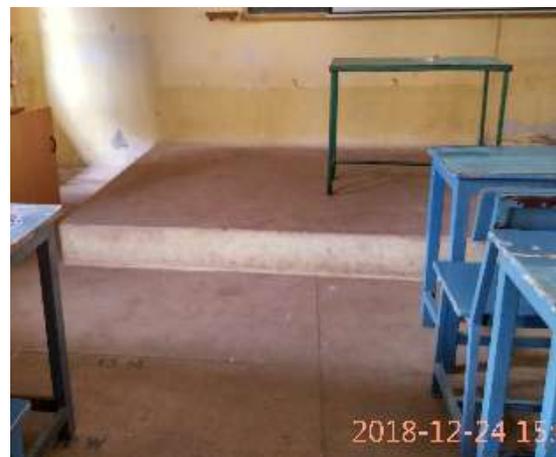
Fig -8: After 2 years

In this paper a innovative method of treating efflorescence by using Sodium Hydroxide and sodium silicate is projected. The concept was obtained from geopolymer technology. The sodium hydroxide is used as alkali activator which neutralizes the chloride and sulphate ions, thereby decreasing the efflorescence in near future. The sodium silicate decreases the permeability of the wall and also binds the rough and powdery surface making it glossy in appearance and decreasing the efflorescence. Only portion IV of wall shows efflorescence of about 10cm wide patch. Other portions are unaffected by efflorescence after 2 years and 9 months.

8. Commercial distemper is applied after primer coat. In March 2016
