## Comparative Study of Pre-Engineered Buildings Based on Codal Provisions and Design Practice

**ABSTRACT:** Current design practices of Pre-Engineered Building (PEB) structures of steel are lacking in order to follow basic codal provisions, which results in serious damages of structure by different member failures and loss of money and lives. The current study is based on various case studies, observations and parametric studies of PEB structures. There is a common practice to ignore basic clauses during design of PEB structures in order to achieve economy and leaving structure under designed and unsafe. Also, in existing structures sometimes designer becomes ignorant to adopt corrective measures to make structure safe. Therefore, this work is a step to highlight basic clauses to be followed in PEB design and suggest remedies for existing PEB structures to make them safe through visual inspections, software analysis and checks. In this study, few sites are chosen for case studies from Indore city (M.P.) India, which are investigated thoroughly by visual inspections, by preparing data sheets and to model the structure on software platform. Further, the modelled structures are anal

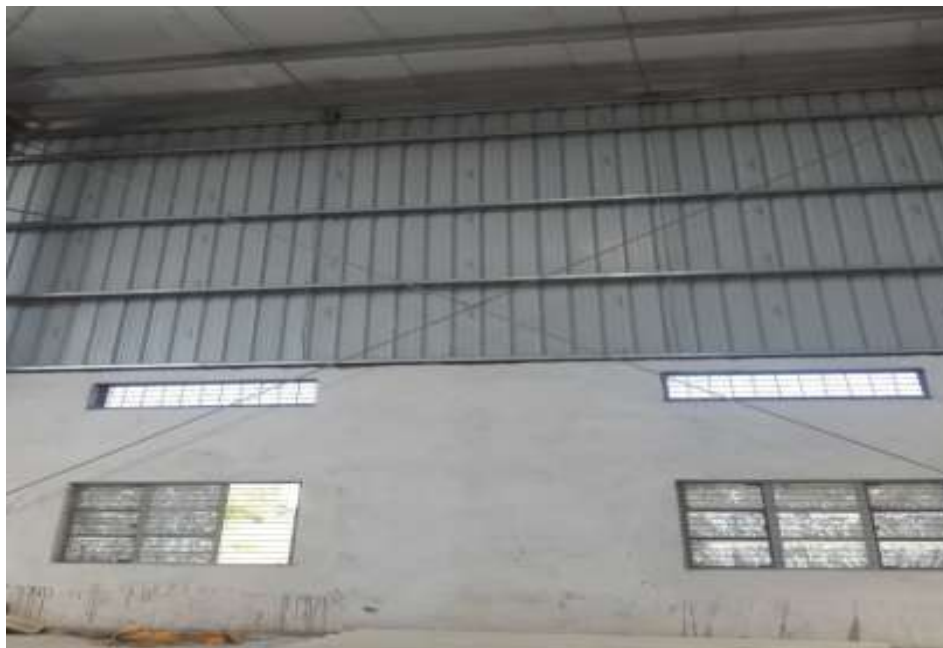
Observation No. 1: As shown in Fig.1 below, it is observed that MS rods or single pipe or single angle is used as bracing member with higher

slenderness ratios for tensile forces. It is found that the slenderness ratio of such members is beyond code based limit of 350.

**Fig.1** MS rod used as column bracing

3. Clause 3.7: Bracing member required as per design is NB-80 or equivalent, however MS

rods are provided at sites which are not acceptable.

Remedial Measure: MS rods need to be replaced with the designed section.

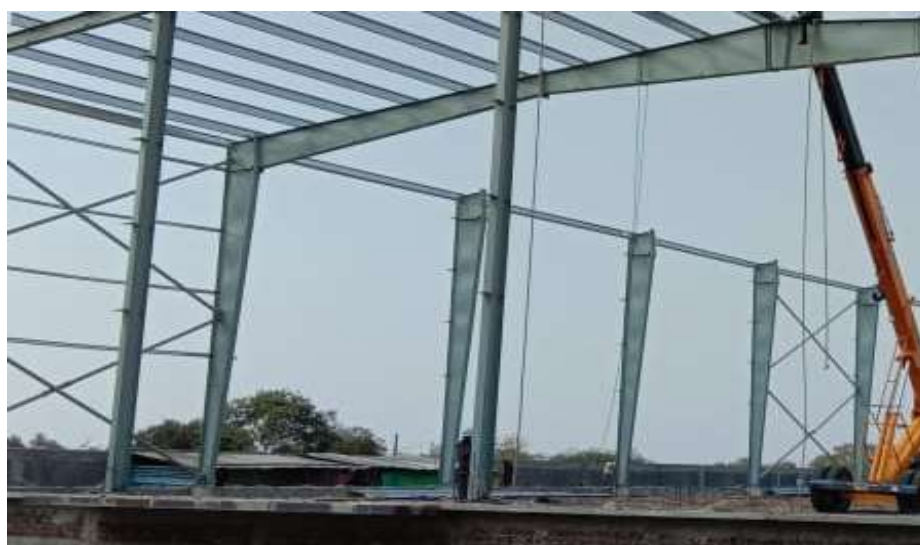
Observation No. 2: It is observed that flange and web thicknesses are below code based minimum thickness limits resulting in warping of

column and rafter web plates during erection under self-weight (Fig.2).

**Fig.2** warping of column and rafter web plates during erection

2. Clause 3.8: Minimum thickness of member required accessible for cleaning is 6.0 mm, Frame 1, Frame 2 and Frame 3 has thicknesses of 5 mm or 4 mm in column webs and/or rafter webs which is less than minimum required. Frame 4 fits well for this clause.

Remedial Measure: As the plate size shall be 2.0 mm greater than the weld size, therefore extra 4.0 mm thick plates need to be welded on flanges.

4. Clause 6.7.3: This clause checks the requirement of stiffeners in webs; here it is found that all frames lacks to satisfy this clause having lesser web depth to thickness ratios. For Frame 1 and Frame 2, 8-10 mm thicknesses are required and for Frame 3 and Frame 4, 10-12 mm thicknesses are required in column and/or rafter webs.

Remedial Measure: Extra plates (4.0 mm thick minimum) need to be welded on webs for its full depth to make them stiffened webs. Alternatively, stiffeners need to be provided as per provisions mentioned in IS800:1984.
