Retracing the Colonial Roots of Bungalow Architecture in Bangalore

Prerana Manjunath¹, Sahithi C², Tejas Gowda³, Nazish Abid⁴

^{1,2,3} Student, 6th Sem, B.Arch., School of Architecture, Reva University, Bengaluru

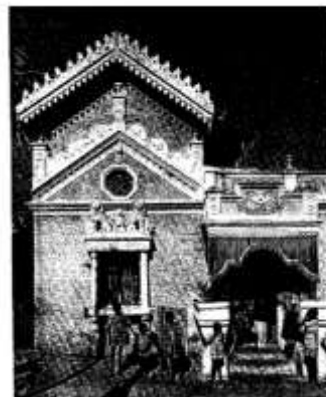
Figure 1: The old bungalow in Bangalore
Source: Janet Pott, 1977

- It has many architectural features like:
 - Monkey tops
 - Balustrades
 - Pediments
 - Doric, Ionic, Tuscan columns
 - Cast iron railings
 - Stone walls
 - Trellis
 - Cast iron brackets
 - Madras roof
 - Fan light
 - Sky light

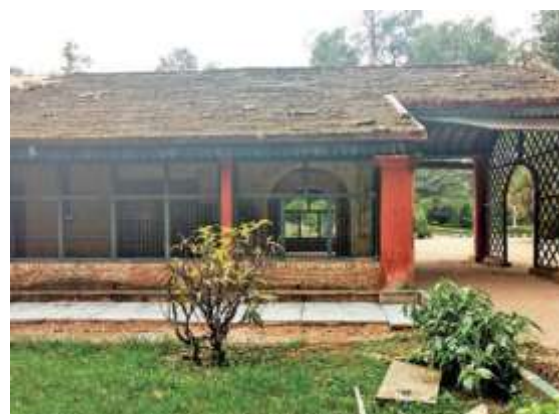
Figure 3: Krumbiegel Hall, Lalbagh botanical garden, Bangalore. Source: Author

Even though the Pompeian red façade and the high Mangalorean tile roof remain, the rooms show a stark contrast. They are painted in shades of blue and purple, and done up in contemporary style. The bungalow is not accessible to the public.

The section of the bungalow that houses the horticulture library - that once housed 7,000 books - now lies desolate. The building with discolored walls, shattered glass, peeling paint and dust is a sorry sight. “The restoration should be completed by the yearend,” said a horticulture department official.

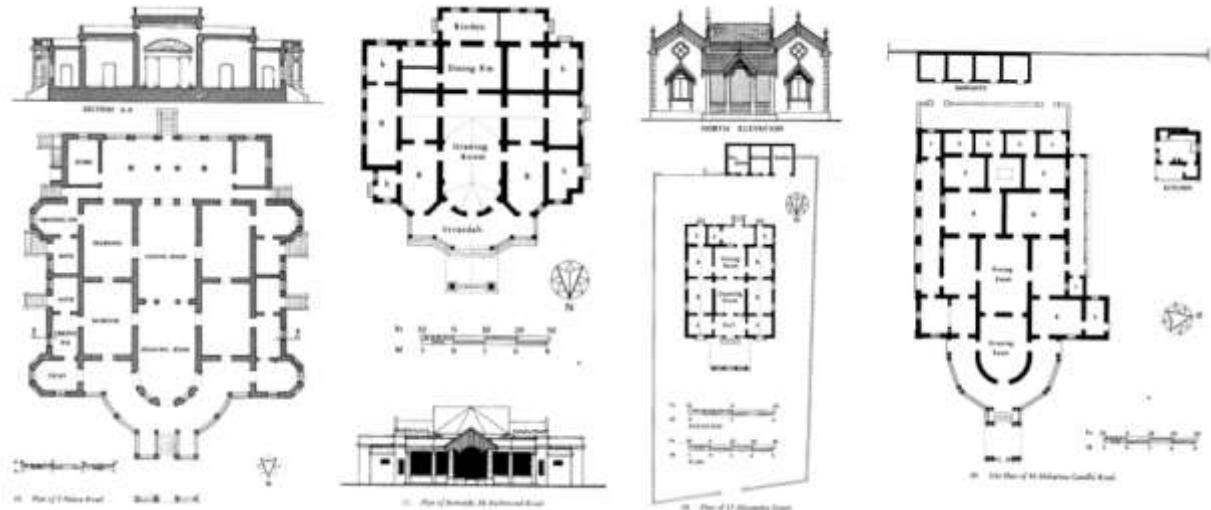
Figure 4 : Plans of the Bungalows, source “Old bungalows in Bangalore” by Janet Pott

The planning of bungalows was generally influenced by the 19th-century vernacular style, which was later modified as time passed ahead. The British engineers mostly followed symmetrical planning. Based on the drawing available from the Janet pott book and the primary case study held we understood the bungalow lied inside a property of more than 20,000sft enclosed by compounds and a gate in the entrance, the carpet area of the bungalow was in average 13,000sft to 15,000sft.

The main entrance to bungalows was in common with a porch, continued with veranda,

entering a huge hall divided into living area and dining hall. Both the side of the halls were an entry to the bedroom, where each bedroom had an attached bathroom, the kitchen and storeroom would in average be in the rare end of the bungalow or outside the bungalow. Depicting the social discrimination for the servants who could not enter the bungalow, we can also notice the servant's quarters provided located in the rare end of the property. The entrance to the bungalows were naturally one in the front and the other in the back for the servant's entry. The study on planning alone signifies the social significance of the British.

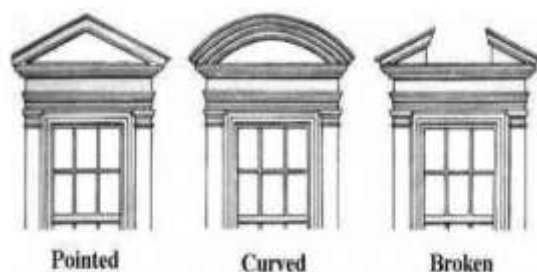
Figure 5: Types of pediments

A **pediment** is an **architectural** element found particularly in Classical, Neoclassical and Baroque **architecture**, and its derivatives, consisting of a gable, usually of a triangular shape, placed above the horizontal structure of the lintel, or entablature, if supported by columns.

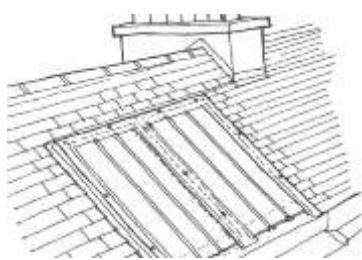
Figure 6: Sketch of the skylight

Skylight, Roof opening covered with translucent or transparent glass or plastic designed to admit daylight.

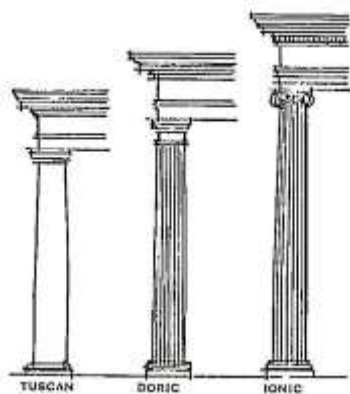
Figure 7: Types of columns

Roman columns were purely for decoration, unlike Greek columns that used to support their buildings and temples. There were four types of columns used throughout the Ancient Roman Empire. These columns were: Doric, Ionic, Corinthian and Tuscan. Doric style columns are the plainest of the four columns

Columns were about 18 in. dimeter usually of Doric types, though occasionally ionic, spaced rather more widely than in the traditional European classical porticoes which allowed for better airflow. They were either built up of courses of 4 to 5 wedge-shaped flat brick or else they consisted of a sing rough stone pier about 1 ft. * 8 in. in section encased in brick rubble to form a cylinder, and surfaced with chunam. In most of Bangalore bungalows, huge take beams carried

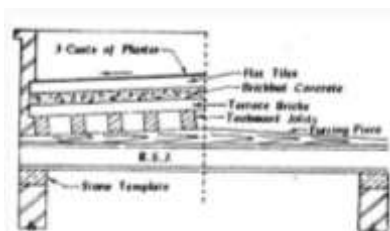
Figure 11: Section of the Madras roof

The **Madras terrace roofing** is a traditional **roof** building technique using handmade 'achikal' brick, wood and lime plaster.

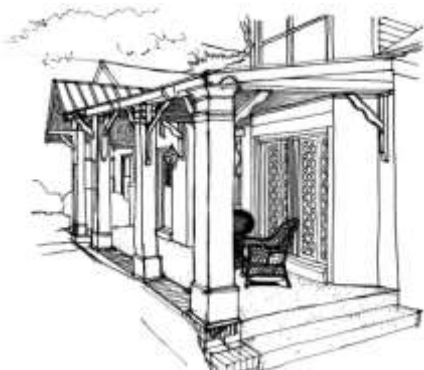
Figure 9: Sketch of the porch

Porch, roofed structure, usually open at the sides, projecting from the face of a building and used to protect the entrance.

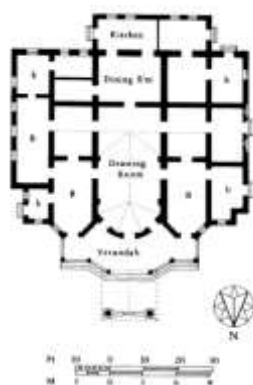
Figure 10: Plan explaining the verandah

A **verandah** is an outdoor porch with a roof. Most **verandahs** extend along the sides and rear ends of a house or building.

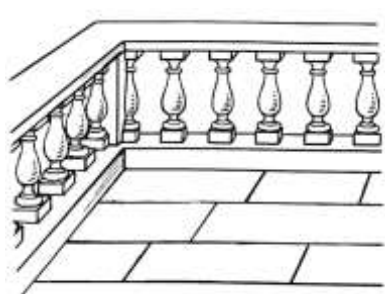
Figure 13: Sketch of Balustrade

A railing supported by balusters, especially one forming an ornamental parapet to a balcony, bridge, or terrace

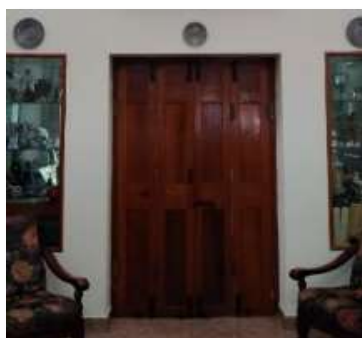
Image 16: Four leaf door to the hall, Bungalow RT001

The windows and doors found were unique in the bungalow during the documentation. Each design of the window and door found were never same.
