## Full-Scale Service Load Test of 40m span FSLM 434P08-09 Girder in the Mumbai–Ahmedabad High-Speed Rail Project

A full-scale service load test was performed on the FSLM 434P08-09 girder in Package C6 of the Mumbai–Ahmedabad High-Speed Rail (MAHSR) project. The 40 m prestressed concrete girder, weighing ~1100 tonnes, was tested under 100% service load (1055.81 kN) in accordance with IRC:SP:51-2015, IRC:112-2011, and Eurocode 2. The theoretical midspan deflection was 18.70 mm, whereas the measured deflection was 13.80 mm, representing a 26% reduction compared to permissible values. Recovery after unloading was ≥96%, exceeding the 85% code requirement, and no cracks were observed. The girder exhibited satisfactory serviceability performance, confirming design adequacy and manufacturing quality.

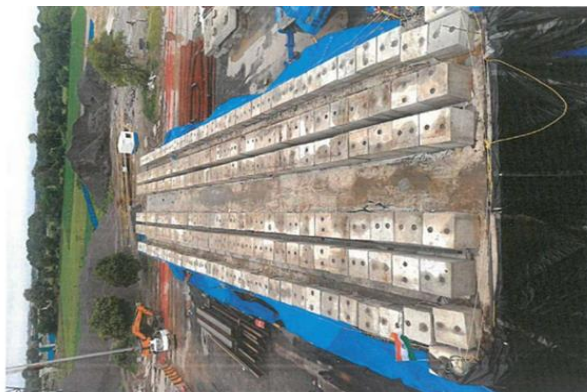
Placing of Concrete blocks (Type-1&3) On the FSLM Girder for completion of 50% test load

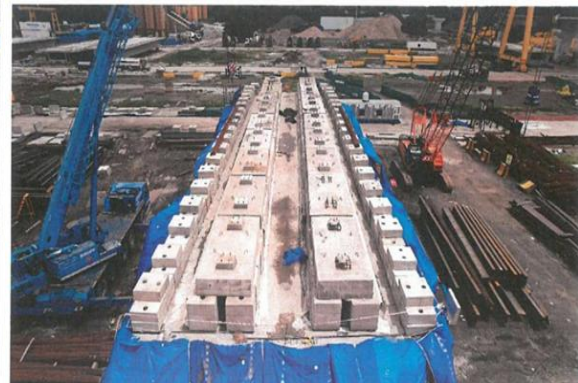
Placing of Concrete blocks (Type-1&3) On the FSLM Girder for completion of 75% test load

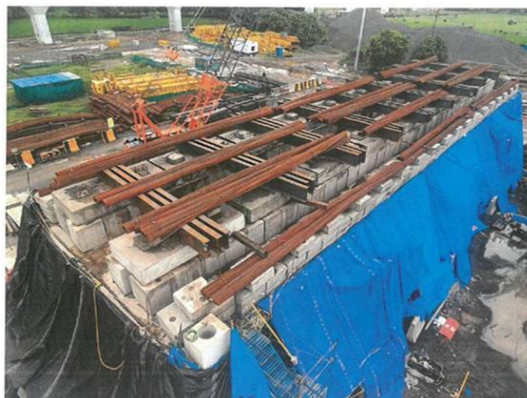
Placing of ISMB steel sections and rebar bundles on the FSLM Girder for completion of 90% test load

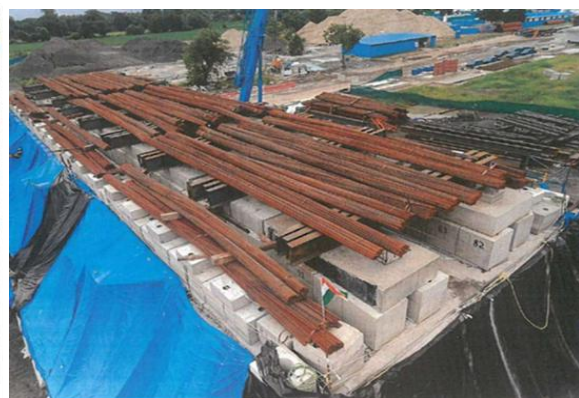
Placing of ISMB steel sections and rebar bundles on the FSLM Girder for completion of 100% test load

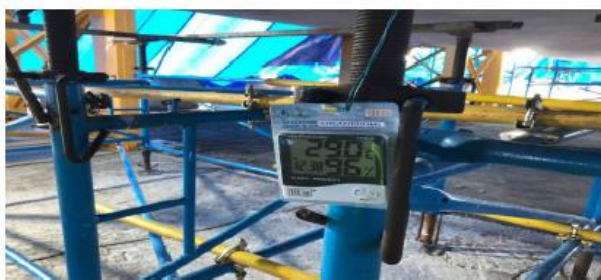
View of Digital Thermometer with External sensor firmly fixed to the soffit of FSLM Girder of Deflection measurement region.

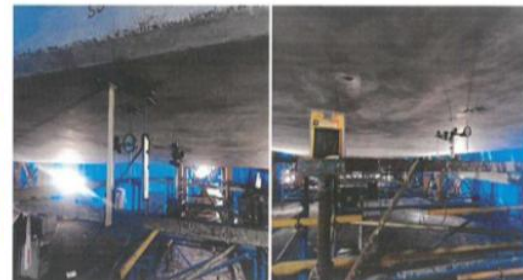
View of Independent HD Towers at Mid span (L/2) for placing of LVDT's and Dial Gauges

Instrumentation and loading were conducted in accordance with the approved test procedure. Linear Variable Differential Transformers (LVDTs) and dial gauges were installed at designated locations along the soffit, cantilever arms, and bearing zones of the girder. Glass plates were affixed at all measurement points to facilitate accurate deflection readings. LVDTs were connected

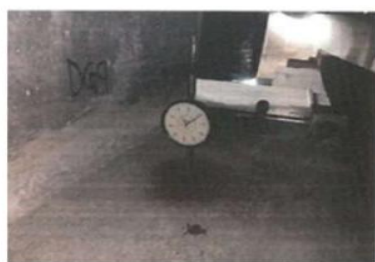
Position of Dial Gauges of foundation and Bearing regions for measurement of settlement and compression

The measured deflection values were corrected by deducting the average settlement of the foundation supports, obtained from the dial gauges installed at pedestal locations during loading and unloading cycles.

The compression of neoprene bearings under load was measured using dial gauges positioned near the bearing zones. The average compression values were subtracted from the observed deflection to obtain the corrected response of the girder.

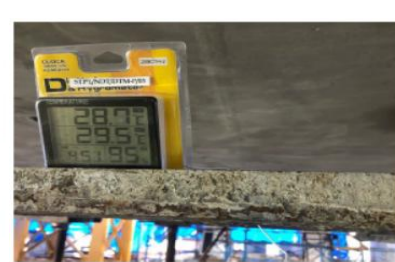
View of Digital Thermometer placed closed to the FSLM girder for measurement of ambient temperature
