An Examination of Surface Morphology and In-Situ Study on ASTM A106-Gr.B 'CUI' Piping in EDC Plant

A.C. Mariappan*, A. Ramesh**

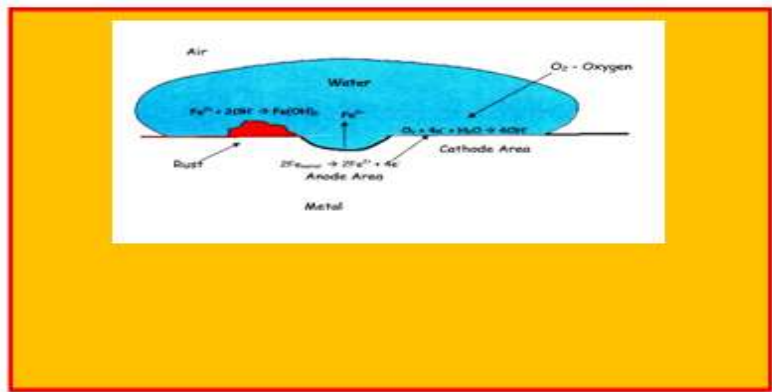
Fig - 1

The formation of rust can occur at some distance away from the actual pitting or erosion of iron as illustrated below. This is possible because the electrons produced via the initial oxidation of iron can be conducted through the metal and the iron ions can diffuse through the water layer to another point on the metal surface where oxygen is available.

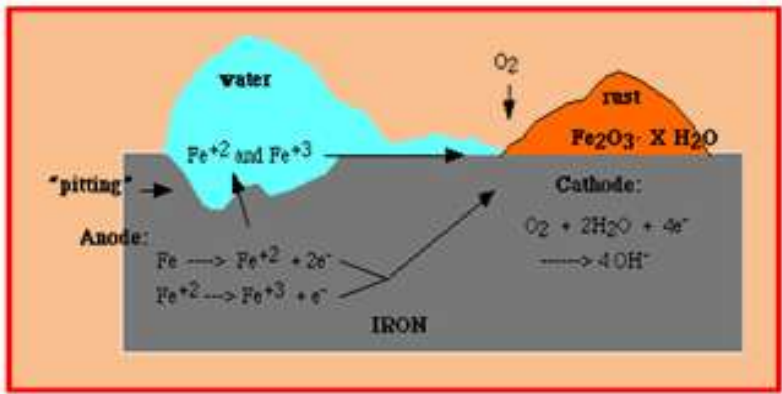
Fig - 2

This process results in an electrochemical cell in which iron serves as the anode, oxygen gas as the cathode, and the aqueous solution of ions serving as a "salt bridge" as shown below.

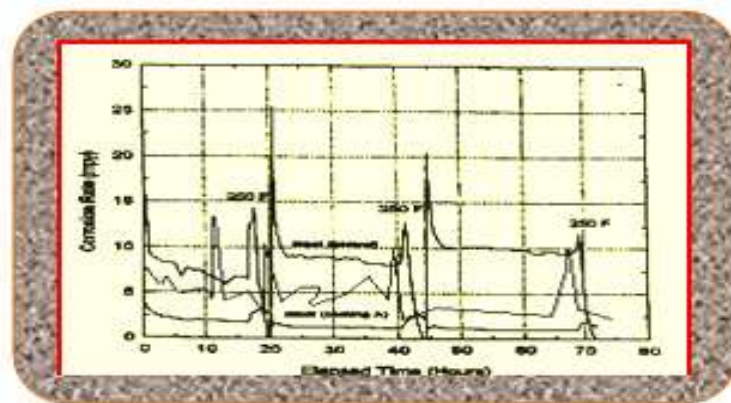
Fig – 3

3.1.2 High temperature: Operating temperature is the next most important element. Above 350⁰F, most moisture CDA algorithm presented in the following Figure considers distance to salt water, leading either to the very severe AA rating for close distance to seashore or a consideration of moisture factors. However, between 10⁰F and 350⁰F is where CUI can happen for carbon steel, and between 140⁰F and 350⁰F for 300 series stainless steel. The "optimum" temperature range for aggressive corrosion on both carbon steel and 300 series stainless steel is between 200⁰F and 350⁰F. In this range, there is plenty of heat energy but not enough of heat to efficiently evaporate moisture before it contacts the equipment surface.
