An Investigation On The Slope Failure Of Bank Revetment Work Along Jamuna River At Chouhali, Bangladesh

Nabila Sumaia Hussain *, Mohammad Mashrur Fateh **

*(Bangladesh Water Development Board, Dhaka, Bangladesh

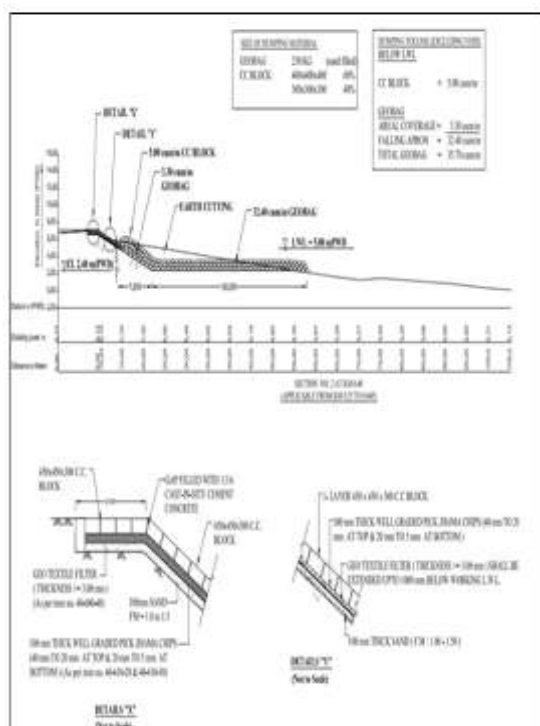
Figure 2.1: Approved design at Chouhali

The calculated design parameters as shown in the above Table indicates that the design of the revetment work at Chouhali is accurate in terms of thickness of cover layer, size and thickness of dumping material, length of launching apron and total dumping volume. The observed scour level is slightly higher than the calculated scour depth which is negligible.

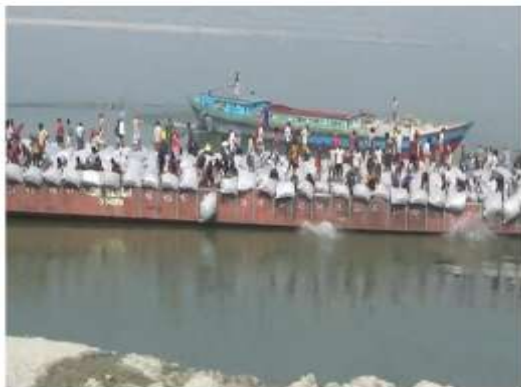
Figure 2.4 : Dumping of geobags

The protective work was implemented in two isolated phases. In the first phase, the erosion situation was controlled by providing under water coverage with sand filled geobags. The river bank was covered with geobags temporarily in the first phase to prevent bank-line shifting. Geobags were placed on a prepared bank slope of 1V:2H which was a deviation from the approved design of 1V:3H bank slope. The dumping of geobags was executed from floating dumping pontoon which was positioned exactly by power driver winches, thus obtained a uniform under water coverage of sand filled geobags. Every dumping of geobags was monitored by global positioning system. The dumping of geobag is shown in Fig. 2.4. The completed temporary wave protection is shown in Fig. 2.5. The first phase started from November 2015 and completed in December 2016.

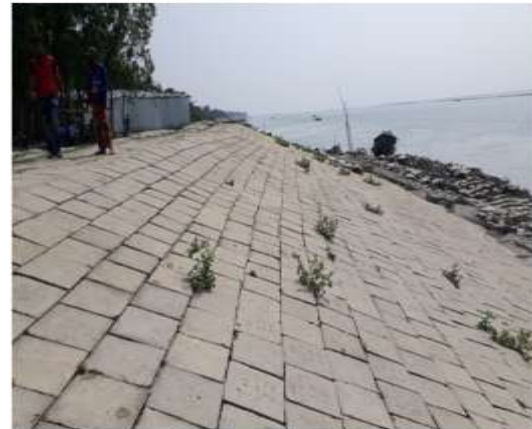
Figure 2.6: Permanent Wave Protection, February 2018

In the second phase, the geobags on the bank slope was removed and the river bank was flattened to a slope of 1V:3H. The permanent wave protection consisting of a 30cm thick layer of concrete slab over filter layer was then constructed supported by a key at low water level covered with 5 m³ concrete block. This phase started from January 2017 and completed within April 2017 (Fig. 2.6).
