Delamination Detection By Thermography

Rashed A.Sultan, Samer W. Guirguis, Mahmoud M. Younes, El-Dessouky
E. El-Soaly

Abstract

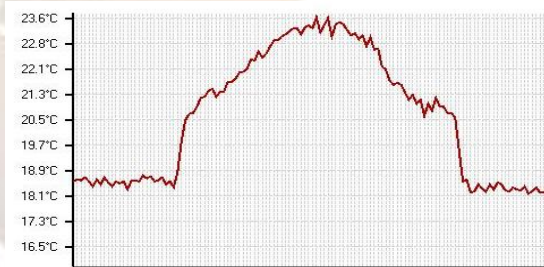
b) Delamination area (50x50) mm²

Figure.4 Surface temperature profiles across the centre line of the plate

Figure.3 (a) and Figure.4 (a) show that the temperature was almost uniform throughout the surface of healthy plate. From the Figure.4 (a) the average temperature across the length of the healthy plate is 22.4°C experimentally. Figures.3 (b, c, d) and Figures.4 (b, c, d) show that there are some non-uniform temperature distributions at the specific location of simulated delaminations, revealing that the plate does have delamination. The approximately maximum thermal contrasts obtained experimentally at the delamination locations were 5.1°C and 5.7°C for delamination areas (50x50 and 100x100) mm² respectively. When the area of the

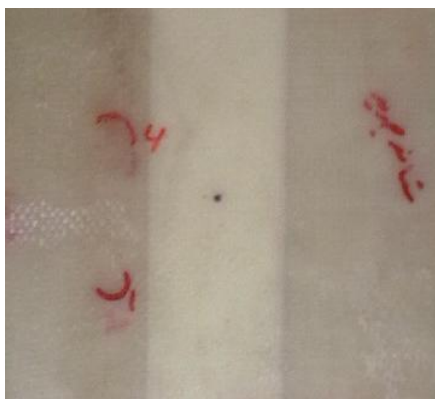
E glass woven with epoxy specimens were fabricated including artificial delaminations located at same depth 1.25 mm Figure.7. The areas of these test samples were (205x205) mm², number of layers was 8 and the area of delamination was (60x205) mm². The simulated test plates used in present

a) Sample 1 (Aluminum delamination)

Figure.7 Test specimens

experiment consist of different delamination thermal properties, such as sample 1 contains simulated delamination Aluminum foil coated with special isolated wax and sample 2 with simulated delamination air gap. All these simulated delaminations have different thermal properties.

1. Air gap delamination, a manufacturing defect where air was trapped between layers of fiber glass so that there was glass fiber but no resin to bond it.
2. Aluminum alloy delamination, an area of specimen whereby one layer of fiber glass has separated from the adjacent layer, by using an Aluminum foil coated with special wax.

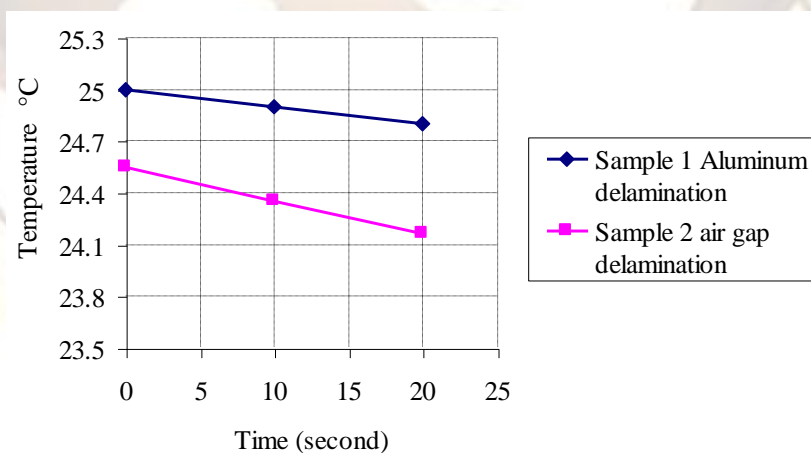
The thermal images show prominent thermal decay when heated for 12 seconds, compared to the case of heating for 7 seconds, the corresponding temperature decay is shown in Figure.10. Sample 1 attains maximum temperature when heated for 12 seconds followed by sample 2.

Figure.10 Temperature decay for different delamination thermal properties heated for 12 seconds
