## Improving Impact Strength Recovery of Fractured and Healed Rice Husks Fibre Reinforced Polypropylene Composites.

Rice husks fibre reinforced polypropylene composite (rhfrpc) is a natural plant fibre reinforced polymer composite having advantages of high strength, light weight and affordability. They are commonly used for light load structural and non structural applications. They are mainly used as particle boards, for fencing post, roofing tiles, for interiors of car and aircrafts among other usages. This material once cracked by impact forces cannot be repaired using traditional repair methods for engineering materials such as metals or other composites that can be repaired by welding or by patch repair methods respectively, thus a method of repair of rice husks fibre reinforced polypropylene composites by refilling the damaged volume by injection of various healing agents has been investigated. The composite coupons were produced by injection moulding, cooled sufficiently and prepared for charpy impact tests. Test results for pristine coupons were a maximum of 48 J/mm<sup>2</sup>. The destroyed coupons were then subjected to healing in a fabricated healing fixture. Healing a

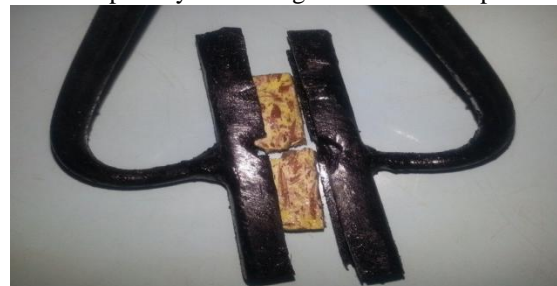
Healing agents (Ethyl cyanoacrylate, Epoxy resin and Tannin gum) were procured from Synresins, Makungu Close, Off Lunga Lungu Road in Industrial area, Nairobi. The fractured surfaces of the tested coupons (destroyed) were examined and loose fibres or matrix removed. The pairs of fractured surfaces were arranged to match, and each pair fitted in a holding fixture for healing such that vertical hole in the fixture was aligned with the area occupied by the damaged volume as in plate 1.

Plate 1. Healing set up.

Healing fixture was fabricated from hollow square mild steel tube of 12.5 mm by 12.5 mm cut all through in the middle and size further reduced at the cut edges to 5 mm from each side. A 2 mm diameter feeding hole for inputting healing agent into the damaged volume was drilled. Each side of the fixture had R8 rod bent and welded to it to act as handle.

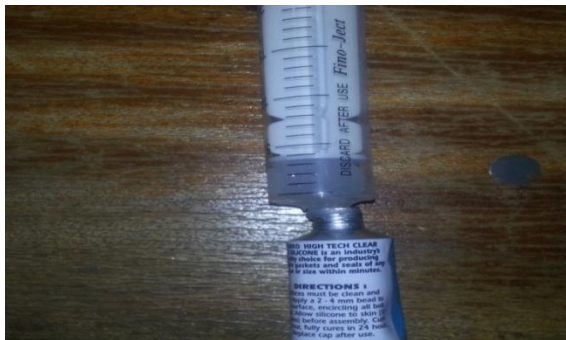
A syringe was used to suck healing agents [ethyl cyanoacrylate, tannin gum and Epoxy resin

(araldite adhesive)], one healing agent at a time for every fractured test piece (coupon) as in plate 2.

**Plate 2.** Sucking of healing agent into syringe

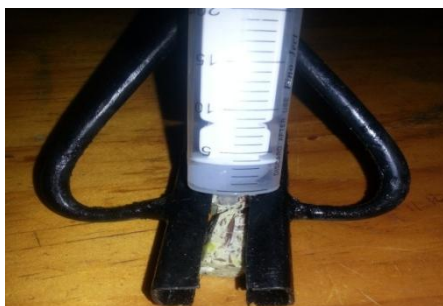
Healing agent was then injected into the damaged volume via a hole in the holding (healing) fixture while the fractured coupon was firmly held into the fixture during curing as seen in plate 3.

**Plate 3.** Curing set up.

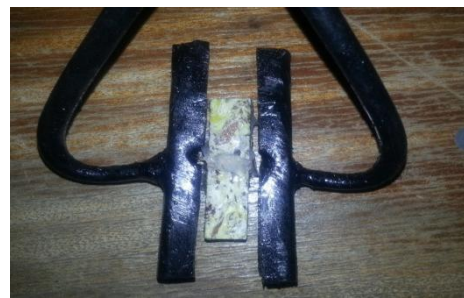
The process was done for all the fractured coupons while varying the curing / healing time in 5 minutes, 10 minutes and 15 minutes. Healed composites were as seen in plate 4.

**Plate 4.** Healed coupon

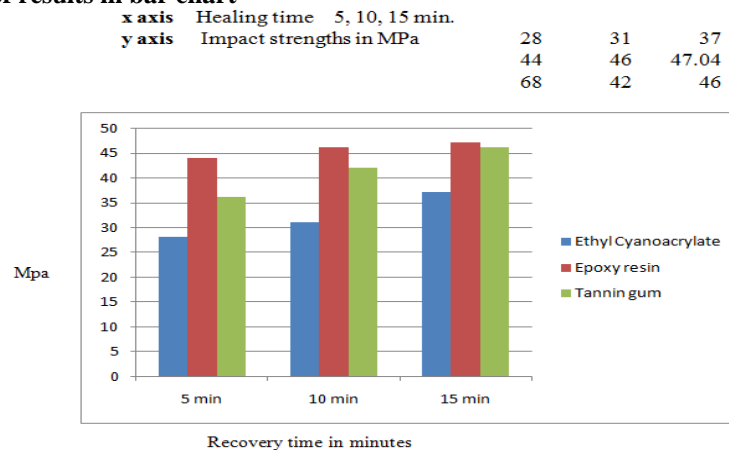
Fig. 1 Graph of recovered impact strengths subjected to unaided healing.

Recovered impact strengths increased with increase in healing time but the difference narrowed with time. Maximum recovered impact strength was obtained from epoxy resin based type of healing agent.

HEALING AGENT	HEALING TIME IN MINUTES		
	5 minutes	10 minutes	15 minutes
ETHYL CYANOACRYLATE	28	31	37
EPOXY RESIN (Araldite)	44	46	47.04
TANNIN GUM	36	42	46

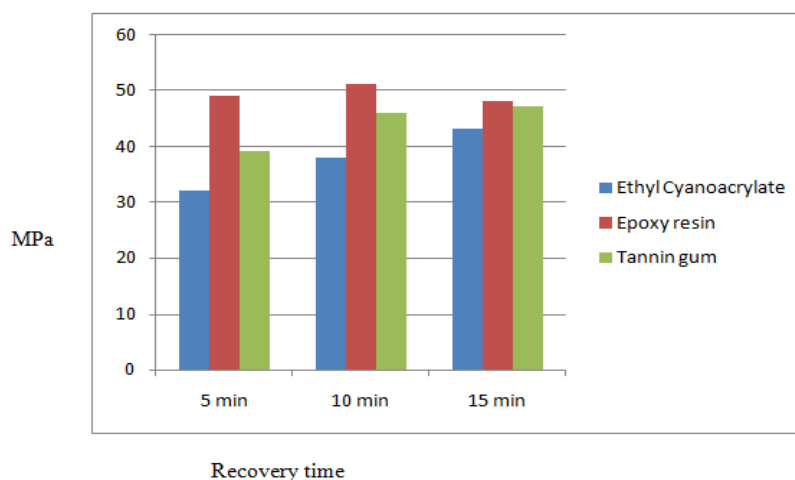
From table 3 (and also in graph 3), the maximum recovered strength is 51 J/mm<sup>2</sup>. Therefore, maximum Impact strength recovery as a % =  $[51/48] \times 100 = 106.25$

**Fig 2.** Graph of recovered impact strengths for coupons healed after fractured surface preparation

Coupons healed after fractured surface preparation had their recovered strengths as recorded in table three. Graph two shows the results in details.

Healing agent	Healing time in minutes		
	5 min.	10 min.	15 min.
Ethyl Cyanoacrylate	32 J/mm <sup>2</sup>	38 J/mm <sup>2</sup>	43 J/mm <sup>2</sup>
Epoxy resin (Araldite)	49 J/mm <sup>2</sup>	51 J/mm <sup>2</sup>	48 J/mm <sup>2</sup>
Bisphenol E cyanate Esters	39 J/mm <sup>2</sup>	46 J/mm <sup>2</sup>	47 J/mm <sup>2</sup>

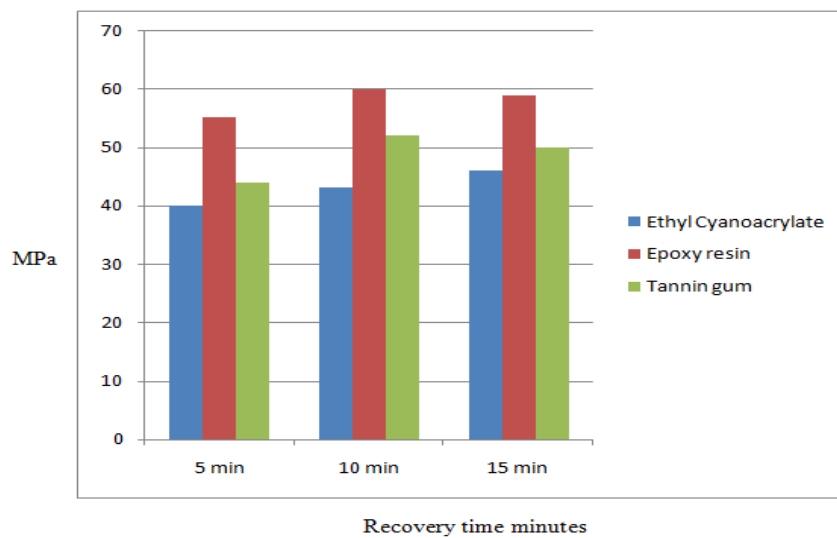
From table 4 (and also in graph 4), the maximum recovered strength is 60 J/mm<sup>2</sup>. Therefore, maximum impact strength recovery as a % was =  $[60 / 48] \times 100 = 125\%$

Fig 3. Graph of recovered impact strengths for healed coupons by application of draught fan

Healing agent	Healing time in minutes		
	5 min.	10 min.	15 min.
Ethyl Cyanoacrylate	40 J/mm <sup>2</sup>	43 J/mm <sup>2</sup>	46 J/mm <sup>2</sup>
Epoxy resin (Araldite)	58 J/mm <sup>2</sup>	60 J/mm <sup>2</sup>	60 J/mm <sup>2</sup>
Bisphenol E cyanate Esters	49 J/mm <sup>2</sup>	52 J/mm <sup>2</sup>	53 J/mm <sup>2</sup>

Preparation of fractured surface removed loose fibres and matrix that could inhibit proper re-creation of fibre-matrix interface during healing and also created a wider area for adhesion of healing agent [13]. A part from capillary action and injection pressure of healing agent from syringe, the application of a drawing force by use of a draught fan aided in better filling of the damaged volume and resulting impact strength recovery was therefore much higher i.e. at 125 %.

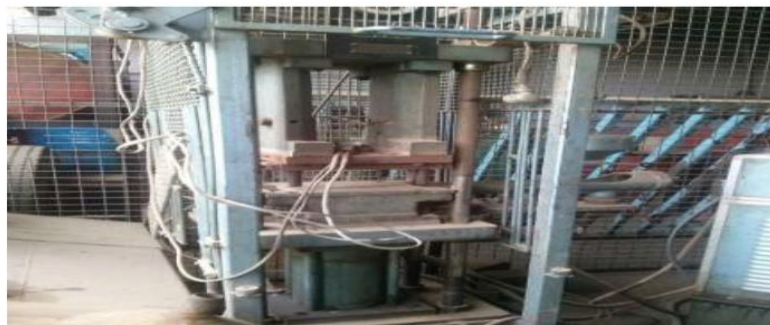
Appendix 1.Moulding equipment

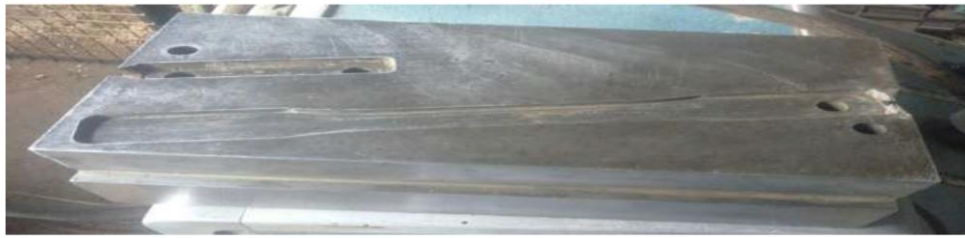
**Appendix 2.** Redesigned lower die

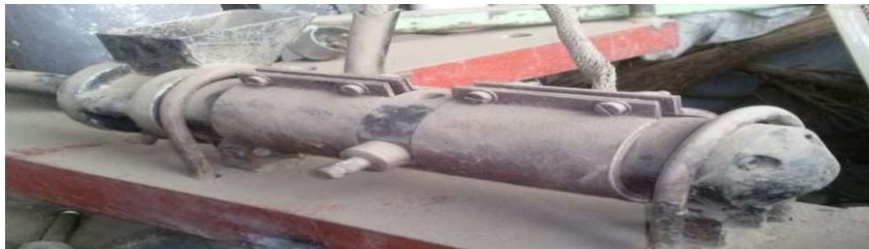
**Appendix 3.** Heating chamber

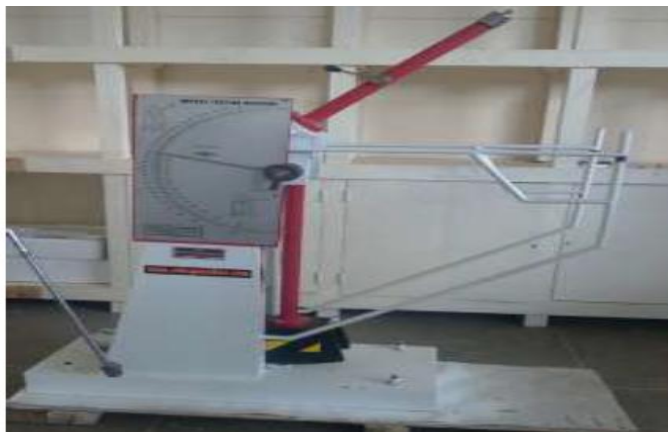
**Appendix 5.** Impact testing machine

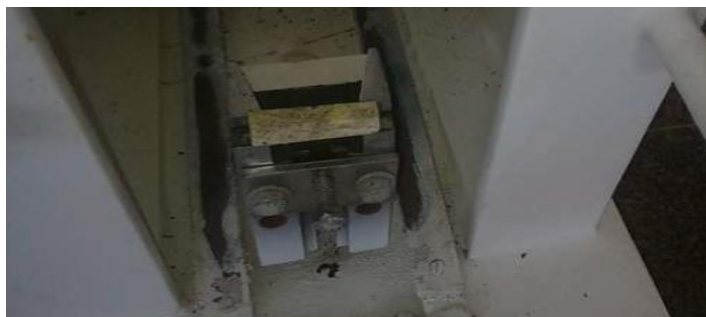
**Appendix 6.** Composite set for destructive impact test

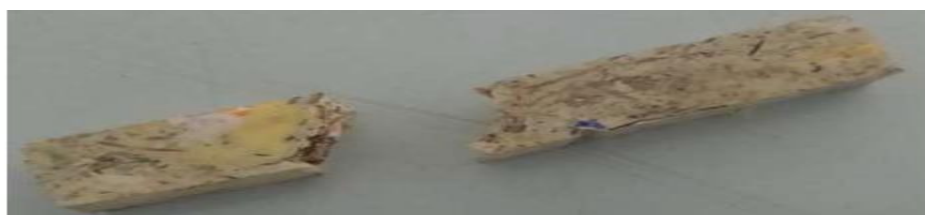
**Appendix 7.** Fractured rice husk reinforced polypropylene composite
